Fiber-Reinforced Polymer Pipe Lining

Emergency repair to penstock allows power plant to enter service

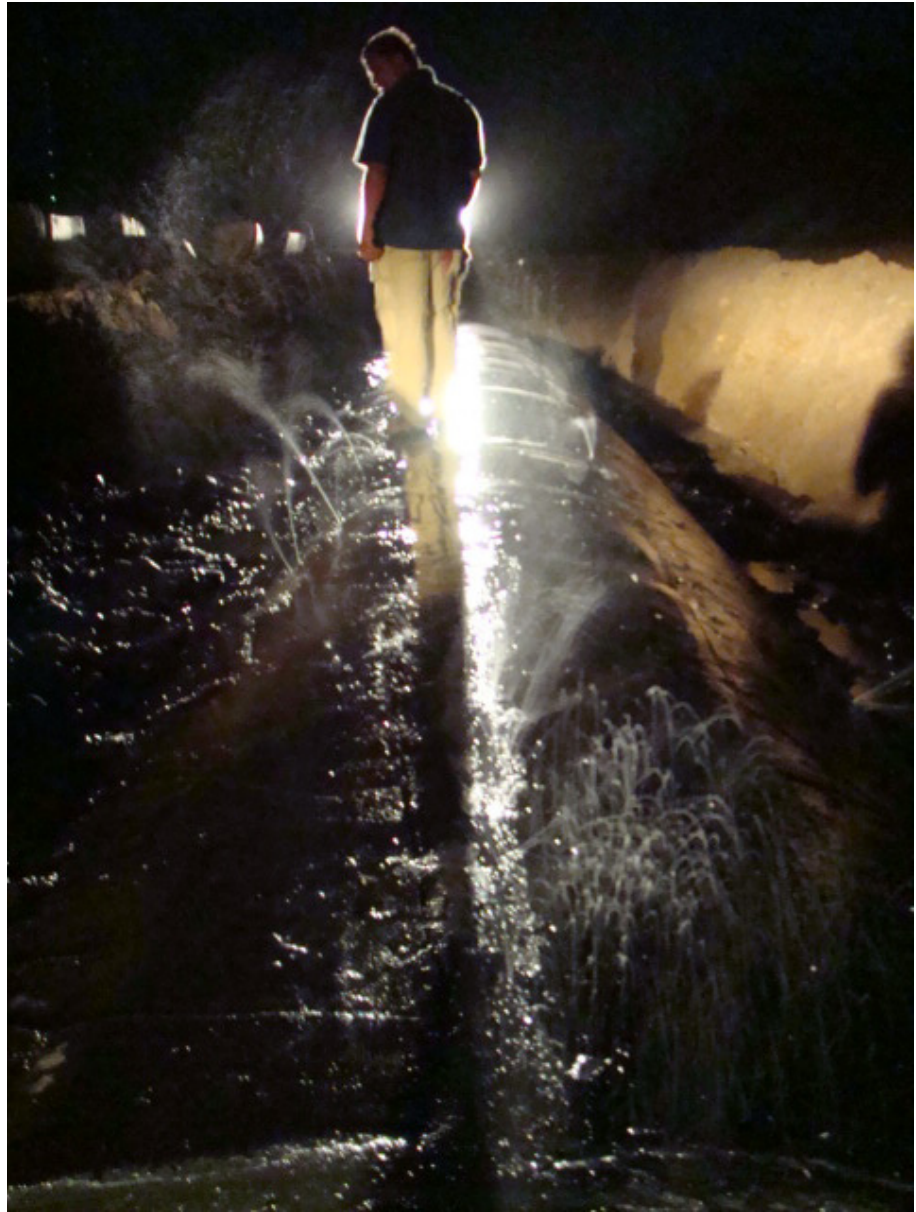
Before it was placed in service, a pressure test showed that the pipe had significant longitudinal and transverse cracking. As a result, as much as 20% of the flow was lost due to leaks. The penstock was drained and all visible cracks were sealed using locally available repair materials; but when it was pressurized for a second time, the repaired cracks continued to leak (Fig. 2).

Fig. 2: After conventional crack sealing, the penstock failed to pass a second pressure test.

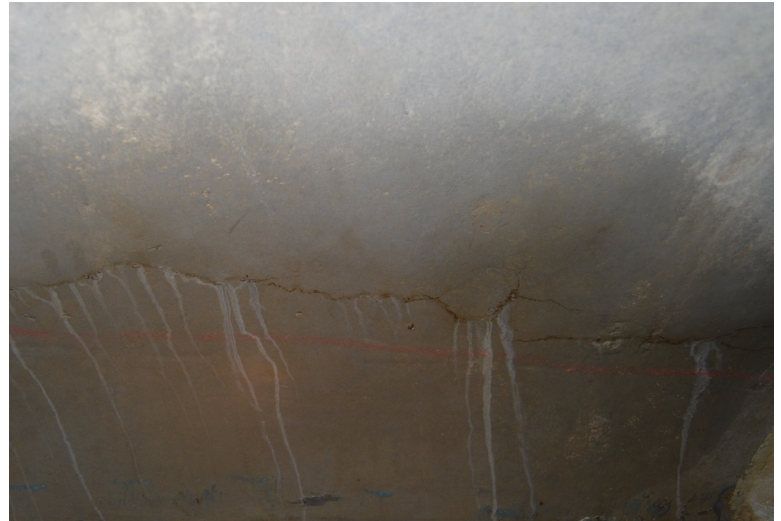
We were then contacted to engineer repairs. After inspection of the cracks (Fig. 3), review of the structural plans, and consideration of the engineering reports pertinent to the leak issues, we determined that an FRP lining would provide a solution.

Fig. 3: A typical crack in the pipe wall

The FRP lining was designed to bridge cracks in the concrete, provide a moisture barrier, and supply additional hoop strength to compensate for future loss of circumferential steel due to corrosion. We designed the adhered FRP laminate to achieve full deformation compatibility with the pipe during pressurization, and we specified bidirectional glass fibers in the fabric to ensure that existing or future cracks are intercepted in orthogonal directions. It should be noted, however, that although the laminate will prevent water from leaking from or into the pipe, corrosion of the steel reinforcement will not be slowed significantly in this case due to the constant presence of seepage water in the cracks.

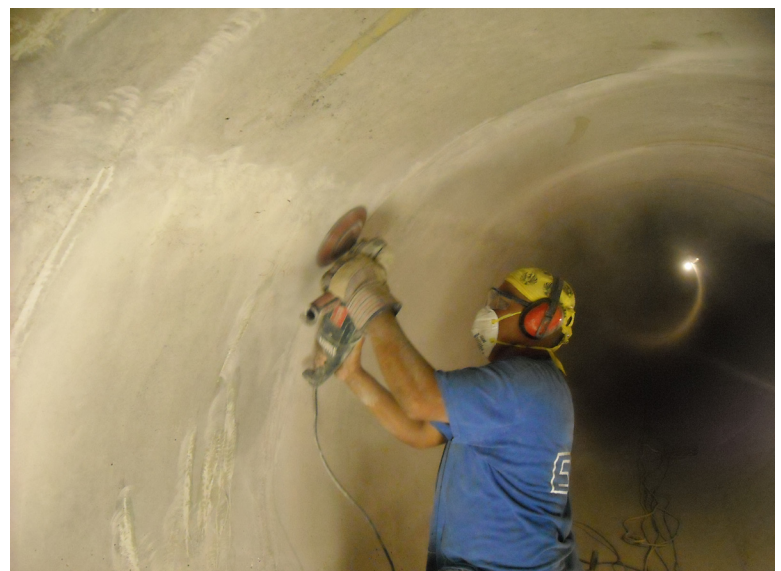
Fig. 4: Prior to installation of the FRP lining, surface preparation included grinding

Before an FRP lining can be applied, the substrate must be prepared to maximize contact and bond strength. The inside of the pipe was pressure washed with 7,000 psi (50 MPa) machines to remove scour, sediment, curing compounds, and any other substance that could hinder the bond between the FRP and the pipe surface; surface irregularities (such as roughness at construction joints and fins at formwork joints) were ground smooth (Fig. 4).

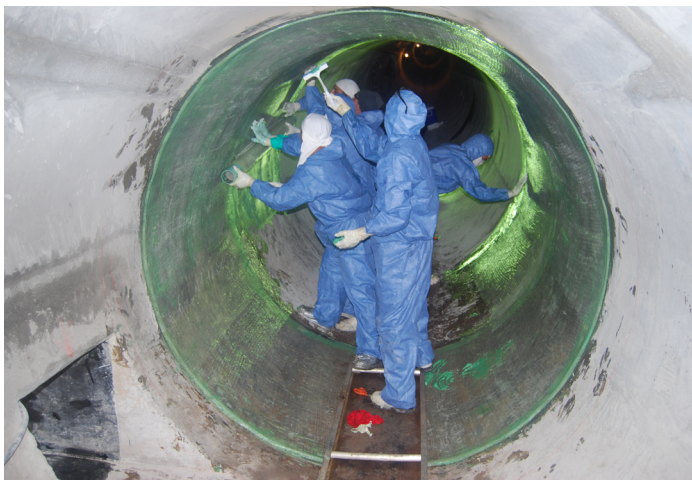
Fig. 5: Installation of FRP sheets on the interior surface of the pipe. An access point is visible at the lower left

To help prevent the joints in the lining from being lifted by the water flow, the installation direction was opposite to the flow direction. An installation crew initially applied an epoxy paste to the top half of the penstock. This not only sealed the surface of the concrete to prevent the dry concrete from absorbing excessive resin from the saturated fabric but also prevented peeling of the saturated FRP fabric before the resin cured. Figure 5 shows the installation of the first roll of FRP lining material at one of the installation stations. After they were saturated with resin, 50 in. (1,270 mm) wide bands of fabric were rolled onto the prepared surface—much as one would install wallpaper.

Because gravity helped to hold the FRP fabric in place, only a seal coat of epoxy resin was used to prevent the dry concrete from absorbing excessive resin from the fabric in the lower half of the pipe. The edges of the fabric bands were lapped in the circumferential and longitudinal directions to achieve full continuity of the FRP. To help prevent delamination, the edges of the laps were feathered with epoxy paste or resin.

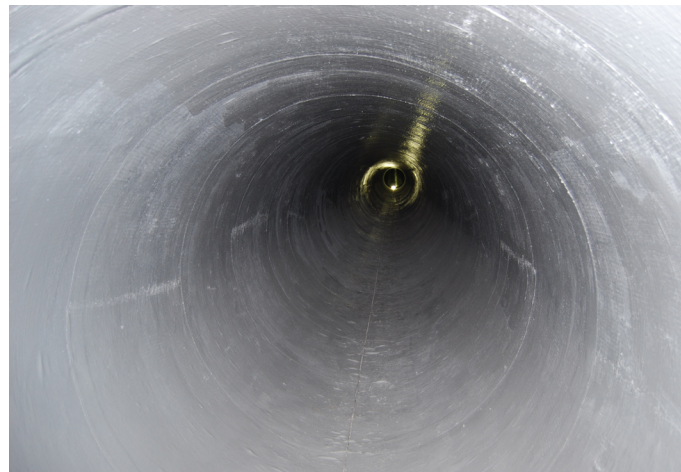
Fig. 6: Completed lining, including gray top coat, prior to testing

The final step involved installation of an epoxy top coat as a cover for all the installed FRP. This coat was designed to protect the laminate against abrasion caused by sediment carried by the river water as well as to cover possible pinholes in the FRP lining. The coating has a concrete gray color to facilitate quality control by providing a visual indication that the light green-colored FRP lining was fully covered. The top coat application took place before the lining was fully cured (the lining surface was tacky on contact) to ensure maximum bond.

The average rate of production of each of the four installation stations was 2,500 ft.² (230 m²) of FRP lining installed in an average 8-hour work day. The operation continued 7 days a week, allowing the complete installation of approximately 150,000 ft.² (14,000 m²) of the FRP lining system in 15 calendar days. This time included the application of the epoxy top coat. The FRP lining installation was completed on July 8, 2009 (Fig. 6), and pressurized test runs were successfully completed on July 15.
