WORLD'S LARGEST PROJECT ON PIPE RENOVATION WITH FRP COMPLETED AHEAD OF SCHEDULE

Mo Ehsani, Ph.D., P.E., S.E. & Carlos Peña, M.S., P.E.

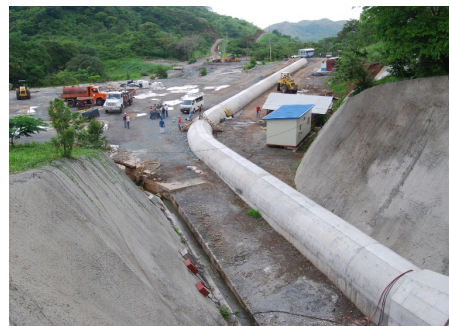
Figure 1: Above ground segment of the "El Encanto" pipeline

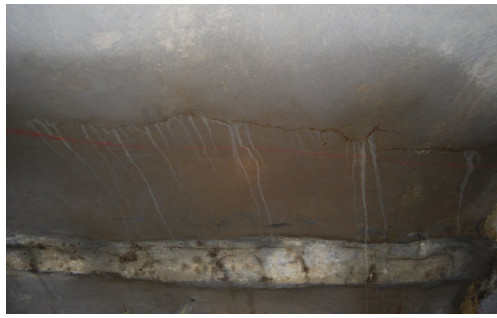
Figure 3: Seepage water draining into pipeline

water was observed draining through some of the longitudinal cracks (Figure 3). It was at this point that Quake-Wrap's Mexico (QWM) office was contacted for engineering consultation to repair the longitudinal cracks. A site visit was quickly arranged for one of QWM's structural engineers. The engineer inspected the cracks, reviewed structural plans and available local engineering reports pertinent to the leak issues, and identified the main cause of the problem.

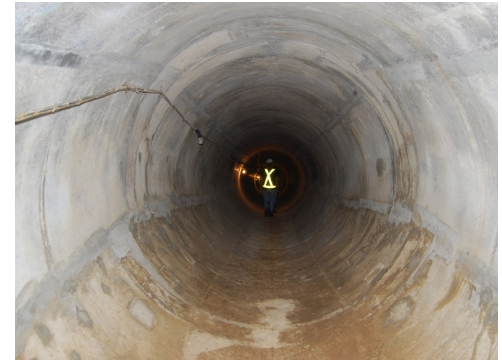
such as Prestressed Concrete Cylinder Pipe (PCCP). Figure 4 shows the typical condition of the interior surface of the pipeline prior to initiating prep work activities. Evidence of cast in place procedures can be observed, such as construction joints, formwork fins, etc. The pipeline was pressure washed with 7,000 psi (482 bar) machines to remove any scour, sediment, and curing compounds, or

Figure 4: Initial interior surface conditions of the pipeline

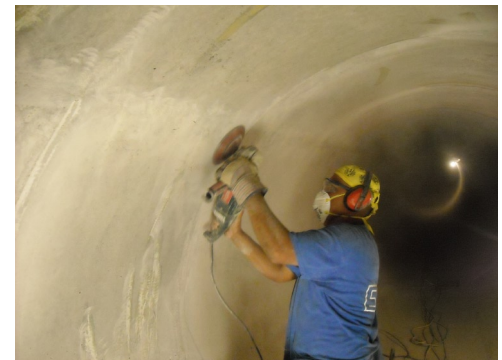
Figure 5: Prep work activities prior to installing FRP lining

any other substance that could hinder the bond between the FRP and the pipe surface. Figure 5 shows grinding of protrusions on the interior surface of the pipeline.

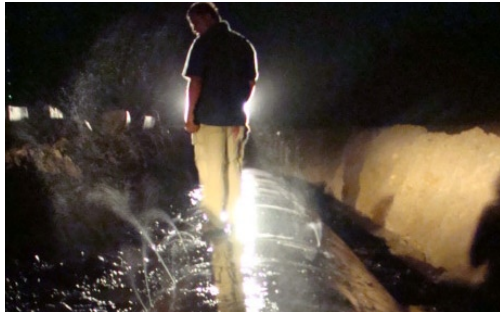
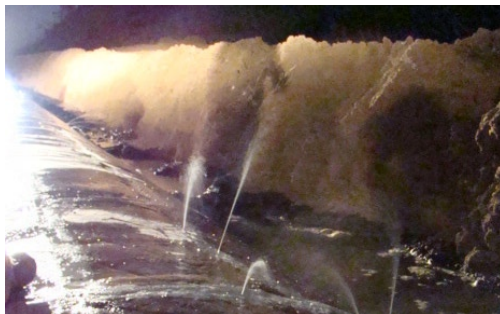
able locally. When the pipeline was pressurized again, the repaired cracks again leaked. The leaking at the repaired cracks was most likely due to the increase in the crack width due to the deformations of the pipeline caused by the increase in internal pressure. Given the rigidity of most crack sealing materials, full deformation compatibility between the repair material and concrete could not be

Figure 2: Leaking after conventional crack sealing

achieved, degrading the seal and allowing leaks to reoccur. Figure 2 illustrates typical leaks occurring at two locations along the length of the pipeline during tests conducted at maximum operational pressure.

An FRP lining consisting of one layer of bidirectional glass fabric was designed to provide a humidity barrier, to provide an effective crack control mechanism, and to provide additional hoop strength to account for a significant loss of hoop steel due to corrosion. Since in all likelihood the corrosion process at the reinforcing steel had already started due to the two-way humidity paths occasioned by the existing cracks, the additional

Moreover, the adhered FRP laminate was designed to achieve full deformation compatibility with the pipe as the pipe expands due to pressurization, and the bidirectional orientation of the high strength glass fibers in the fabric guarantees that existing and/or future cracks are intercepted in orthogonal directions providing superior crack control. Nonstructural linings, on the other hand, cannot serve as an effective crack control mechanism.

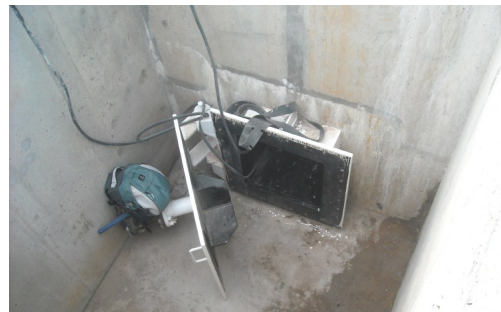
The 5,742 ft. long pipeline had four lateral access points at the locations of relief valves, with spacing ranging from 1,000 ft. to 1,500 ft. These 24" x 24" access points (Figure 6) were

Figure 6: Typical 2 ft. x 2 ft. access point

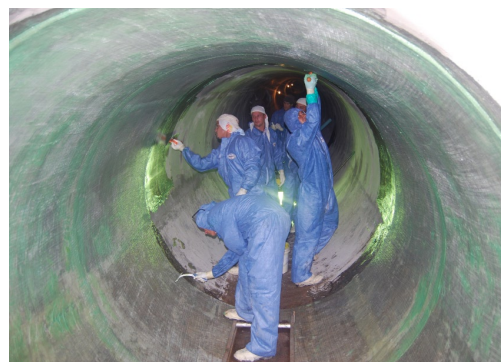
Figure 7(a): Epoxy paste installation on top half of pipeline

Figure 7a illustrates the application of an epoxy paste to the top half of the pipeline; the main purpose of the paste is to prevent peeling due to the weight of the saturated FRP fabric, and to seal the surface to prevent excessive absorption by the dry concrete surface of the epoxy resin from the saturated FRP fabric. Figure 7b shows the installation of the first roll of FRP lining material at one of the

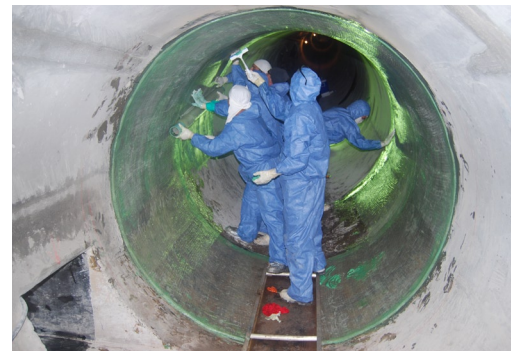
Figure 7(b): Installation of FRP lining

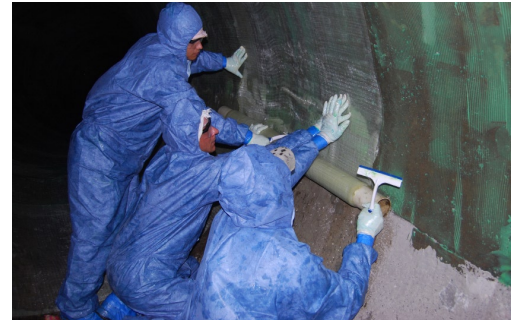
Figure 7(c) Transitions between top and bottom half installation

installation stations. The access point is clearly visible on the lower left portion of the figure. Figure 7c shows the transition between the top and bottom half installation. Notice that there is no epoxy paste used in the lower half. Since gravity effects in this area tend to hold the FRP fabric in place, only a seal coat of epoxy resin was used to prevent excessive absorption from the saturated fabric. Figure 7d illustrates overlap and fabric edge detailing. Detailing is done with epoxy paste and/or epoxy resin to feather down edge fibers, and to secure in place the overlaps in the lining.

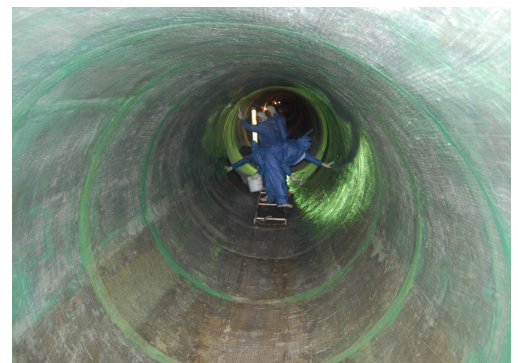
Figure 7(d): Detailing of FRP lining

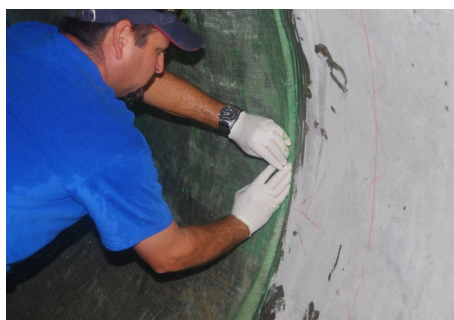
Specially designed construction joints (Figure 8) were prepared at the starting point of each installation run, which also became the end points of the installation front that started at a downstream access point. The joint was later sealed with an epoxy paste. Nowhere in the 5,742 ft. length of the pipeline were FRP lining edges left exposed to peeling from water

Figure 8: Construction joint of FRP lining

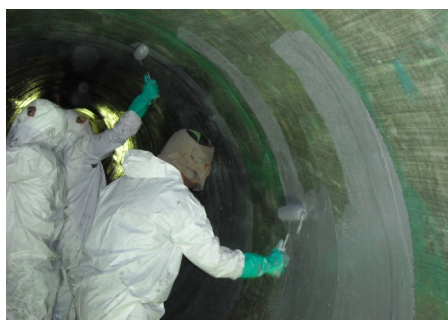
Figure 9: Application of epoxy top coat

viously, was used to provide abrasion protection for the FRP, as well as to seal any remaining pores in the installed FRP laminate. Figure 9 shows the application of the top coat. The application took place before the lining was fully cured (surface was still tacky on contact) to ensure maximum bond.

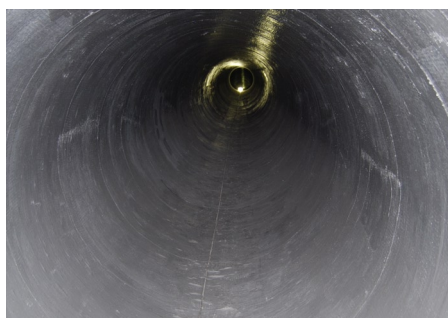
Figure 10: Completed segment of the FRP installation

The FRP lining installation was completed on July 8th, 2009, and pressurized test runs were successfully completed. Figure 10 shows a completed lining installation prior to testing.
