**ASSESSMENT AND REHABILITATION
OF WEST 7TH STREET BRIDGE
FULTON, MO**

August 2002

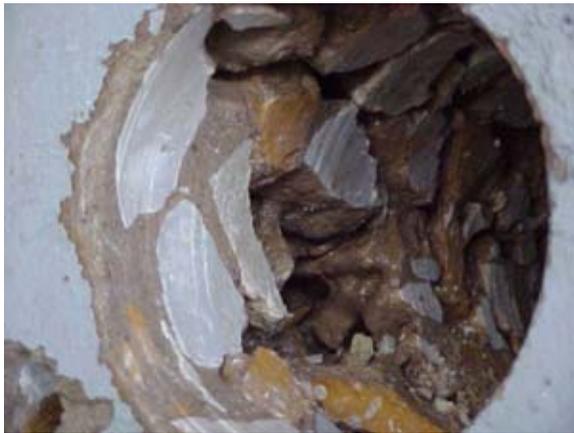
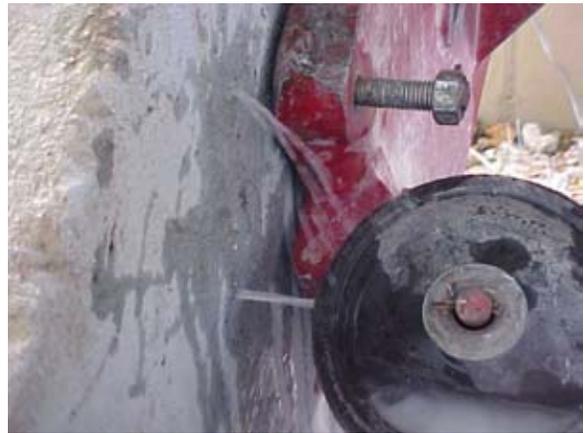
Figure 3-2. Concrete Condition in South Rib

Concrete was cored from the east side of both arch ribs, close to the abutment. Visual inspection of the concrete in the north arch rib showed material soundness; whereas, concrete in the south arch rib allowed to observe some deficiencies, basically presence of air pockets and honeycombs (see 3-2a). During the coring, the water used to operate the coring machine, did flow out of the rib indicating that air pockets were spread throughout the region (see 3-2b). The area exhibiting honeycombs will require to be pressure-injected with a fine grout. The extension

of the air pockets and honeycombing can only be determined with a thorough inspection of the entire bridge.

(a) Air Pockets

(b) Water flowing out

The areas having honeycombs or large voids will be repaired by internal grouting of a hydraulic cement-based material.

- Repair of spalled areas of concrete needs to be conducted
- The concrete in the south arch rib exhibiting air pockets and honeycombs needs to be grout injected
- Shear and flexural capacities of RC members need to be upgraded using a CFRP system

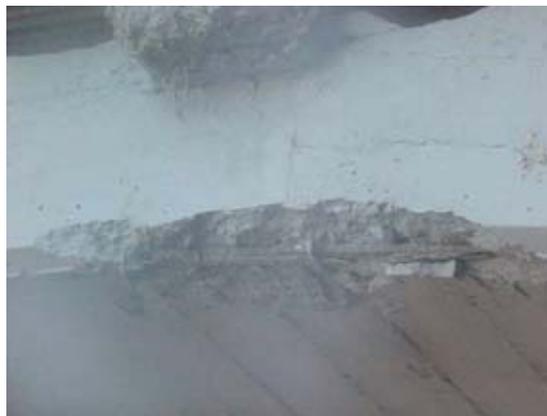
Figure 3-3. Reinforcement Exposed in the Bridge Crown

Some areas of the bridge exhibited concrete spalling and delamination caused by corrosion of steel reinforcement, as a consequence the reinforcement is exposed in some regions, mainly in the bridge crown (see 3-3). The repair work will include the replacement of the affected parts and restoration of the cross section with a no-shrinkage cementitious mortar.

The repair work of concrete will include the replacement of the affected parts and restoration of the cross sections. The procedure to follow can be summarized as:

- Location and marking of delaminated concrete areas using a hammer sounding technique.
- Removal of delaminated concrete until a minimum depth of ¾” under the corroded steel bars.
- Sawcutting of concrete in the periphery of the affected area to prevent feather edged conditions.
- Sandblasting and exposing of steel reinforcement to remove rust and scale. Surface cleaning is required to achieve an adequate bonding between the repair and the existing concrete.
- Impregnate an epoxy bonding agent to exposed areas. The material must meet the requirements specified by ASTM C881 (Epoxy-Resin Based Bonding Systems for Concrete)
- Guniting back using a design mix having a compressive strength of 5000 psi and finishing of surface.

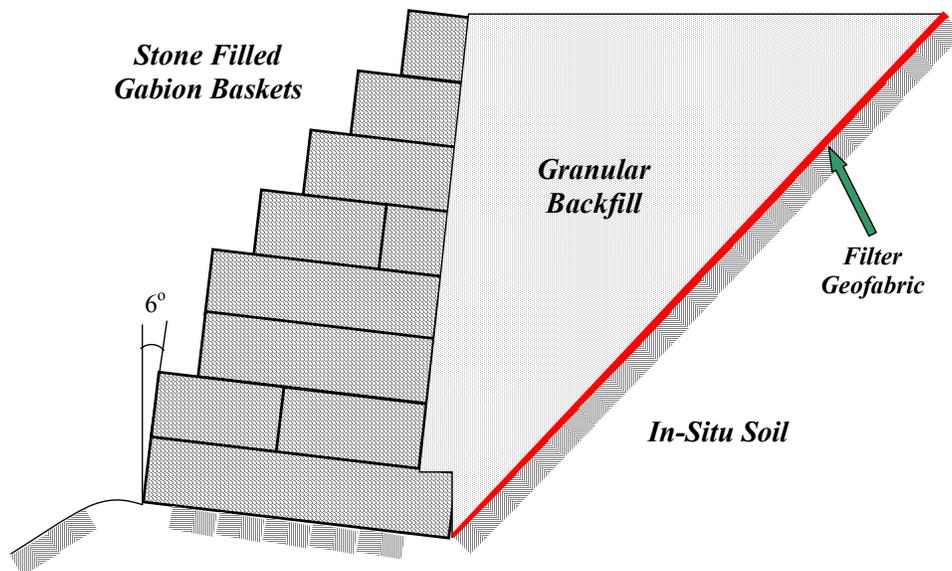
Table 4-1. Gabion Wall Conceptual Design

In-situ soils consist of soft to medium stiff, low plasticity silty clay fill with trace to some gravel. It appears that placement of this fill was not performed adequately, resulting in highly variable consistencies within the soil mass. The fill has continued to settle and creep under its own weight, resulting in increased lateral loads on the wingwalls. The increased lateral loads in combination with the lack of adequate reinforcement of the wing wall sections has resulted in considerable wall cracking and lateral displacement.

It is recommended that gabion walls be used to replace the existing wing walls at the bridge. Gabion walls are deemed to be the most practical and economic option for this site. The gabion wall is to be supported on the weathered limestone layer encountered at the site. Backfill behind the gabion wall may consist of clean gravel, with a filter geotextile between the gravel and in-situ soil.
