# **Performance of an RC Corner Beam-Column Joint Severely Damaged under Bidirectional Loading and Rehabilitated with FRP Composites**

**by M. Engindeniz, L.F. Kahn, and A.-H. Zureick**

**Synopsis:** This paper presents the performance of a full-scale reinforced concrete corner beam-column-slab specimen that was first severely damaged under bidirectional quasi-static loading, then rehabilitated and retested. The specimen was built using the pre-1970s construction practices including the use of low-strength materials (3000 psi [21 MPa], Grade 40 reinforcing bars) and deficiencies in reinforcement detailing. The rehabilitation process consisted of: (1) epoxy injection, (2) addition of a bar within the clear cover of the column at the inside corner, and (3) external application of a multilayer composite system made of unidirectional carbon-epoxy layers placed at different orientations. The carbon fiber-reinforced polymeric system was heat-cured at a temperature of  $80^{\circ}\pm10^{\circ}\text{C}$  ( $176^{\circ}\pm18^{\circ}\text{F}$ ) for 6 hours. The performance was evaluated both before and after rehabilitation based on the progression of damage and the hysteretic behavior incl

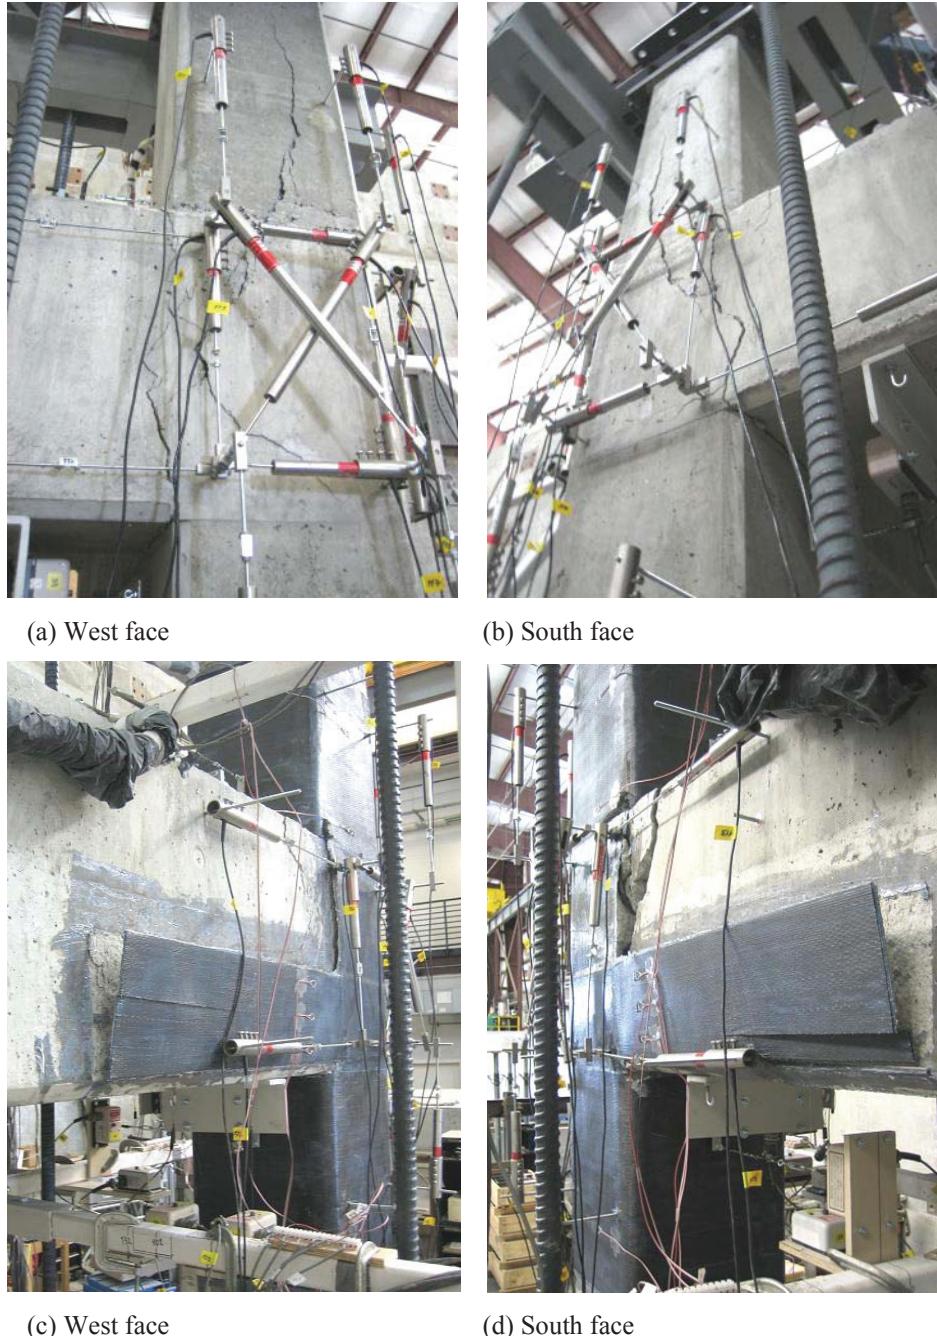
3. Joint shear cracking during the negative load steps. [Figure 5](#) shows that diagonal cracking in the joint occurred in one direction only and not in the often recorded "X" manner, because the loss of anchorage of the beam bottom bars prevented the formation of the other diagonal crack. The maximum width of the joint shear cracks was 0.04 in. (1.0 mm) during the unidirectional cycles. During the bidirectional cycles, they not only opened wider in the plane of the joint panel, but they also exhibited bulging in the direction perpendicular to the surface due to rotation of the hooked beam top bars. At the second peak at -0.93% bidirectional drift, these cracks had joined those at the bottom of the beam and reached a width of 0.07 in. (1.8 mm) to 0.08 in. (2.0 mm).

4. Propagation of cracks into the upper column. At the first peak at -1.40% drift, the diagonal crack in the joint panel propagated vertically into the upper column forming a combined crack extending from the bottom of the beam into the upper column, exhibiting a bulging of up to 0.25 in. (6.4 mm) in the later cycles. At the end of the test, this crack measured 0.31 in. (7.9 mm) wide at the beam embedment region, 0.25 in. (6.4 mm) wide in the joint panel, and 0.125 in. (3.2 mm) in the upper column ([Figure 5a, b](#)). The cracks in EW and NS faces were connected through the joint at an angle of roughly 45 degrees, forming a large triangular prismlike concrete block trying to separate from the outside corner of the column. The two stirrups along the column lapped splice resisted this separation by developing strains as high as 1550  $\mu\epsilon$  in their S and W legs.

the beam-joint interfaces during the  $\pm 1.87\%$  drift cycles, the failure of the joint required a drift of  $-3.73\%$ , at which point the beams had undergone significant yielding and damage. The failure of the joint involved crushing of the joint core and separation of the FRP system with large pieces of the joint concrete attached to it. This indicated a remarkable performance of the FRP system in maintaining the bond to concrete until the failure of the joint concrete.

Figure 5 — Damage at the end of test: (a, b) before rehabilitation at cycle point 12a, and (c, d) after rehabilitation at cycle point 15a.

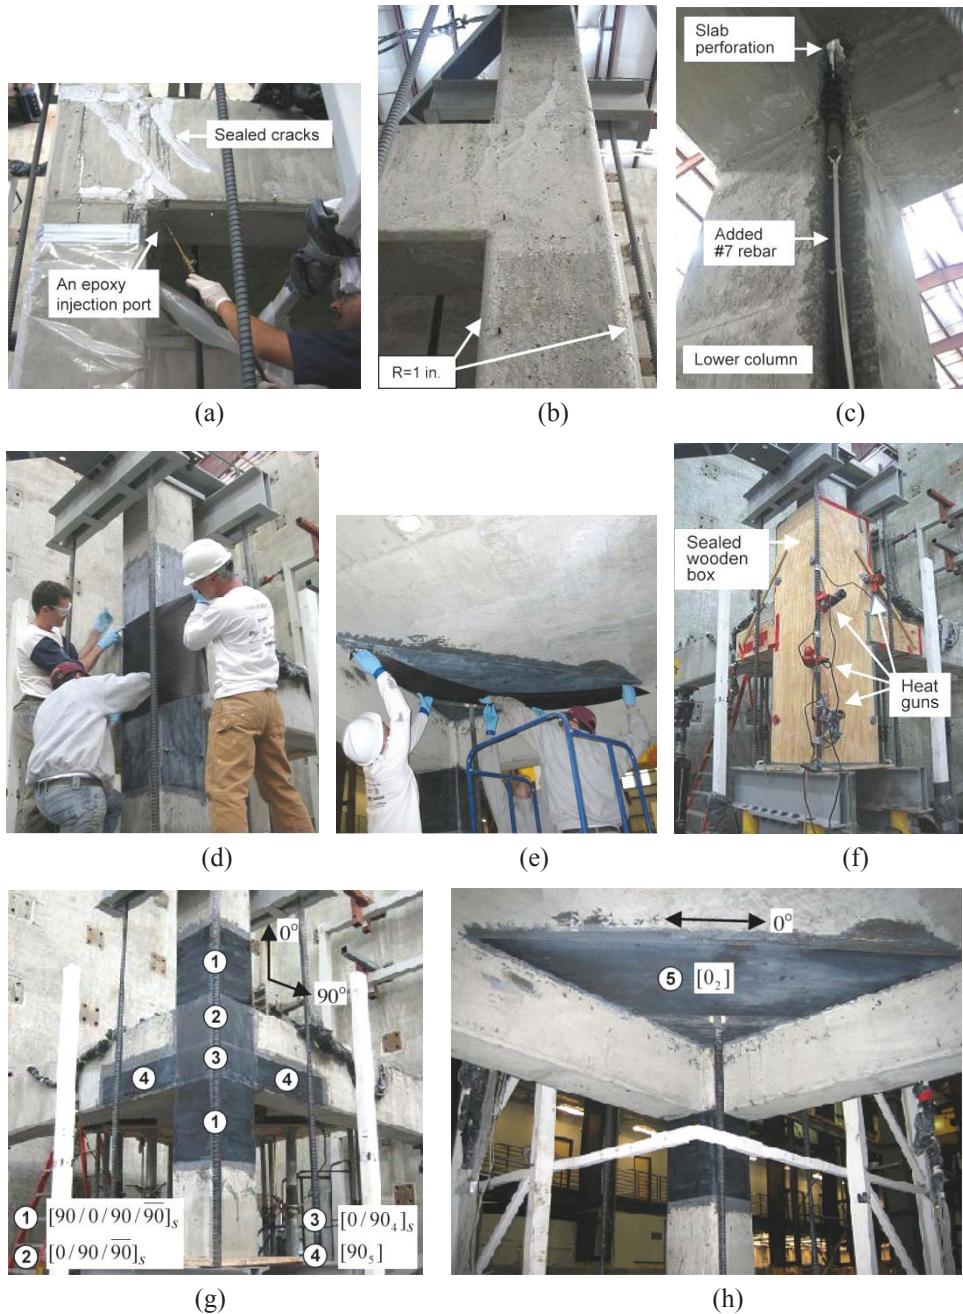
2. **Beam bottom bar anchorage.** The FRP strips bonded on the beams ("4" in Figure 10g) prevented the distress from concentrating at the column face. At the third peak at +0.93% bidirectional drift, distress consisted of 0.01 in. (0.3 mm)-wide flexural cracks at the bottom surfaces of the beams distributed over a distance of 50 in. (1270 mm) from the column face, and cracks at the beam-column interface measuring 0.01 in. (0.3 mm)-wide under the FRP strips and 0.04 in. (1.0 mm)-wide near the inside corner of the column. At the first peak at +1.40% drift, a complete debonding of the FRP strips on the NS beam took place suddenly, initiating at the beam-column interface and moving along the beam. The FRP strips developed a maximum strain of 4570  $\mu\epsilon$  at the level of the beam bottom bars. The strips on the EW beam were debonded over a distance of 10 in. (250 mm) from the beam-column interface, and complete debonding did not occur until the first peak at +1.87% drift. A maximum strain of 3920  $\mu\epsilon$  was developed in these EW strips. After debonding of the FRP strips, the beams lost much of their improved behavior in positive bending. A thin layer of concrete attached to the debonded strips indicated the need for better anchorage schemes for these strips so the resulting interfacial and normal stresses can be maintained by the concrete.

3. **Joint shear capacity.** The problem of joint shear failures prior to ductile failure of the beams was resolved. Although very small portions of the FRP system in the joint ("2" and "3" in Figure 10g) started to debond near

Figure 10 — Rehabilitation process: (a, b) epoxy injection and surface preparation, (c) addition of a #7 reinforcing bar, column inside corner, (d, e) CFRP application on column and bottom of slab, (f) heat-curing of CFRP, and (g, h) finished look.

All rehabilitation steps were performed at the deformed position used as reference for cyclic loading. The specimen was first repaired by pressure-injection of a high-strength, high-modulus, low-viscosity epoxy that filled all cracks larger than 0.01 in. (0.3 mm) [Figure 10a]. The injection of approximately 2 gal. (7.6 L) of epoxy confirmed the severity of damage in the specimen.

1. **Flexural strength of the column.** The higher force demand on the inside corner of the upper column required addition of flexural reinforcement along the entire height of the column and continuous through the slab. The amount of existing column longitudinal reinforcement (2#5) at this corner was doubled by removing a 2 in. x 2 in. (50 mm x 50 mm) portion of the column corner including a perforation in the slab, adding a #7 bar ( $f_y=65 \text{ ksi}$  [448 MPa]) (Figure 10c), and recasting the corner with a polymer-modified, cementitious mortar ( $f'_c=7200 \text{ psi}$  [49.6 MPa] on the test day).
2. **Joint shear strength.** The maximum horizontal joint shear force ( $V_{jh}^{\max}$ ) that could develop was estimated by assuming yielding of all beam top bars and the three slab bars within 20 in. (510 mm) (ACI 318-05, Sec. 8.10.3) next to the beams:

5. **SW corner of the slab.** A 48 in. x 48 in. (1220 mm x 1220 mm) triangular portion of the bottom surface was strengthened with two layers of CFRP to increase the flexural strength to an extent required by ACI 318-05, Sec. 13.3.6. The fibers in both layers were oriented in the NW-SE direction (“Area 5” in [Figure 10h](#)). Strengthening at the top surface was deemed unnecessary due to limited cracking in this region.
