REPAIR OF CRACKED ALUMINUM OVERHEAD SIGN STRUCTURES WITH GFRP COMPOSITES

By Chris P. Pantelides¹ and Justin Nadauld²

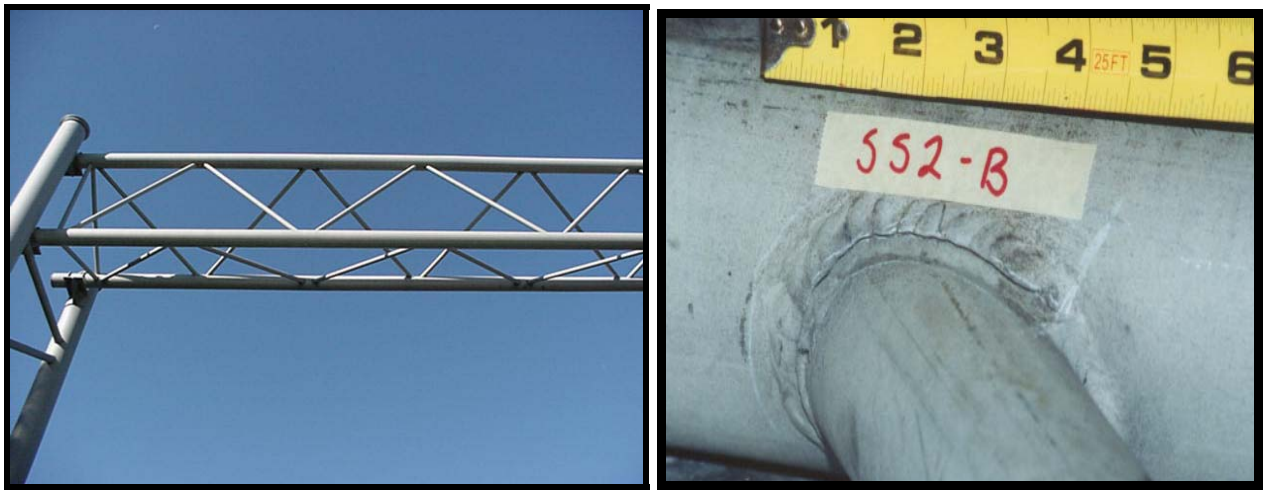
The repaired aluminum tube field specimens had cracks in the weld, induced by fatigue, which went all the way through the thickness of the weld, and varied in length. The length of the crack was measured around the circumference of the diagonal before application of the GFRP

composite. Specimen SS1-A had a crack that was 140 mm (5.5 in.) long which corresponds to 52% of the total weld length; specimen SS2-A had a 64 mm (2.5 in.) long crack corresponding to 24% of the total weld length; and specimen SS2-B had a 178 mm (7.0 in.) long crack corresponding to 66% of the total weld length, as shown Fig. 1. The GFRP composite repair design details were the same for all repaired specimens as outlined in the section on GFRP composite application. It is interesting to note from the results, shown in Fig. 7, that all three repaired specimens (SS1A, SS2A, and SS2B) failed at similar loads regardless of the crack length. This demonstrates the effectiveness of the GFRP composite repair regardless of the crack length. The failure mode was similar to that of specimen SS1-B, which involved complete weld failure followed by tensile failure of the GFRP composite; as the weld began to fail, the GFRP composite took over and carried the load until the GFRP failed in tension. As in test SS1-B, before the weld completely failed, both the weld and the GFRP composite were carrying the load. This explains why the cracked welds failed at similar loads – even though the original crack lengths in the weld differ significantly. However, from Fig. 7 it can be observed that the specimen with the largest crack in the weld (SS2B) failed at the smallest applied displacement (16.9mm or 0.664 in.), and the specimen with the smallest crack (SS2A) failed at the largest vertical displacement (26.8mm or 1.055 in.).

Fig. 1. Cracked welded connection: (a) overhead sign structure, (b) fatigue crack in welded connection of specimen SS2-B with a crack 66% of total weld length

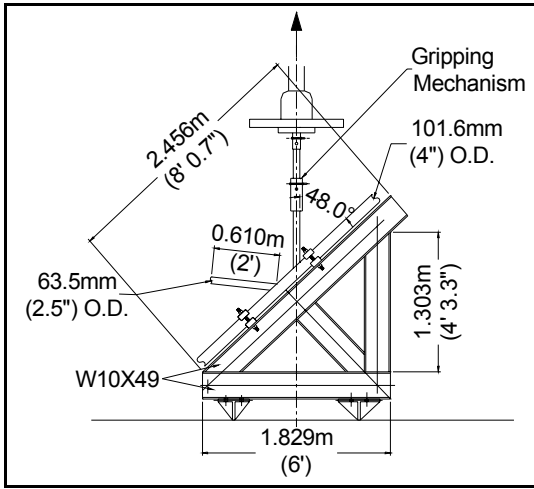
The test specimens consisted of two diagonal members of 63.5mm (2 ½ in.) diameter attached to a main chord of 101.6mm (4 in.) diameter; the diagonals were orientated at 48 degrees from the bottom chord as shown in Fig. 2. In order to apply a monotonic static tensile load, a triangular load frame was constructed such that one diagonal of the specimen could be positioned vertically, directly under the hydraulic actuator as illustrated in Fig. 2. The specimens were gripped using a tapered steel cylinder – chuck device.

Fig. 2. Support frame and test configuration Fig. 3. Application of unidirectional GFRP tendons

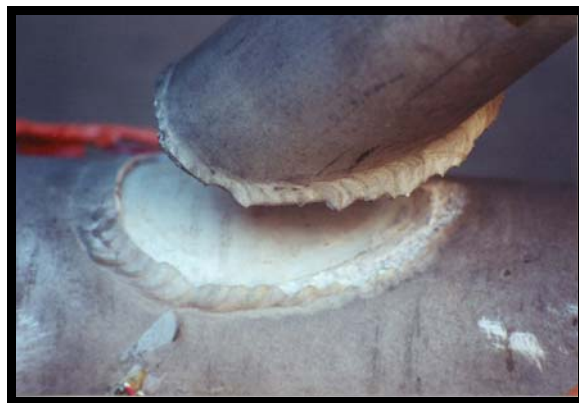
The failure of the as-is welded specimen from the field (Specimen TS3) was a typical weld failure as can be seen in Figs. 6 and 8. As Fig. 6 shows, deterioration of the weld started approximately at a displacement of 2mm (0.08 in.); after a displacement of 5.6mm (0.22 in.) the load displacement curve became linear showing gradual degradation of the welded connection. The maximum strain measured at position #2 on the diagonal (Fig. 4) reached 0.19%, which is just under the offset strain of 0.2% corresponding to the expected minimum value of yield strength across a butt weld (ASCE Task Committee on Lightweight Alloys 1962).

Fig. 8. Close-up of weld failure of specimen TS3

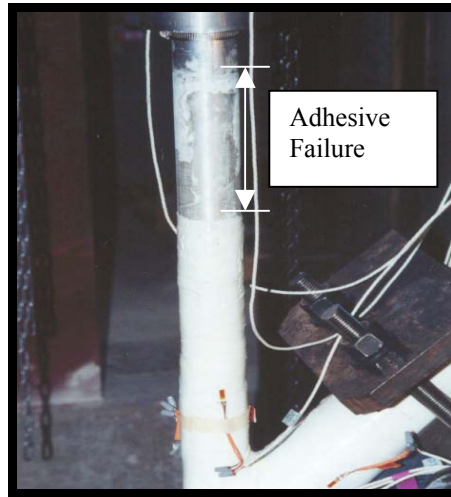
The remaining eight specimens were all repaired with GFRP composites. Two distinct failure modes for these specimens were identified: (1) adhesive failure mode, and (2) weld failure and subsequent GFRP composite tensile failure. Failure mode (1), the adhesive failure mode, was observed for the four new fabricated specimens (TS1, TS2, TS4, and TS4-B). Even though these new fabricated specimens were built using the same aluminum alloy, ASTM 6061-T6, they were constructed by tack welding the diagonals in four spots to the main chord so that the GFRP composite repair could be applied. Therefore, only the GFRP composite held the connection together, which simulates a crack extending the total length of the weld. In all four specimens, the aluminum diagonal member was pulled out of the GFRP composite in an adhesive failure mode, as shown in Fig. 9. In all four tests there was a residual load developed due to the distance that the diagonal member had to pull out of the GFRP composite, as shown in Fig. 5. This is beneficial in a life-safety situation, since failure of the joint and possible collapse of a highway sign or truss substructure can be prevented if a residual strength can be maintained. Two of the specimens (TS1 and TS2) experienced this failure mode at low levels of load and displacement, as can be seen in Fig. 5, due to insufficient GFRP composite bond length. The same failure mode was observed even for the adequately prepared specimens (TS4 and TS4B) as shown in Fig. 5, with the exception that at the end of the test, tensile failure of the outer fine weave GFRP composite layer was observed at the far end of the diagonal; this occurred at an average tensile load 1.5 times that of specimens TS1 and TS2, an average displacement 2.6 times that of specimens TS1 and TS2, and

a peak strain 2.0 times that of Specimens 1 and 2. In fact, specimens TS4 and TS4B experienced the highest strains in the GFRP composite of any of the tests carried out in this investigation.

Fig. 9. Adhesive failure mode for specimen TS4

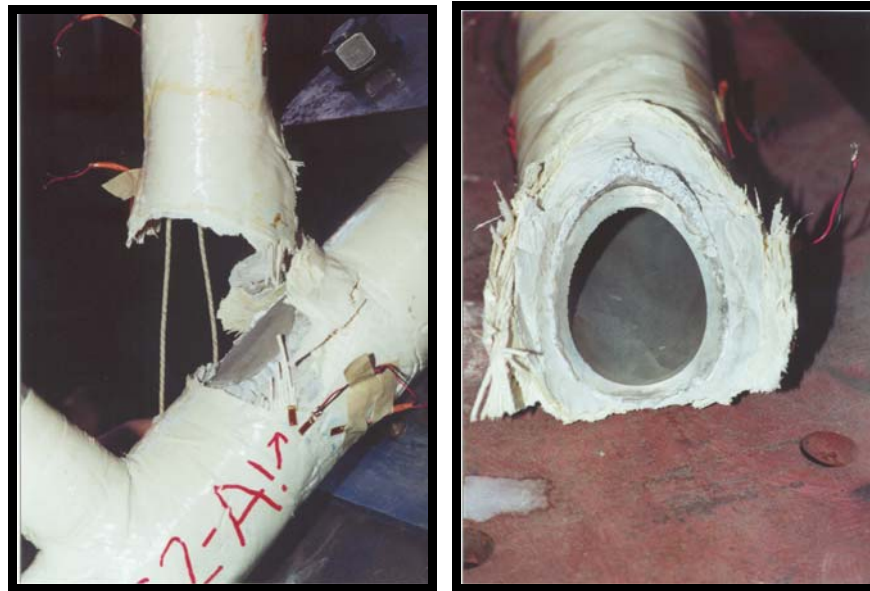
Failure mode (2) was a combination of weld failure, which occurred first, and GFRP composite tensile failure shortly thereafter. This was the failure mode for all field specimens, SS1-A, SS1-B, SS2-A, and SS2-B, regardless of the existence of a crack in the weld or the length of the crack. In each of these tests, the GFRP composite started to share some of the tensile load as the crack initiated or propagated in the weld, until the weld failed completely. The load was then transferred entirely to the GFRP composite until it failed in tension, as shown in Fig. 10. This failure mode showed how the GFRP composite would behave at failure in the actual overhead aluminum sign structure, after the cracked welded connection had been repaired with the GFRP composites.

Fig. 10. GFRP composite tensile failure after weld failure: (a) entire joint, and (b) end of diagonal
