ber Reinforced Seismic Retrofit of the McKinley Tower

By Mo Ehsani, Ph.D., P.E., S.E.

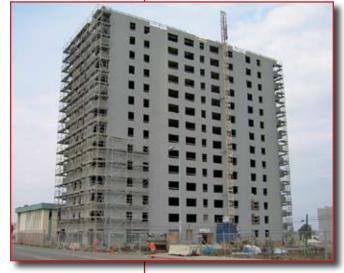
The McKinley towers served as both office and residential space until March 27, 1964, when the 'Good Friday' earthquake (magnitude 9.2) struck the Prince William Sound area of Alaska. Anchorage, located a mere 100 miles from the epicenter of the earthquake, was severely affected. Among the 150 commercial buildings that were damaged or made unstable by the quake, the McKinley building sustained significant damage. The spandrels were broken beyond recognition, while the bearing and interior walls developed large diagonal cracks. The vertical pier on the north end wall failed up to the third story, as did piers on the south end wall.

Figure 1: Damaged McKinley Tower sat vacant for more than two decades.

After the earthquake, the building was vacated and put up for auction. In 1965 some repair work was done consisting of exterior crack patching, replacement of damaged reinforcement of ornamental spandrel beams, removal of loose material, and fixing spalled areas in stairwell and elevator core (Figure 1).

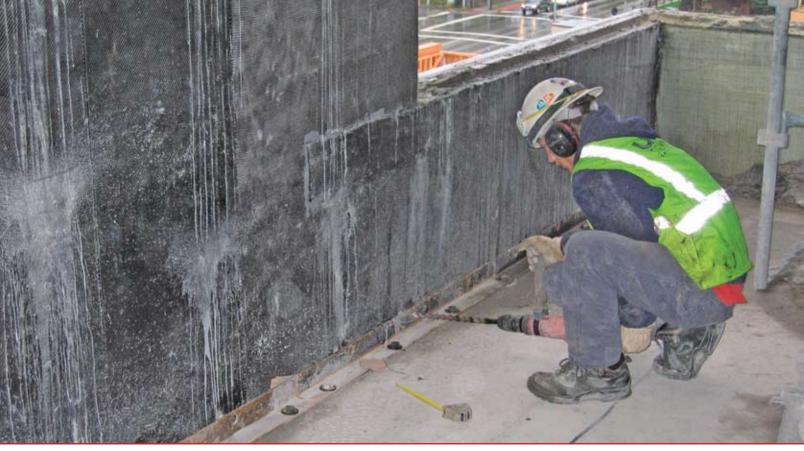
Figure 4: Retrofit of walls with carbon fabric and connection of wall to floor.

The north and south side bearing walls above the 4th floor were converted to shear walls by applying biaxial carbon FRP on the inside face of the wall up to the 9th floor. Vertically oriented unidirectional glass fabric was placed between the 9th and 10th floor. Additional horizontally oriented unidirectional glass fabric was applied on the end of the new exterior shear wall constructed up to the 4th floor. Specialized structural details were developed to ensure proper load transfer to the floor system at each level (Figure 4).
