SEISMIC RETROFIT OF THE LOS ANGELES COUNTY MUSEUM OF NATURAL HISTORY

BY MO EHSANI

SEISMIC UPGRADE OF THE ROOF SLAB WITH CFRP

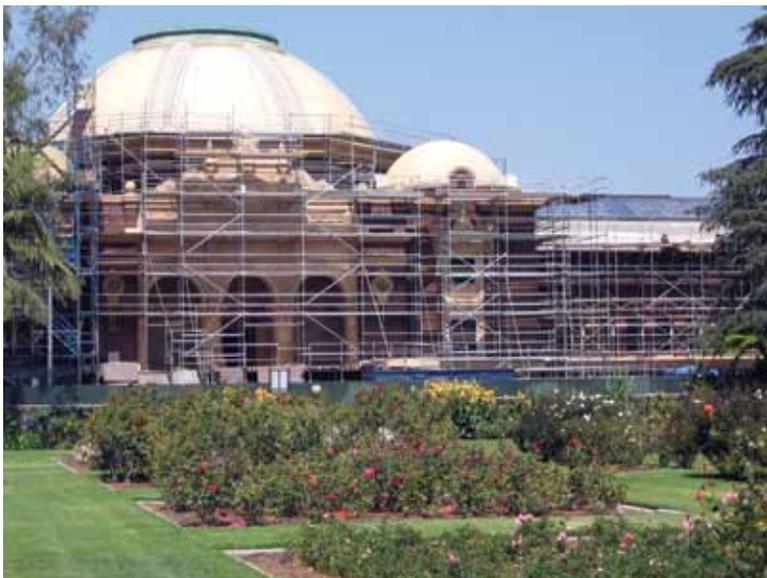
Fig. 2: Building with scaffolding during seismic upgrade in summer 2007

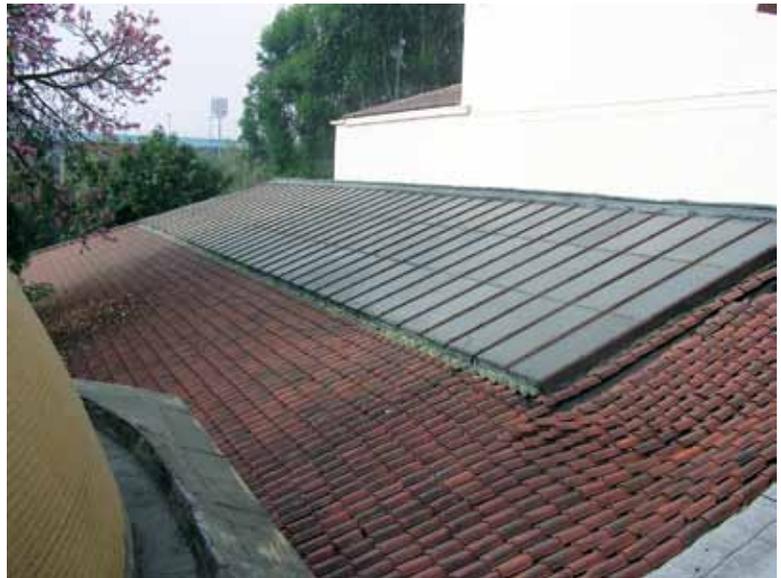
Fig. 3: View of roof and shingles before seismic upgrade

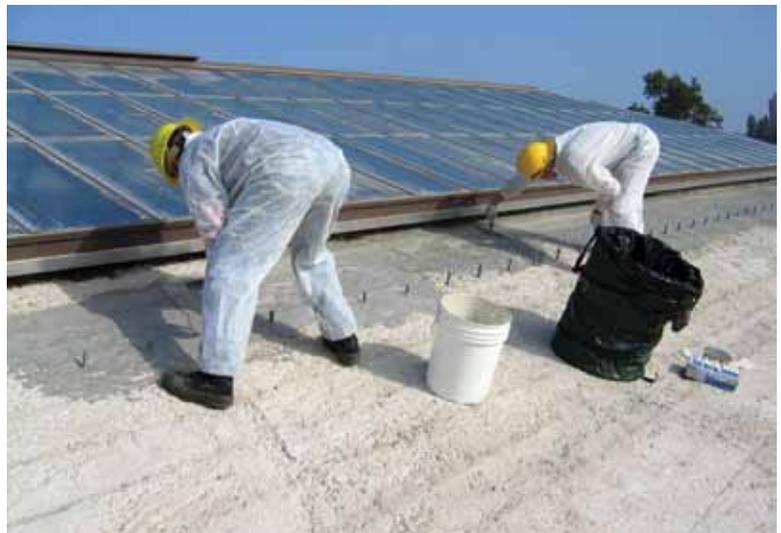
- **Roof surface preparation:** Once the shingles and tile nailers were removed, it was found that the surface of the deck was extremely rough and weak. A number of products were tested to see if the sloping roof surface could be made smooth. Most of these products were cost-prohibitive. A special non-sagging thixotropic two-component epoxy was selected that could be troweled on the surface of the roof. Pull tests were conducted in the field to ensure that the material was suitable for developing the full strength of the system. This activity added nearly 3 weeks of additional work that was not originally planned.

Fig. 4: Smoothing the rough concrete deck

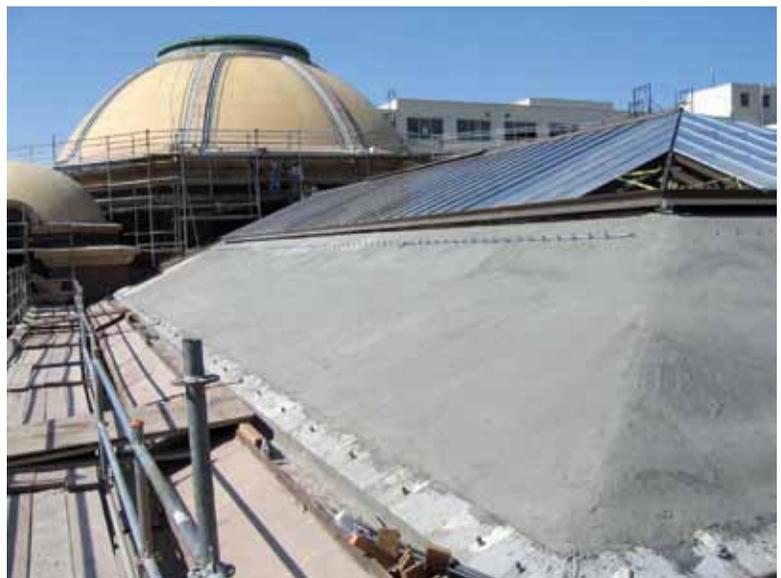
Fig. 5: Roof deck after it has been prepared for CFRP installation

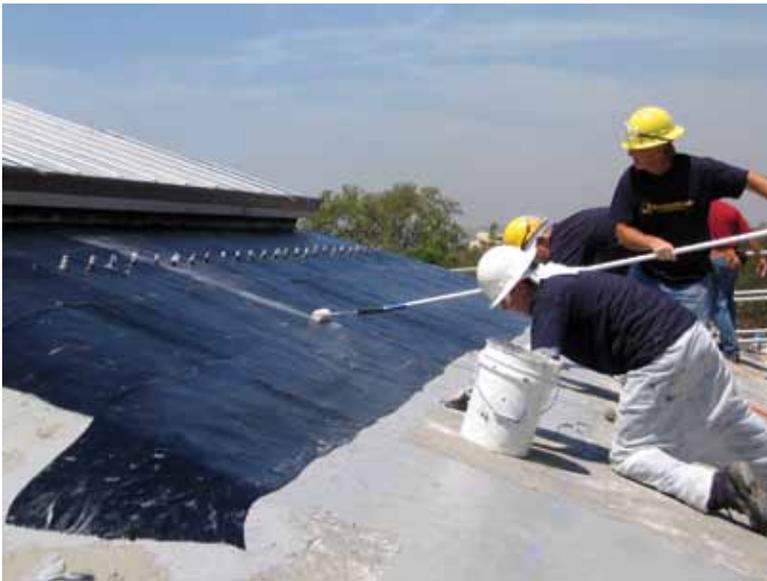
Fig. 6: Installation of CFRP strips over protected steel bolts

- **Protection of steel bolts:** As part of the connection of the newly added steel frame, steel bolts were penetrating through the slab. Direct contact between steel and carbon may lead to galvanic corrosion of the steel. To prevent this, the threaded heads and protruding shanks of the bolts were protected during the installation and the carbon fabric was cut in a circular area around the shank. In addition, because long steel plates were going to be laced over the bolts, a 12 in. (305 mm) wide strip of glass fabric was installed along the bolt lines to prevent direct contact between the steel plate and the CFRP.

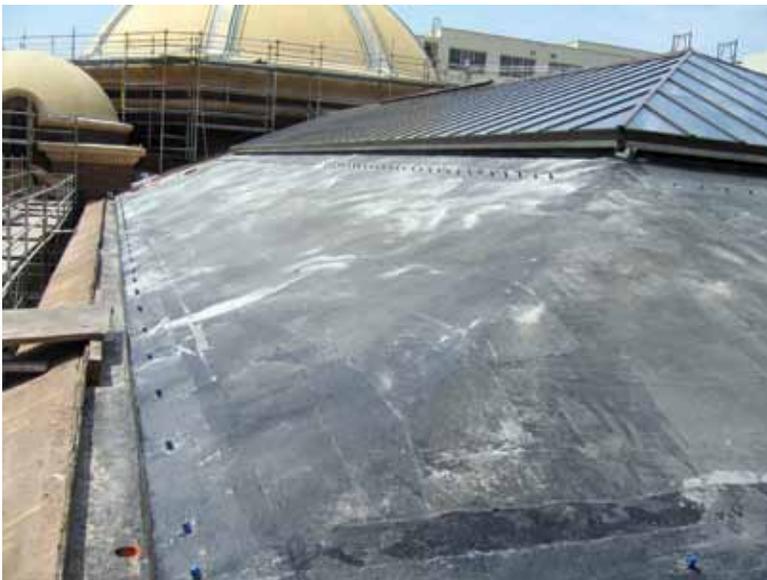
Fig. 7: Retrofitted slab after broadcasting of sand on top of CFRP

- **Slippery slope:** Once the FRP is cured, it leaves a fairly smooth and slippery surface. Considering the steep 25-degree slope of the roof, there was concern for the safety of the workers from other crafts that would have to walk on such a smooth surface. Consequently, immediately following the installation of CFRP, a thin film of resin was applied as a top coat and sand was broadcast on top of that. Upon curing of the epoxy, this resulted in a non-slippery surface.

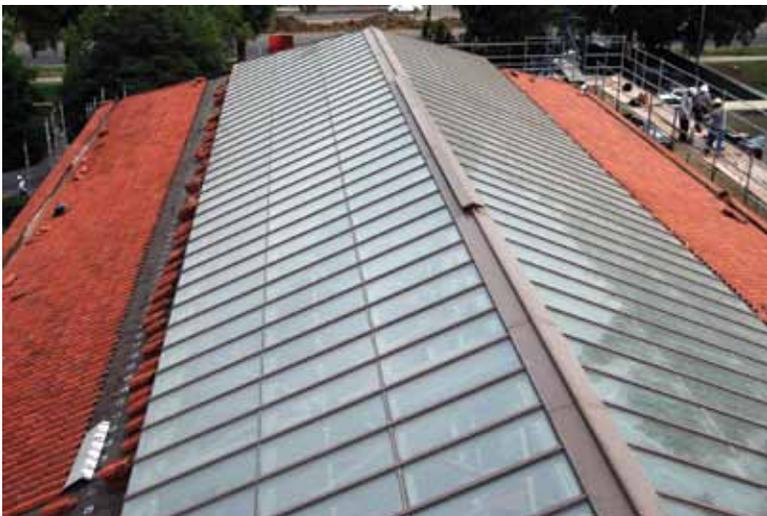
Fig. 8: Restored shingles replaced on the roof with new skylights

- **Maintaining the historic appearance:** The application of thin layers of CFRP kept the overall appearance of the roof structure virtually unchanged. Upon completion of the project, the shingles that were salvaged and restored were placed on the roof, giving back the historic building its original beauty. As a result, the owner commented, “seismically upgrading and structurally improving a building listed on the National Historic Record without impacting its appearance was a tall order and without your critical work would have been virtually impossible.”
