Strengthening of Coolidge High School Gymnasium

Project Name & Location: Retrofit of Roundhouse Gymnasium
Coolidge High School
Coolidge, AZ

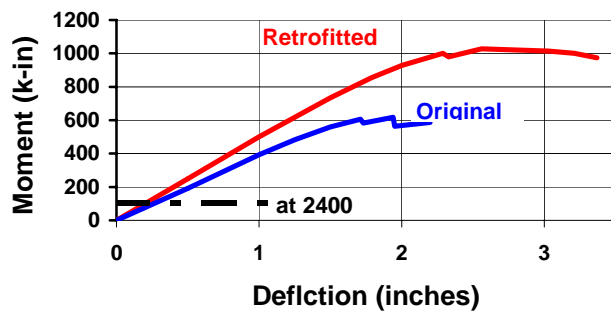
Laboratory tests indicated that if only the carbon plates were added, the capacity of the beam would be limited by a horizontal shear failure near the bottom of the beam (between two laminates). To prevent this mode of failure, the beams were wrapped in a carbon fabric. The carbon fabric had fibers in both directions. Therefore, the fibers along the axis of the glulam beam contributed to flexural strength while the fibers in the vertical direction increased the shear capacity of the beam (similar to stirrups in a R/C beam). Laboratory tests demonstrated that the flexural strength of such a beam could be increased by 67% and that the carbon fabric eliminated the undesirable shear failure that was observed in previous test when only the carbon plates were used.

At the conclusion of the test, the carbon fabric was removed to reveal the extent of damage even though the beam was supporting such high loads
