## FRP REPAIR OF DETERIORATED WOOD BEAM

**Name:** Kinder Morgan Plant Glulam Beam  
**Type:** Wooden Beam  
**Location:** Tampa, Florida  
**Completed:** December 2009

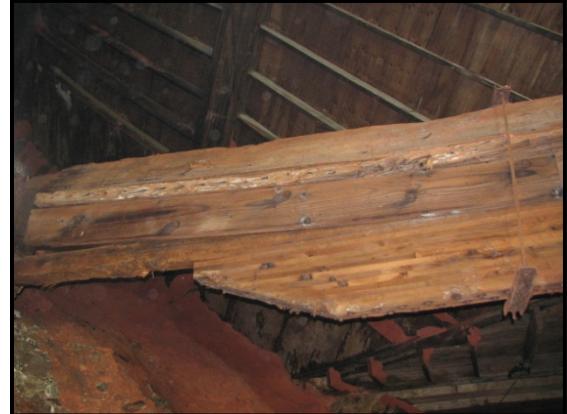
Leakage and very damp environment had caused deterioration of this large glulam beam in a plant. The end of the beam was split, compromising the load-carrying capacity of the beam.

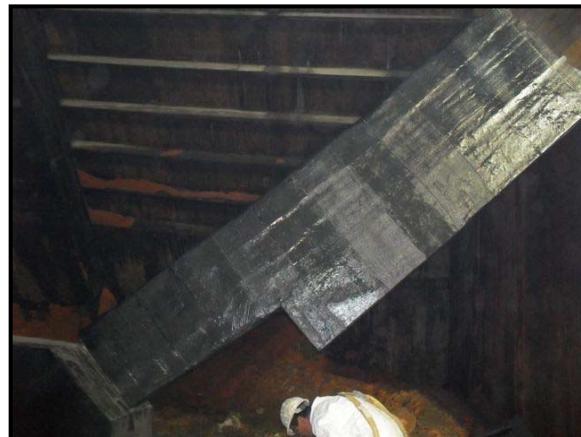
The finished beam is shown in the photograph below.

- FRP repair provided to glulam beam to correct severe deterioration of the wooden glulam beam.
- Repair work done with minimal disruption to the plant operations.
- The original strength of the beam was re-restored.
