CARBON FRP REPAIR OF UNDERWATER BRIDGE PIERS

Name: Bay View Bridge

Type: Bridge Structure

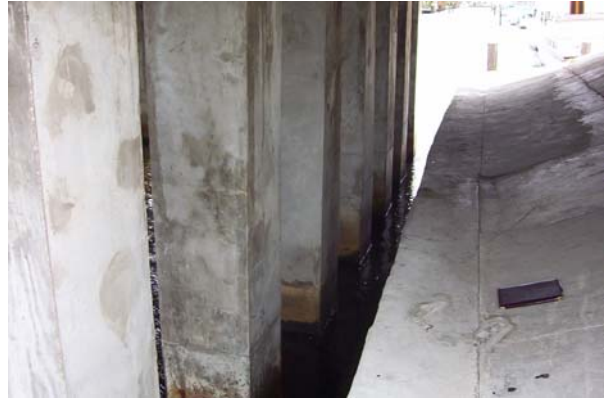
Partially submerged bridge piers have a tendency to present severe corrosion problems at the splash zone, where several wet/dry cycles occur daily due to natural ocean tides.

Patching the concrete at this elevation only provided a temporary fix, since concrete and steel deterioration reappeared in the short term. A long term and maintenance free solution was desired.

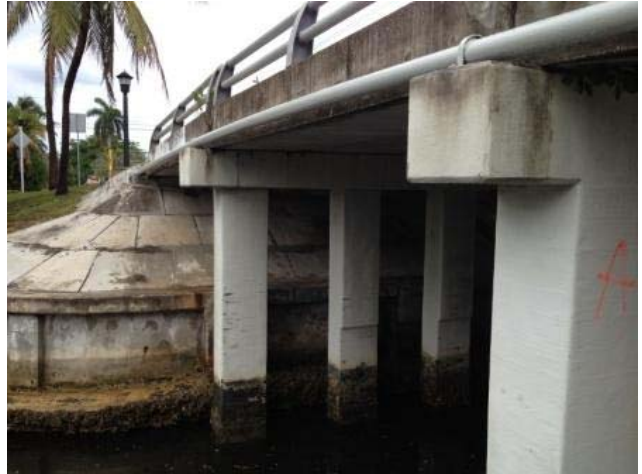
While QuakeWrap was repairing a seawall nearby, this bridge was visited on April 8, 2012. The condition of bridge **after five years in service** is shown here.

There is marine and algae growth in the submerged portion of the bridge and some of the paint has come loose. The same condition can be seen on the adjacent concrete wing walls. However, no damaged to the FRP was observed. The paint in the dry portion of the piles looked in excellent condition.
