CARBON FRP REPAIR OF UNDERWATER BRIDGE PIERS

Name: Bay View Bridge

Type: Bridge Structure

Completed: June, 2007

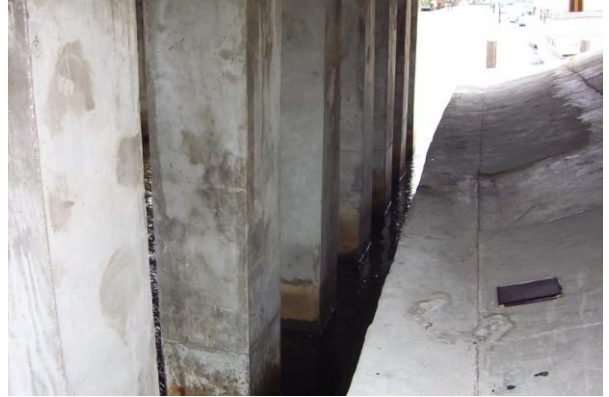
Partially submerged bridge piers have a tendency to present severe corrosion problems at the splash zone, where several wet/dry cycles occur daily due to natural ocean tides.

Patching the concrete at this elevation only provided a temporary fix, since concrete and steel deterioration reappeared in the short term. A long term and maintenance free solution was desired.

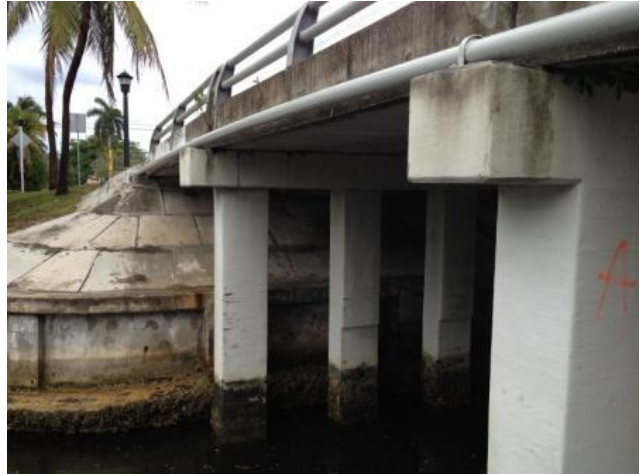
While QuakeWrap was repairing a seawall nearby, this bridge was visited on April 8, 2012. The condition of bridge **after five years in service** is shown here.

There is marine and algae growth in the submerged portion of the bridge and some of the paint has come loose. The same condition can be seen on the adjacent concrete wing walls. However, no damaged to the FRP was observed. The paint in the dry portion of the piles looked in excellent condition.
