FRP REPAIR OF CONCRETE CULVERT

Name: St. Croix Culvert Repair
Type: Pipe
Location: St. Croix, VI
Completed: November 2012

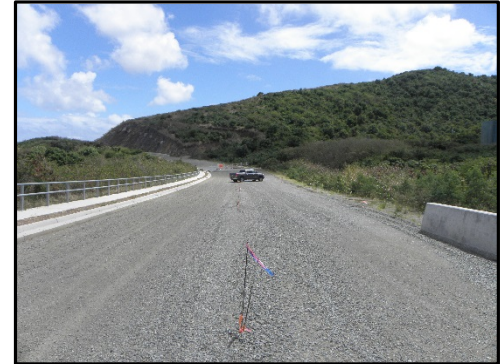
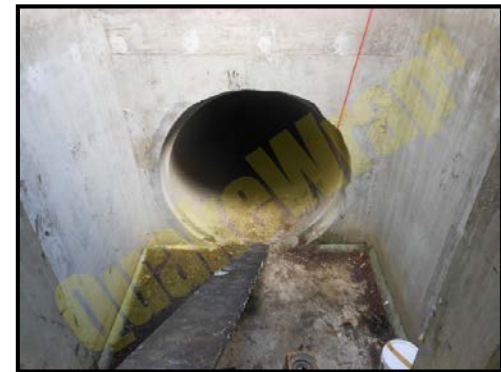
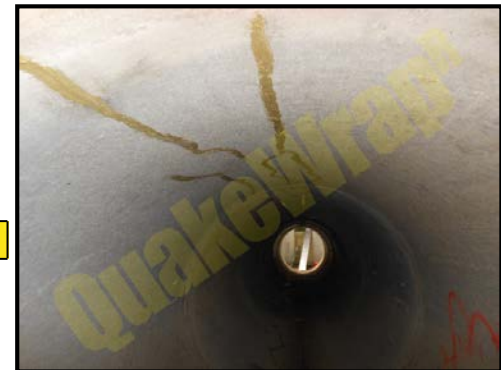
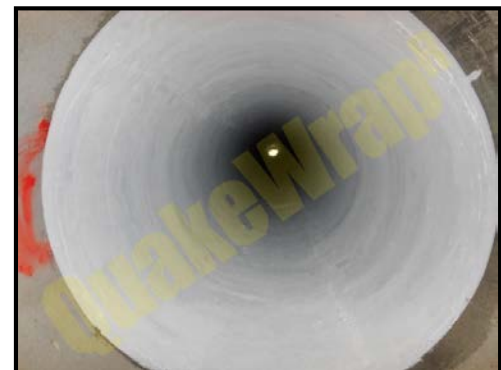
Prior to the opening of the freeway to traffic, the pipes experienced severe cracking and some spalling in the concrete over much of the 280-ft long culvert. Considering the deeply buried location, replacement of the pipe was cost-prohibitive. An in situ repair and strengthening that would be feasible for this remote island was necessary.

It was determined that the reinforcing steel for these pipes was not sufficient. The repair consisted of patching the deteriorated concrete with a polymer-modified mortar; sealing the cracks and injecting resin into the cracks; applying a 10-mil thick layer of QuakeBond™ J300SR to seal the entire surface of the pipe, and strengthening the pipe surface by application of a single layer of QuakeWrap® VB26G fabric, saturated with resin. The entire pipe was then coated with a top coat for further protection against abrasion. The repair was completed in less than two weeks with a small 4—man crew
