## SHEAR REPAIR OF BRIDGE BEAMS WITH GLASS FRP

**Name:** Challenger Middle School  
**Type:** School Building  
**Location:** Tucson, Arizona  
**Completed:** December 2004

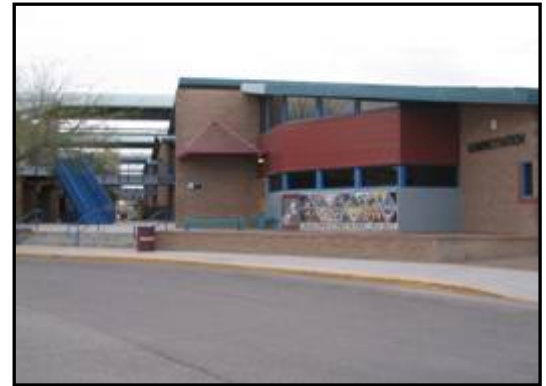
The two main buildings on this school campus are connected by three pedestrian bridges. Six of the bridge beams exhibited excessive cracking due to high shear stresses near the supports. The school district required the repair work to be completed rapidly over the Christmas break.
