Project Overview

FRP REPAIR OF CIRCULAR BRIDGE PIERS

Name: Interstate 94 Highway Bridge at S.R. 49
Type: Highway Bridge Piers
Location: Chesterton, Indiana
Completed: July 2006

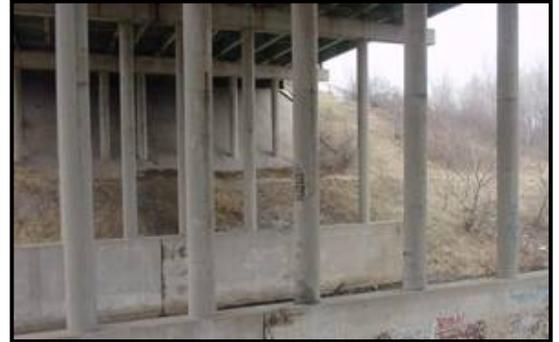
10 circular piers in a bridge bent suffered severe corrosion of spiral hoop reinforcement due to spalling of concrete cover. The concrete cover was too thin due to construction error and spalling occurred due to weathering. As a result, hoop reinforcement was exposed and severe corrosion occurred.

Once patch work was completed on damaged areas, all 10 circular bridge piers were completely wrapped with two layers of FRP fiberglass composite fabric. The FRP repair system not only provided a permanent barrier against future weathering damage by completely encasing the piers, but also upgraded their seismic capabilities by providing additional hoop reinforcement, ductility and compressive strength to the concrete.
