FRP REPAIR OF REINFORCED CONCRETE TUNNEL IN HEALTH CARE FACILITY

Name: Arizona State Hospital
Type: Health Care Facility
Location: Phoenix, Arizona
Completed: May 1999

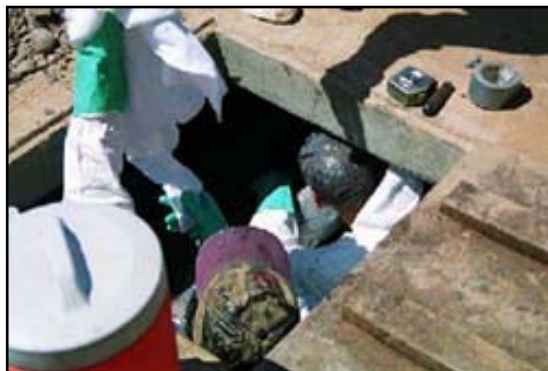
The reinforcing steel in the pull box within the compounds of the Arizona State Hospital was severely corroded, compromising the structural strength of the tunnel. Due to access limitation, repair options were limited.

QuakeWrap® FRP Repair System was selected due to its corrosion prevention properties and the fact that all installation materials could be fitted through small manhole.
