FRP REPAIR OF HILLSBORO INLET SEAWALL

Name: Seawall Repairs
Type: Reinforced Concrete Wall
Location: Pompano Beach, Florida
Completed: May 2012

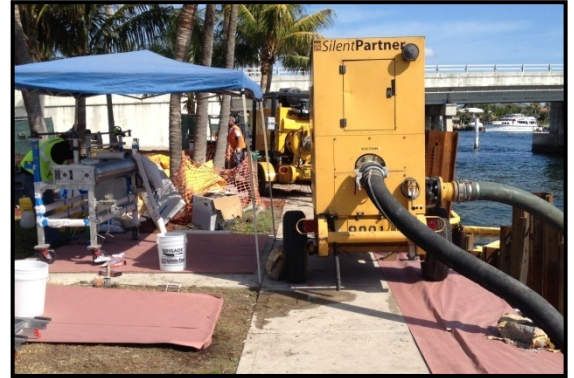
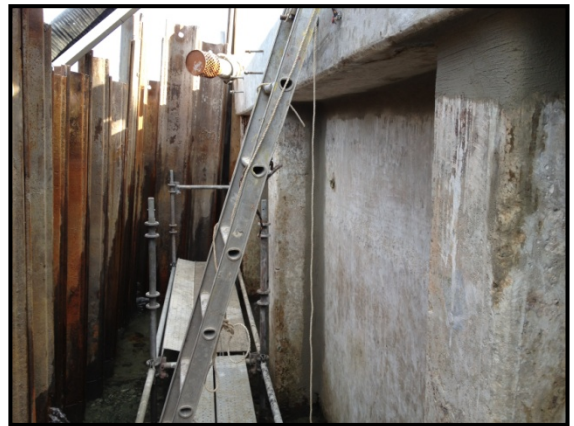
The seawall was cracked and exposure to the salt water had resulted in corrosion of the reinforcement in the wall. The municipality wanted a repair that would strengthen the wall and prevent future deterioration.

To have access to the area in need of repair coffer dams were installed and high flow diesel pumps were used to remove the sea water to gain access to the wall. Immediately scaffolding was erected and the surface prep began. Using pneumatic tools, barnacles were chipped away and the walls were grinded down. We then washed the wall with a 4000 psi pressure washer.

Two Layers of QuakeWrap® VU20G glass fabric was saturated with QuakeBond™ J300SR Saturating Resin and the bands were applied horizontally on the wall. Two Layers were also applied vertically on the beams above the wall. After a 24 hr cure, the pumps were shut off, the water filled back up, and the steel coffer dam was removed. Fifty feet long sections were completed in 48 hrs.
