## FRP REPAIR OF A FLY ASH MASONRY SILO

**Name:** Elk River Power Plant  
**Type:** Industrial Building  
**Location:** Elk River, Minnesota  
**Completed:** August, 2008

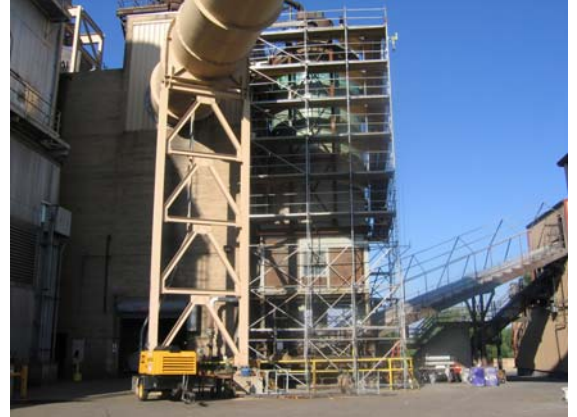
A fly ash silo at the Elk River Power Plant exhibited extensive weathering damage to the masonry surface. A repair solution using gunite had been implemented on the lower elevation of the silo, but due to excessive cracking, a different repair option was desired.
