FRP Repair to a Reinforced Concrete Chimney

This paper reviews the background, philosophy, repair scheme, scope and methodology used in the inspection and strengthening of a reinforced concrete chimney.

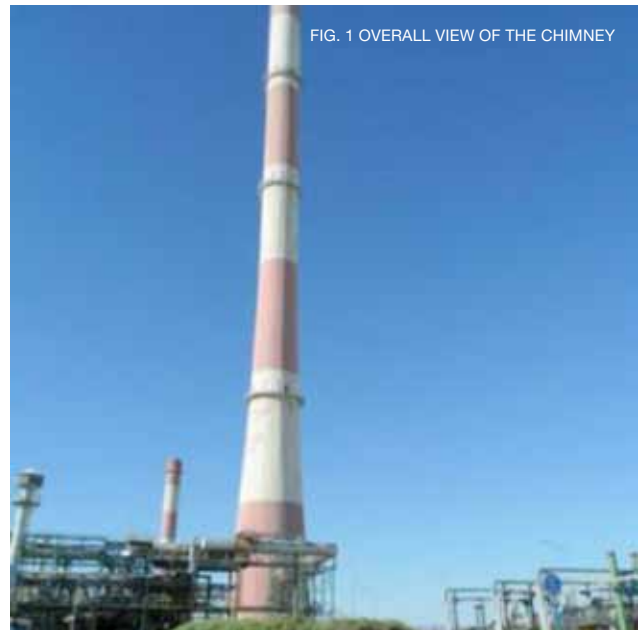
This particular structure was constructed and commissioned in 1984 and has suffered from the absence of a proactive inspection and maintenance plan. (Figure 1)

FIG. 1 OVERALL VIEW OF THE CHIMNEY

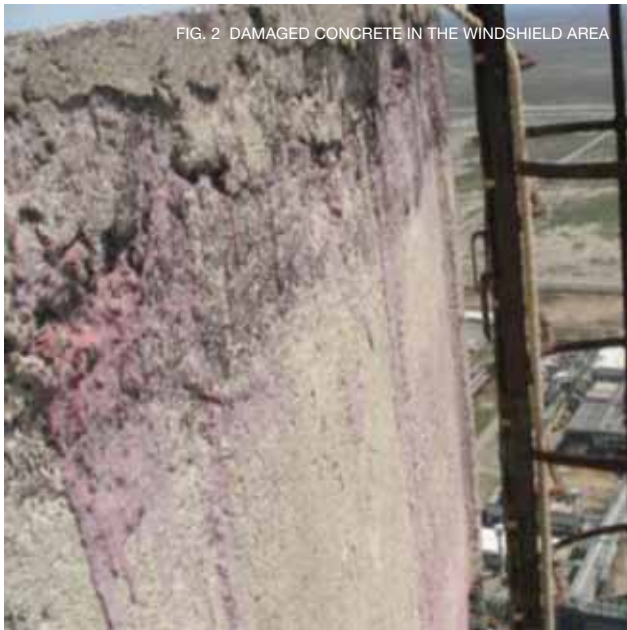
The uppermost 5 meter section of the concrete windshield was found to be in a very poor condition. The reinforced concrete was found to be porous with large sections of spalling and decaying concrete noted throughout. Cavities through the windshield were found in three different elevations (Figure 2). Reinforcement steel was found in a serviceable condition but the concrete was now in a state of disrepair (Figure 3).

FIG. 2 DAMAGED CONCRETE IN THE WINDSHIELD AREA

The strength and durability of the top of the chimney windshield was deemed to have weakened significantly and required re-strengthening. A number of options were available.

However, in this environment and taking into account the resources available the preferred option was to re-strengthen the top of the chimney with a 'Fiber Reinforced Polymer'. This technique has been used in a number of similar projects where there has been general degradation over the full circumference for a relatively short distance from the top.

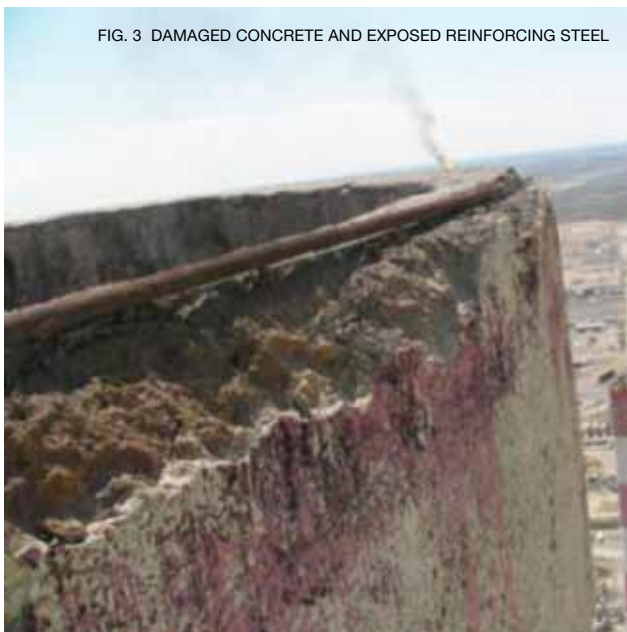
FIG. 3 DAMAGED CONCRETE AND EXPOSED REINFORCING STEEL

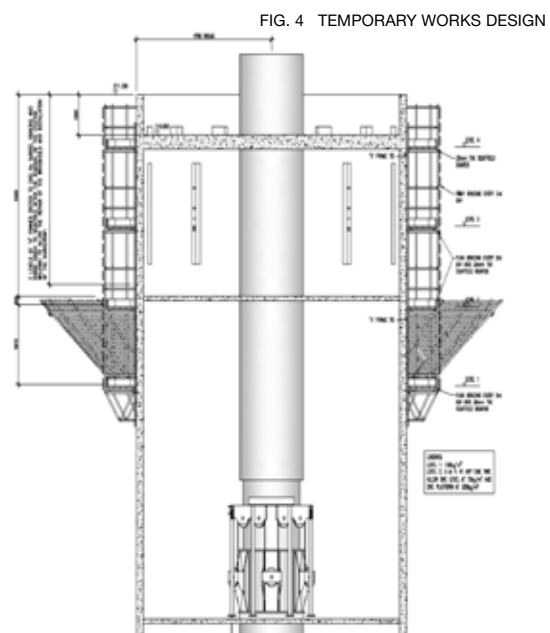
FIG. 4 TEMPORARY WORKS DESIGN

In order to facilitate access to the work area, Zenith's Structural Engineering Department designed a full circumference scaffold to envelop the entire area complete with a fan deck at a position 6m below the chimney termination point. (Figure 4)

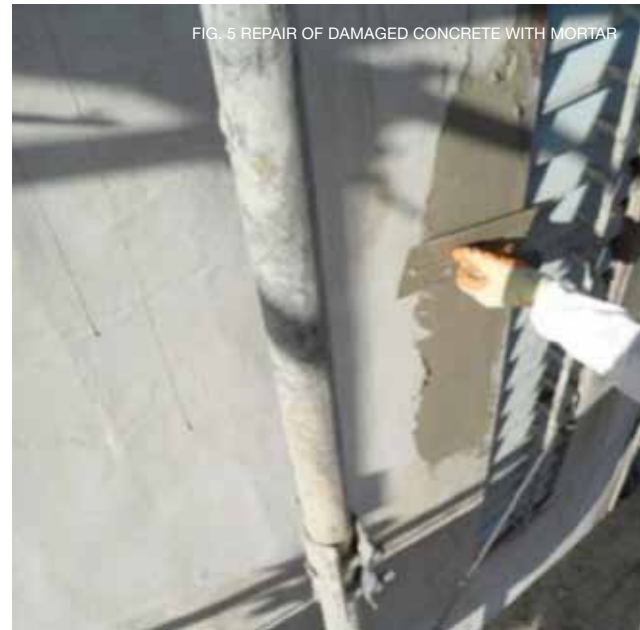
FIG. 5 REPAIR OF DAMAGED CONCRETE WITH MORTAR

The temporary scaffolding was erected on the external face of the windshield, leaving a clearance of about one foot between the scaffold and the concrete surface to facilitate the installation of the fabric. All damaged and defective concrete had to be repaired to be suitable to receive the FRP system. Special structural mortar and patching materials were used for this purpose, targeting areas where surface was not even or sunken. (Figures 5 and 6).

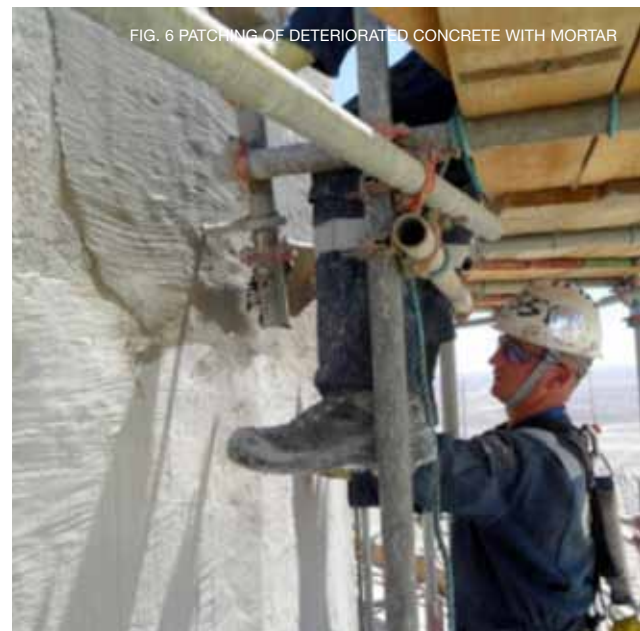
FIG. 6 PATCHING OF DETERIORATED CONCRETE WITH MORTAR

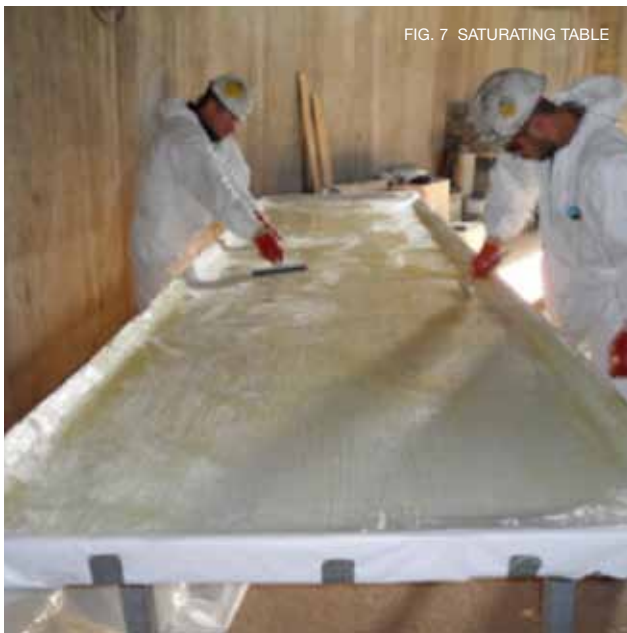
FIG. 7 SATURATING TABLE

A special saturating table was constructed at the bottom of the chimney (Figure 7). Pieces of fabric about 1.2 m wide x 6 m long were saturated with a two component epoxy resin. The option of performing this task at the top of the chimney was considered at first; however, due to space limitation and high winds, this option was ruled out. The saturated rolls of fabric were wrapped around a PVC tube for ease of transportation and handling.

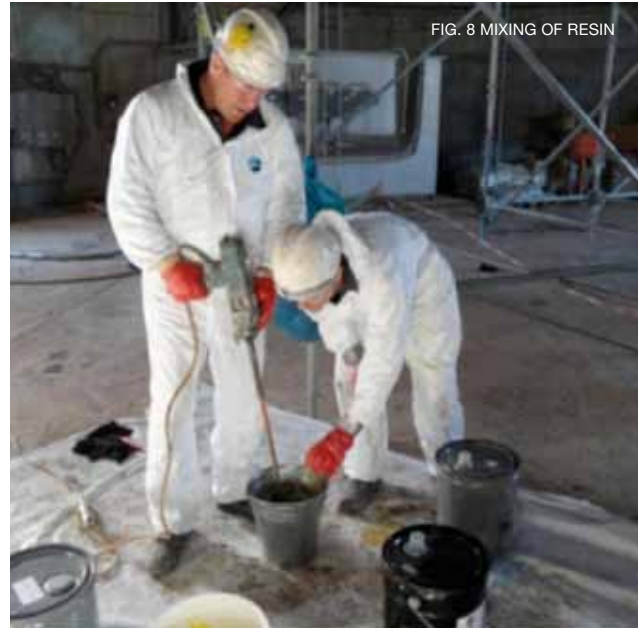
FIG. 8 MIXING OF RESIN

Once the resin was mixed (Figure 8) and poured onto the fabric, the crew was against the clock since they only had close to twenty minutes from the resin mixing to the final installation of the fabric on its final destination. Usually, when resin starts to set while the fabric is being installed, it becomes difficult to handle and is not recommended to use it. Being on a remote location, wasting of materials due to temperature was not an option, therefore, special care was taken on the timing and handling of materials. Saturation of dry fabric and the application of the bonding agent (epoxy paste) were done simultaneously and by the time that the saturated fabric arrived on top, the coated surface was ready to receive the fabric, which created a nonstop routine.

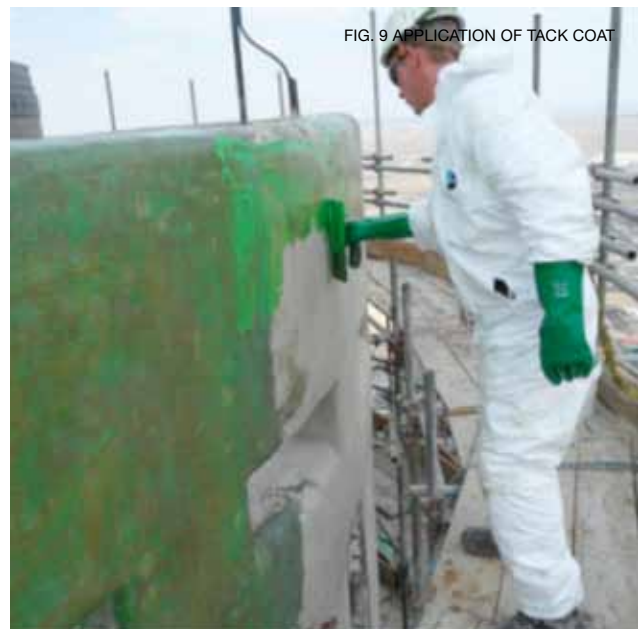
FIG. 9 APPLICATION OF TACK COAT

As the first step of installation, a high-viscosity epoxy (Tack Coat) was mixed and applied with a trowel to the concrete surface (Figure 9). The thickness of this coating was approximately 1 mm. Installation process began at the interior-top part of the chimney (Figure 10), applying the fabric vertically and unrolling it all the way down (Figure 11), ensuring that any entrapped air between the fabric and the concrete surface was removed. A crew of four men performed this task on top of the chimney, where the high wind gusts often added to the challenge of the installation.

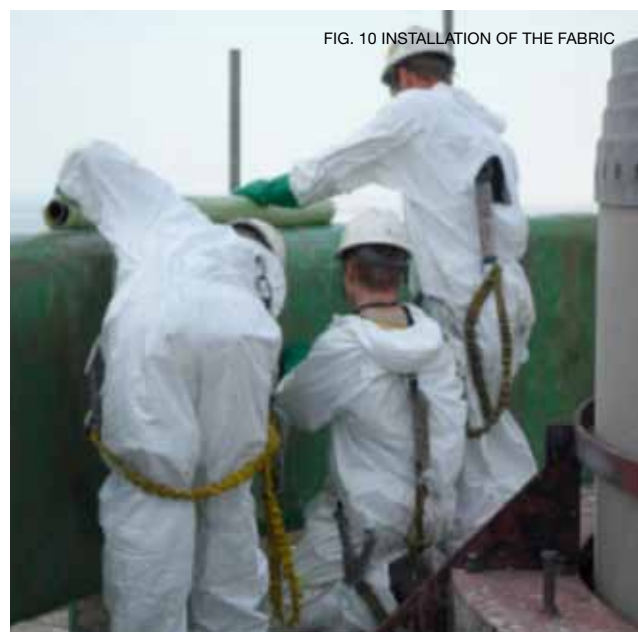
FIG. 10 INSTALLATION OF THE FABRIC

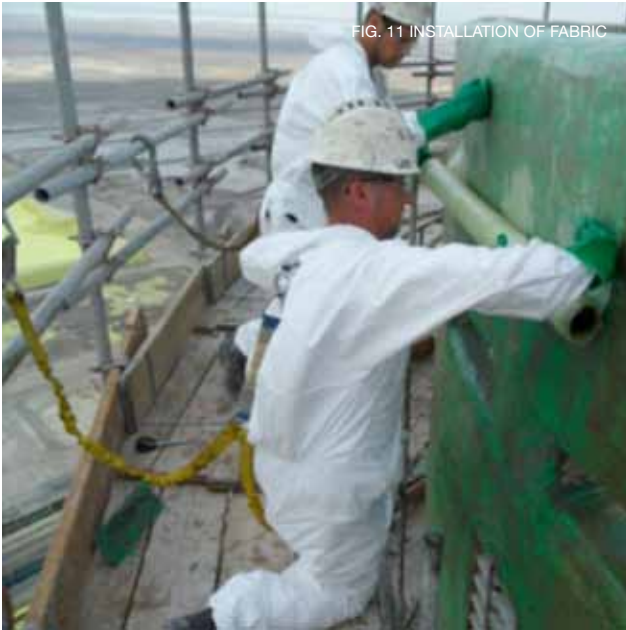
FIG. 11 INSTALLATION OF FABRIC

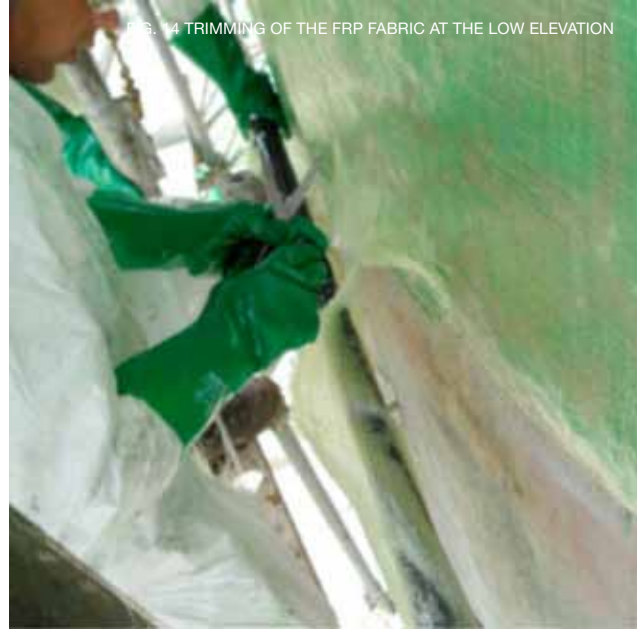
FIG. 14 TRIMMING OF THE FRP FABRIC AT THE LOW ELEVATION

The FRP fabric was cut and trimmed around the openings (Figure 12). This added a little extra time to the installation and on hot days care had to be taken to ensure that these activities could be completed before the epoxy would begin to set. Installation of the fabric was facilitated through a clearance of approximately one foot between the scaffold and concrete substrate (Figure 13) that allowed the fabric to go all the way down to the limits of the repair area, and then trimmed at the bottom (Figure 14).

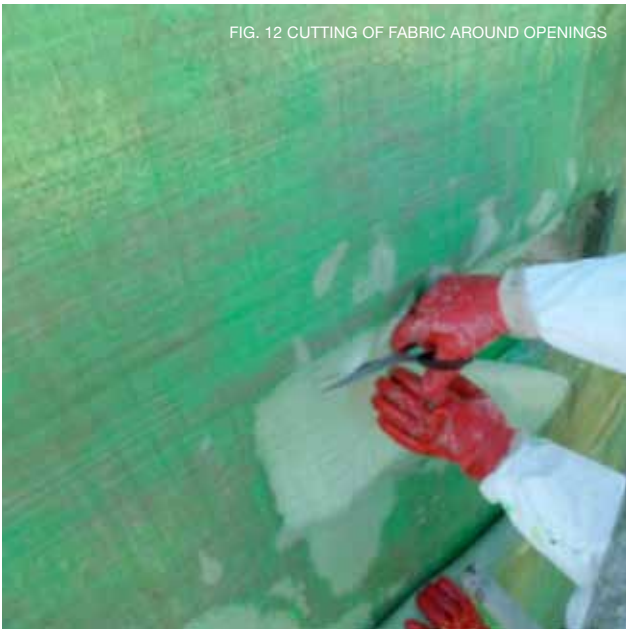
FIG. 12 CUTTING OF FABRIC AROUND OPENINGS

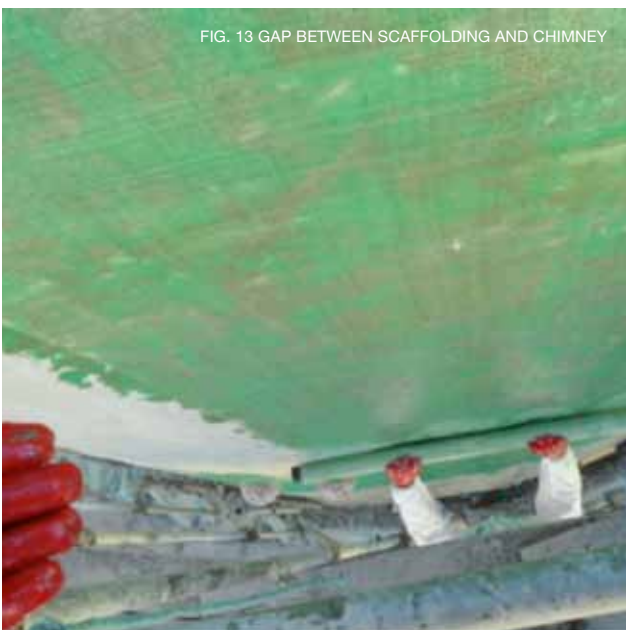
FIG. 13 GAP BETWEEN SCAFFOLDING AND CHIMNEY

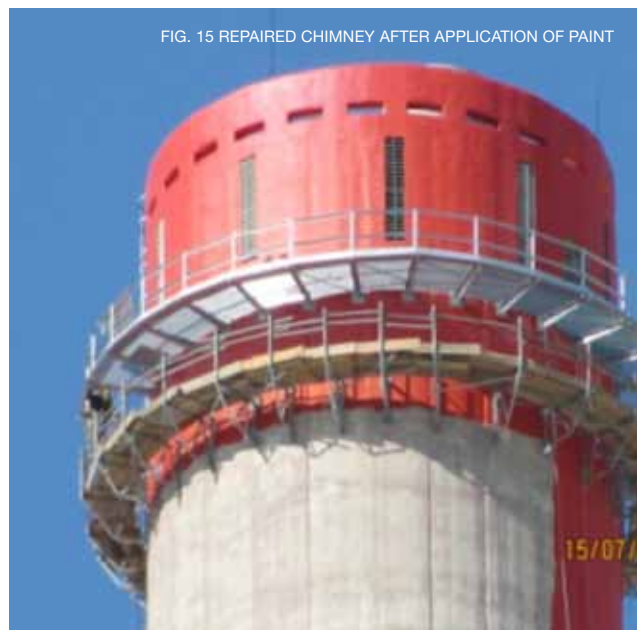
FIG. 15 REPAIRED CHIMNEY AFTER APPLICATION OF PAINT

The FRP application process continued non-stop for four days at a height of 690 ft from the ground, checking and inspecting the quality of the application and repairing any imperfection that might have occurred due to the wind or other factors. After the FRP installation was completed, a special coating of chemical liquid plastic heat tolerant acid resistant paint was applied to the windshield area, restoring the original colour of the chimney (Figure 15).
