Composites: Part B 38 (2007) 751-758

Application of FRP composites for underwater piles repair

Rajan Sen *, Gray Mullins

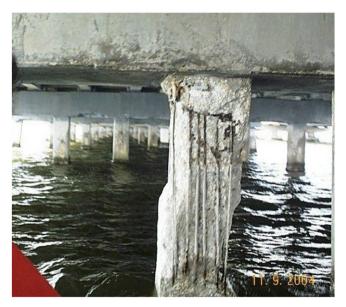
The emergence of new adhesives [1] that allow FRP to be bonded to wet concrete surfaces makes it possible to economically conduct emergency repairs on sub-structure elements. Fig. 2 shows impact damage that led to both cross-section loss and breakage of the spiral ties. Conventional repairs will require the cross-section to be enlarged to accommodate new ties. If instead, FRP were used it

Fig. 2. Damage to pile requiring emergency repair (Courtesy FDOT).

would only be necessary to re-form the cross-section and apply bi-directional layers that could restore lost tensile capacity while providing equivalent lateral support to the longitudinal steel. Moreover, the application of a protective UV (ultra-violet) coating on the wrap of the right color will render the repaired pile indistinguishable from other undamaged piles. The aesthetics of FRP repair is one of its unheralded benefits.

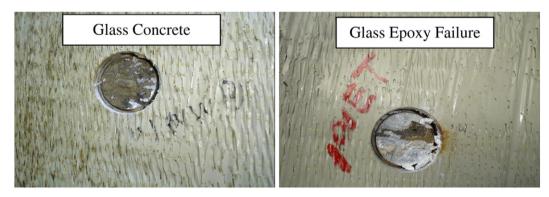
Table 4 and Fig. 9 summarize the results of the pullout tests. The bond of FRP to the concrete substrate was found to be poor. Most of the wet layup wrapped piles showed epoxy failures where the dolly separated from the concrete at its interface (Fig. 10). All tests conducted on the pre-preg system were inter-layer failures (Fig. 11) indicating that the bond between the FRP layers was poorer than its bond to concrete.

Fig. 10. Failure mode in wet lay up wrap system.

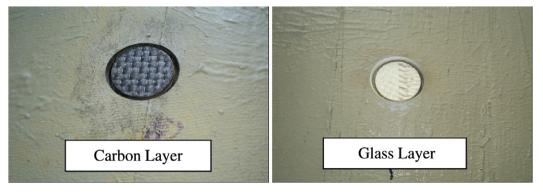
Fig. 11. Failure mode in pre-preg wrap system.

Inspection of Table 4 shows that the bond from System B performed better in the wet region while System A was better for the dry region. Similar differences were not observed on laboratory specimens tested [6]. Therefore, the problem with bond can be attributed to the field techniques used for wrapping. On-going research is developing a new protocol to prevent such inconsistency.
