# Rehabilitation of Plaza De Diego Building in San Juan, P.R. using CFRP

by M. Ehsani

**Synopsis:** Carbon Fiber Reinforced Polymer (CFRP) products have been used to strengthen a variety of structures. They offer very high tensile strength and offer unique advantages in projects where access is limited. This paper presents the retrofit of a high-rise building in San Juan, Puerto Rico which was necessitated as a result of change in use. Unidirectional carbon fabrics and plates were used to strengthen the floor beams and slabs in flexure. The location of the floor (on the 12<sup>th</sup> story) and the fact that the partition wall frames were already installed provided unique challenges to this project and limited the strengthening alternatives. The project was completed in time and within budget. Field tests on the installed materials demonstrated that the FRP system met or exceeded the strength values claimed by the materials supplier.

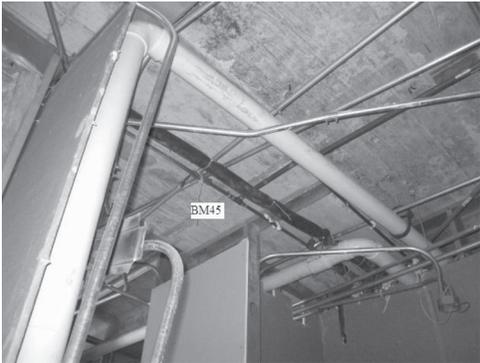
Initially, consideration was given to strengthen the beams with conventional methods, such as the use of new steel beams to carry part of the loads. However, as shown in Fig. 2, there were a number of pipes and utility conduits present that would interfere with such installation. Additionally, transportation of the steel beams to the 12<sup>th</sup> floor was not an easy task and would have added significant cost to the construction. A further challenge was due to the fact that framing for partition walls was already installed on the entire floor (Fig. 3). This imposed major difficulties. First, it limited access to the underside of the concrete beams. It also made the handling of any steel beams on the floor very difficult.

Figure 2 – Utilities limited access to the underside of the beams

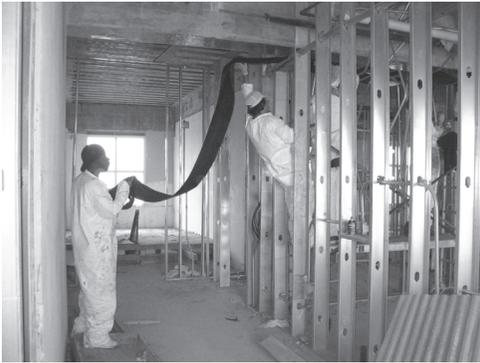
Figure 3 – Partition wall framing limited access throughout the floor

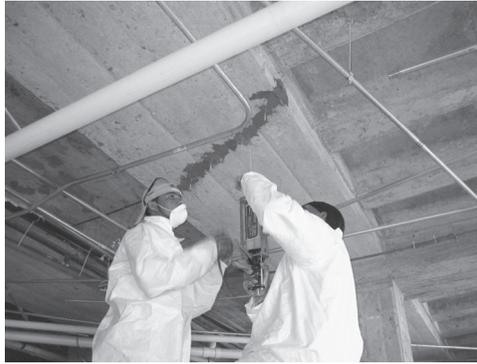
Figure 4 – Crack injection prior to strengthening of beams

Prior to strengthening, the existing cracks that were found in several of the beams were injected with a low-viscosity resin. Figure 4 shows the crack injection. The beam surfaces were then grinded with diamond discs.

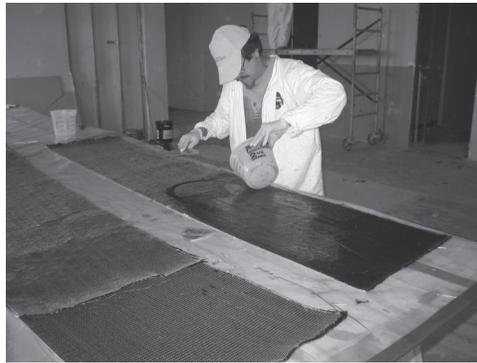
Figure 5 – Saturating of carbon fabrics by hand

Although the FRP supplier does have special equipment to saturate the fabrics, considering the relatively small size of this project, it was decided to perform this task by hand. Working tables were assembled on the 12<sup>th</sup> floor and after the two-component saturating resin was mixed, it was poured on top of the fabric. The resin is easily worked into the fabric with a putty knife (Fig. 5). A two-component high-viscosity tack coat is also mixed in the field and a 40-mil thick (1-mm) layer is applied to the surface of the beam. The saturated carbon fabric (or the carbon plate) is then applied to the beams. The fabric is pressed to make sure that it is bonded properly and any trapped air is removed. Figure 6 shows a typical installation.

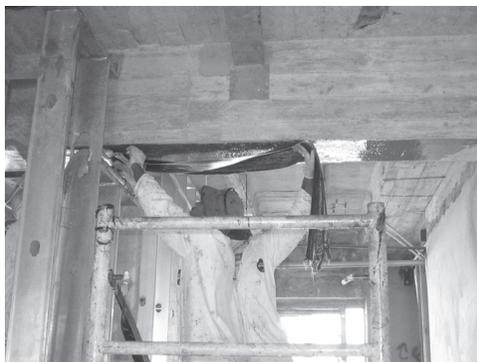
Figure 6 – Saturated fabric is bonded to the beam surface covered with tack coat

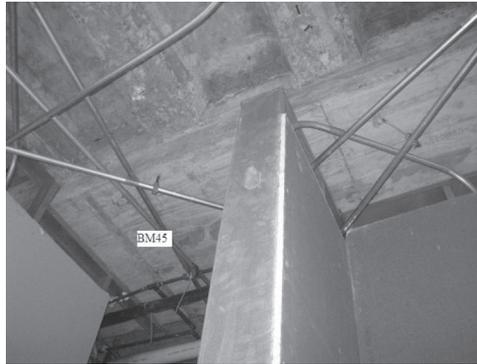
Figure 7 – Partition wall framing crossing the beam axis

Among the salient advantages of FRPs is its versatility. There were instances where the partition walls were already framed to the bottom of the beam (Figs. 7 and 8). The small thickness of the carbon fabrics made the installation much easier in such cases. The upper channel of the partition walls was removed and the fabric was bonded to the underside of the beam. If the partition wall ran along the bottom of the beam (Fig. 8), after the installation of the carbon fabric, steel angles were used to connect the channel to the sides of the beams; this prevented damaging the carbon fabric. In the latter case, this provided a further advantage in that it did not require the removal of the partition wall and the insulating material that was already in place.

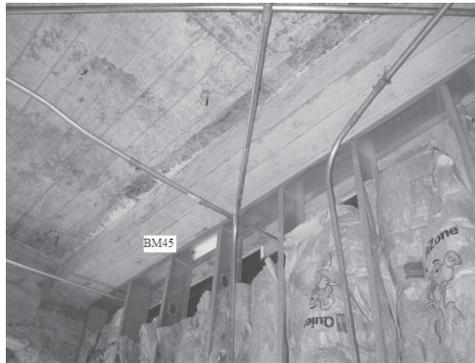
Figure 8 – Partition wall framing running along the beam axis

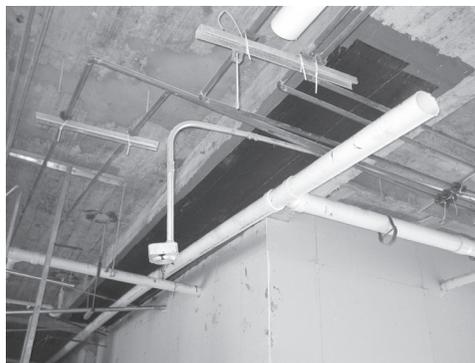
There were a few locations where the bottom of the beams were partially covered by existing partition walls (Fig. 9). Instead of applying a 36-in. 915 mm) layer of carbon

Figure 9 – Two layers of fabric were used when the tension face of the beam was not fully accessible

fabric to this beam, two layers of fabric were applied. The first layer was 30 in. (760 mm) wide and it was bonded directly to the beam; the next layer of fabric was 6 in. (152 mm) wide and it was bonded to the first layer of fabric.

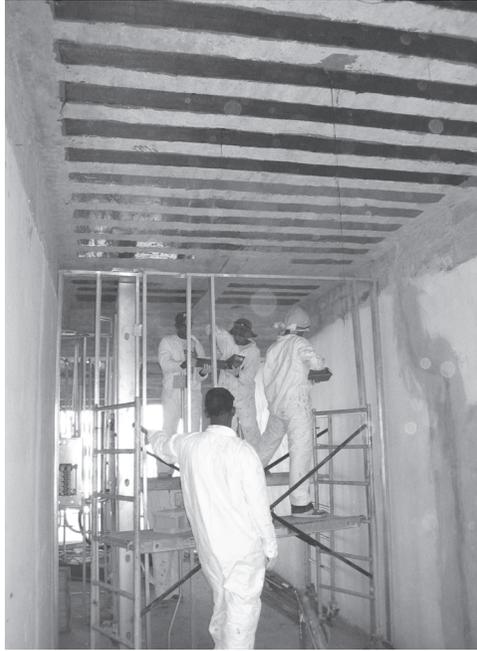
Figure 10 – Strengthening of slab with carbon fabric

In addition to the above beams, there was a 72-ft wide (21.9-m) section of slab that spanned 8 feet (2.44 m). This slab was also reinforced with 6-in. (152-mm) wide carbon fabrics placed at 12-in. (305-mm) on center. Figure 10 shows a portion of the retrofitted slab.
