Seismic Retrofit of McKinley Tower

Anchorage, Alaska

Submitted by QuakeWrap, Inc.

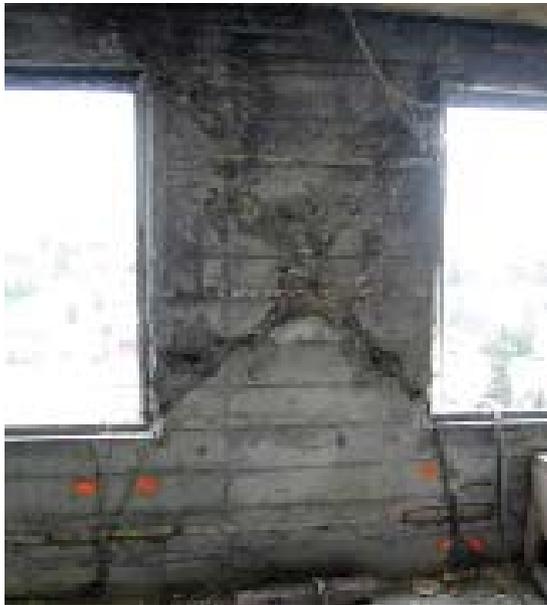
Fig. 1: Damage to walls caused by the earthquake

The building survived the 1964 “Good Friday” Alaska Earthquake, which had a Richter scale magnitude of 9.2, making it the strongest earthquake in North America to date. Damage to the building consisted of shear failure of exterior spandrel beams and extensive diagonal cracking of exterior walls (Fig. 1). The east vertical pier on the north-end wall failed up to the third floor at a construction joint and similar failure was observed on the south-end wall. The walls around the building’s core suffered light diagonal and horizontal cracks at construction joints, with damage being more severe from the third to sixth floors.

After the earthquake, the building was vacated and put up for auction. In 1965, some repair work was done, consisting of patching exterior cracks, replacing damaged reinforcement of ornamental spandrel beams, removing loose material, and fixing spalled areas in the stairwell and elevator core.

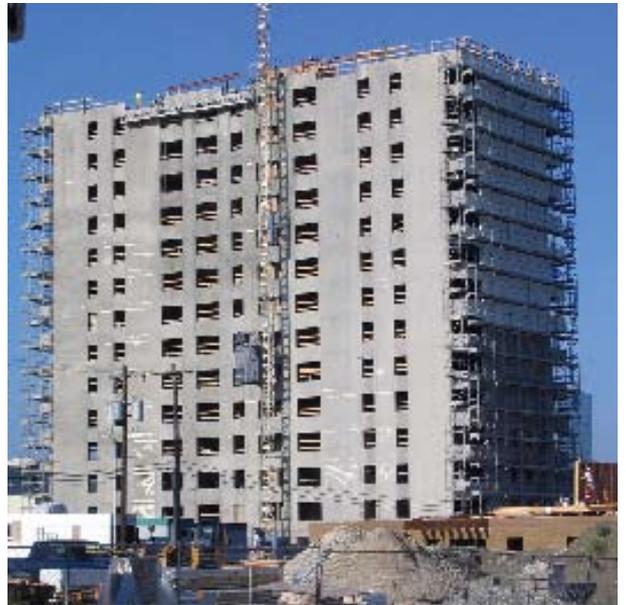
Fig. 2: Stripped building was an eyesore for over 20 years

The current owner acquired the building in 1998. Since then, extensive structural repairs were undertaken to bring the building up to current seismic code requirements. Due to the excessively high costs involved, however, all repair work was stopped. As a consequence, the building remained vacant for more than 20 years, becoming an eyesore in downtown Anchorage (Fig. 2).

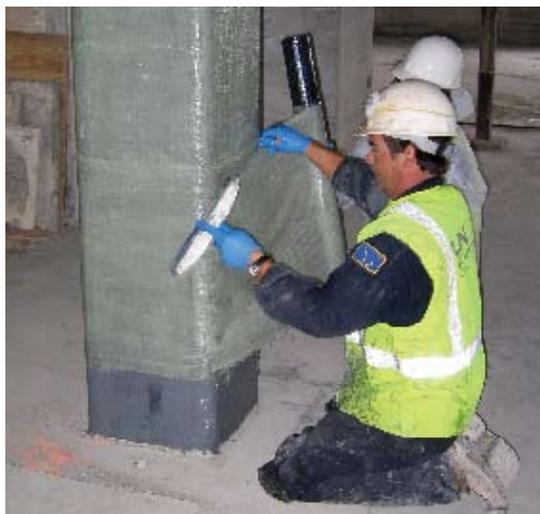
Fig. 3: Wrapping of columns with GFRP

Unidirectional glass FRP (GFRP) fabrics were applied to all columns to provide a confining effect to the concrete, which increased its compressive strength and ductility. This eliminated the need to increase the size and steel reinforcement of all existing columns. The fabric was supplied in 24 in. (61 cm) wide tapes that were wrapped around the column in two or more layers; along the height of the column, the bands of fabric were butt jointed (Fig. 3).

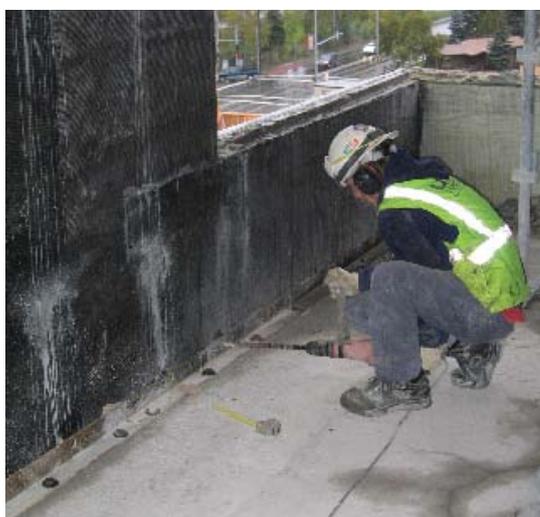
Fig. 4: Steel angles and bolts for transfer of loads from shearwalls to floors

The north- and south-side bearing walls above the 4th floor were converted to shearwalls by applying biaxial carbon FRP on the inside face of the wall up to the 9th floor. Vertically oriented unidirectional glass fabric was placed between the 9th and 10th floor. Additional horizontally oriented unidirectional glass fabric was applied on the end of the new exterior shearwall constructed up to the 4th floor. To assure proper load transfer to the floor system at each level, a special structural detail was developed (Fig. 4).

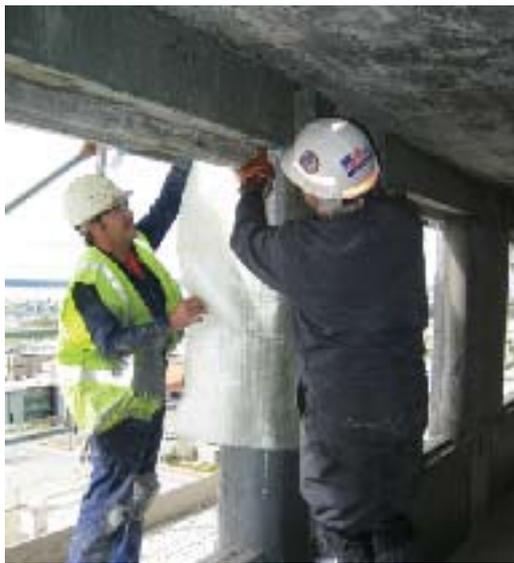
Fig. 5: Reinforcing boundary elements in shearwalls with GFRP

Coupling beams for east and west shearwalls were reinforced for shear by applying biaxial GFRP on the inside face (Fig. 5). The same design was applied on the inside face for shear reinforcement of cantilever beams on the west and east building elevations. For the cantilever beams on the north and south elevations, shear reinforcement was achieved by applying a biaxial carbon fabric on the inside face. Cantilever beams were also reinforced for negative flexural strength by applying unidirectional carbon FRP to the top face.

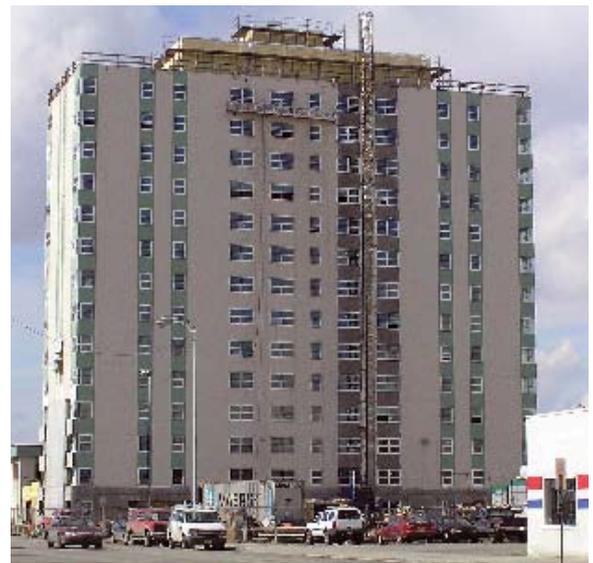
Fig. 6: The building nearly completed and painted
