FRP REPAIR OF CORRODED PEDESTALS OF A COOLING TOWER

Name: Tucson Main Library
Type: Office Building
Location: Tucson, Arizona
Completed: June 2005

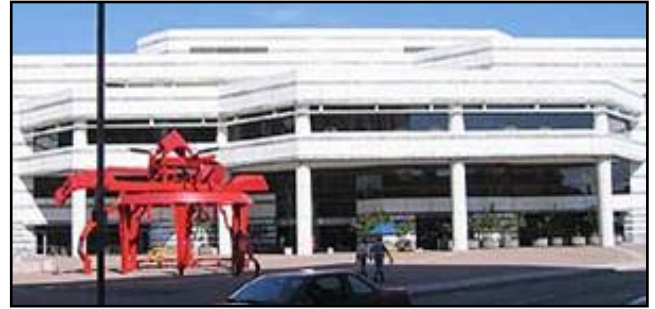
Leaking of water from the cooling tower located on the roof had resulted in severe corrosion damage to the four concrete pedestals that supported the tower.

As part of the replacement of the cooling tower with a new one, the pedestals required to be repaired and protected against future damage by corrosion.

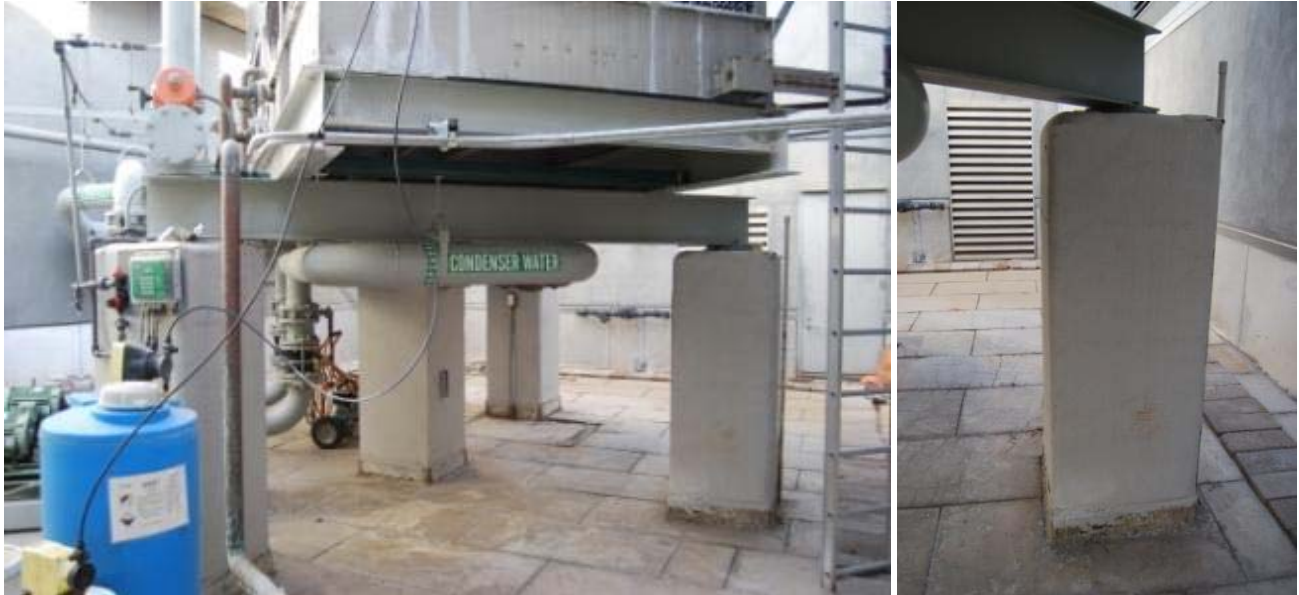
At the time the above project was completed, we offered a two-year warranty on the repairs. Nearly **7 years later**, the above site was visited and the repaired pedestals were inspected. As can be seen in the following pictures taken on 3/7/2012, the pedestals are in perfect condition.
