## FRP REPAIR OF FIRE DAMAGED ELECTRIC POWER STATION

**Name:** Tucson Electric Power (TEP)

**Location:** Peoria, Arizona

**Completed:** October 2008

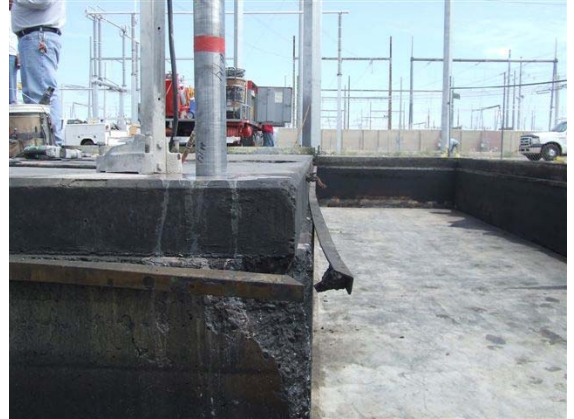
A section of the TEP station in Peoria, Arizona, was damaged by an explosion and fire. The affected section had a platform with the electric installations and was surrounded by a basin whose function was to capture dripping oil. The fire led to concrete damage particularly on the platform. Tests showed a significantly lower strength of the concrete due to the fire and spilt oil. Additionally it had lost its capacity to serve as a sealed basin. Bidirectional glass fiber was used to effectively seal the basin and recover the functionality of the plant.
