## FRP RETROFIT OF BRIDGE PIERS SUBJECTED TO CORROSION DAMAGE

**Name:** I-40 Bridge  
**Type:** Bridge Structure  
**Location:** Oklahoma City, Oklahoma  
**Completed:** June 1997

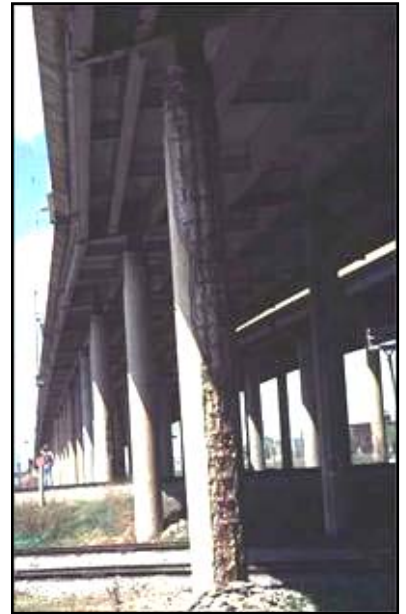
Interstate Highway 40 (I-40) passes through Oklahoma City and includes a viaduct that passes over a Union Pacific railway. Many of the piers were damaged by corrosion. A conventional retrofit, which would increase column diameters from 3-ft to 4-ft, was not acceptable because the wider columns would interfere with the railroad right-of-way.

QuakeWrap® FRP Repair System was selected since it could provide the corrosion repair with insignificant increase to the pier's cross section. QuakeWrap® composite glass fabric was wrapped around the 3-ft diameter piers, adding only ¼ of an inch to the column width.
