PROJECT PROFILE

Corroded Tank Repair using QuakeWrap FRP

Client: Copper Mining Operation

Project Location: Northwest Mexico

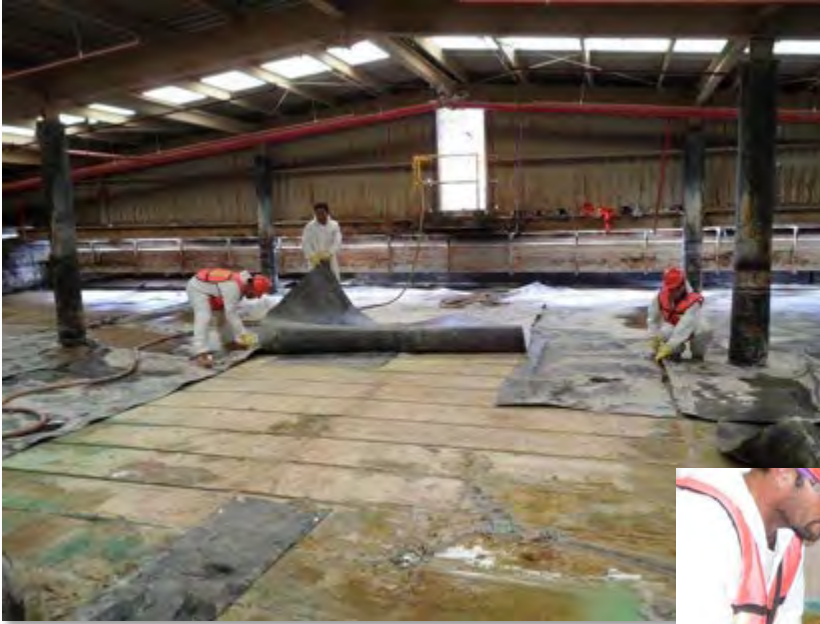
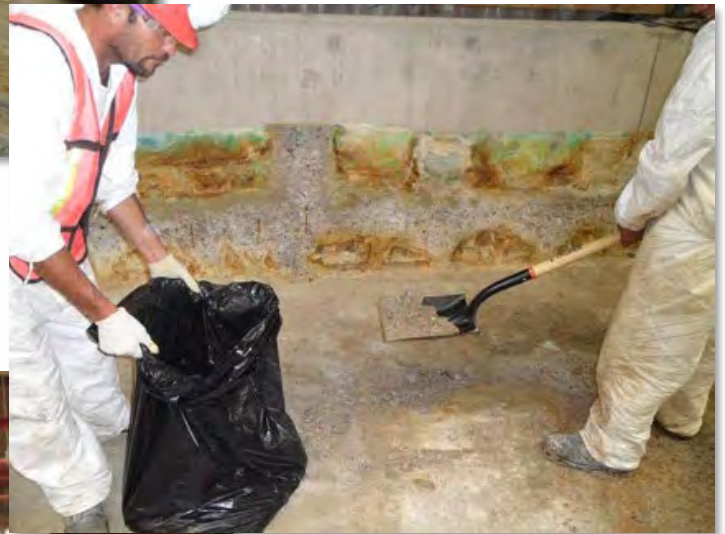
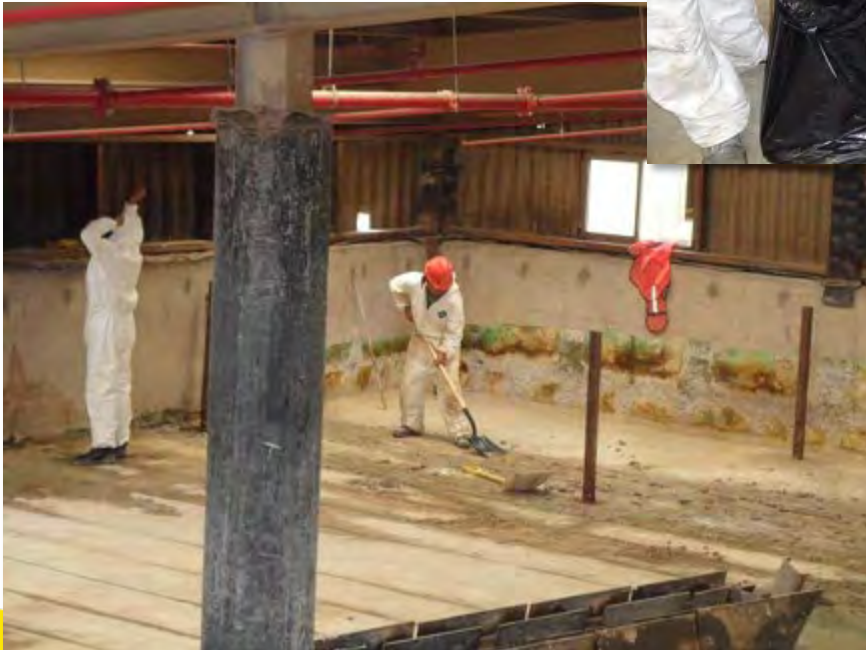
Project Photos: Before

- Tanks carry an electrolytic fluid and prior to repair were being protected with a semi-rigid liner bolted to the insides of the tanks
- A combination of chemical and age degradation caused multiple breaches in this liner, leading to subsequent damage to the concrete surface due to long term exposure to the electrolytic fluid.

QuakeWrap's FRP repair procedure included removal of the existing semi-rigid liner, removal of damaged concrete on tank walls and floors, washing and neutralization of concrete surfaces, repairing damaged concrete, preparation of concrete surfaces, and preparation and saturation of the bidirectional glass fiber fabric. Saturated FRP was applied to both vertical and horizontal surfaces.

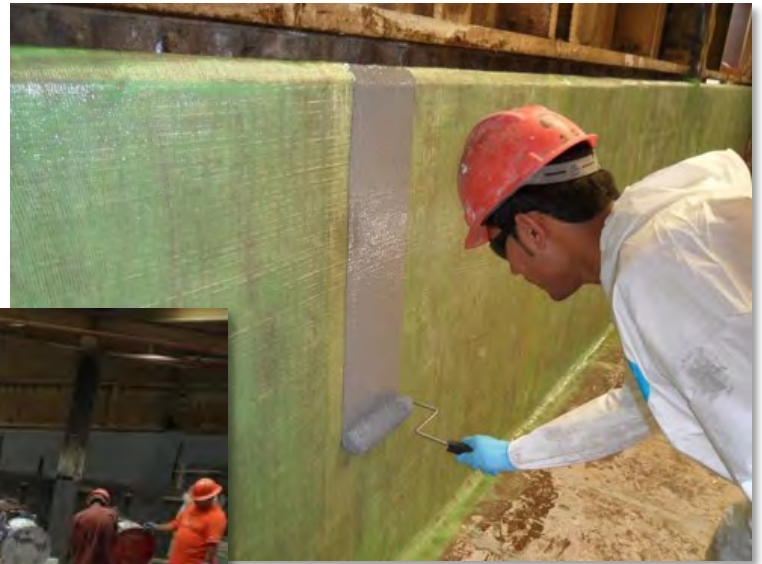
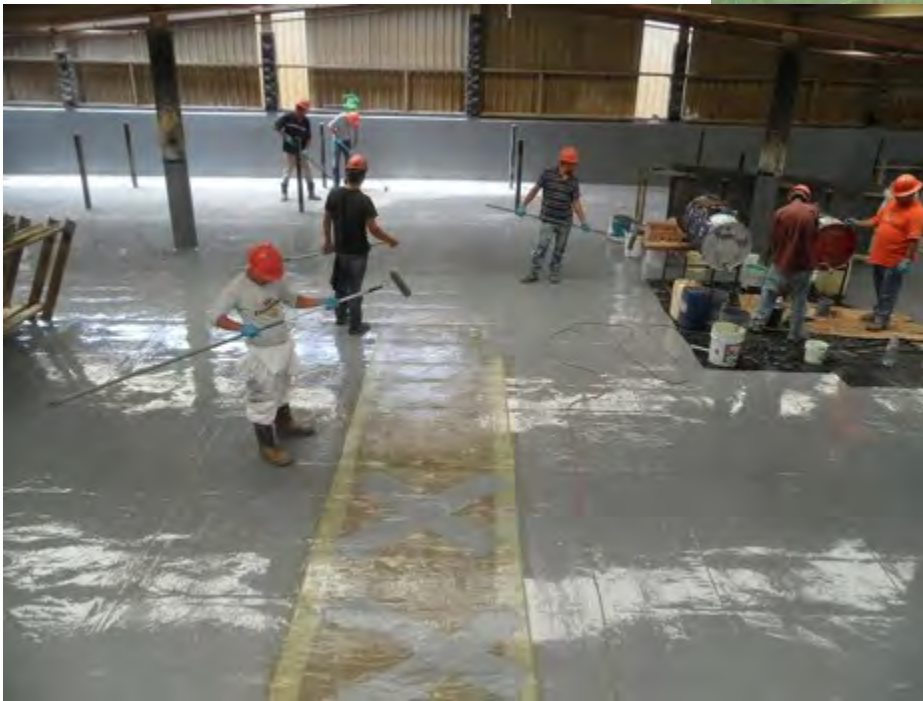
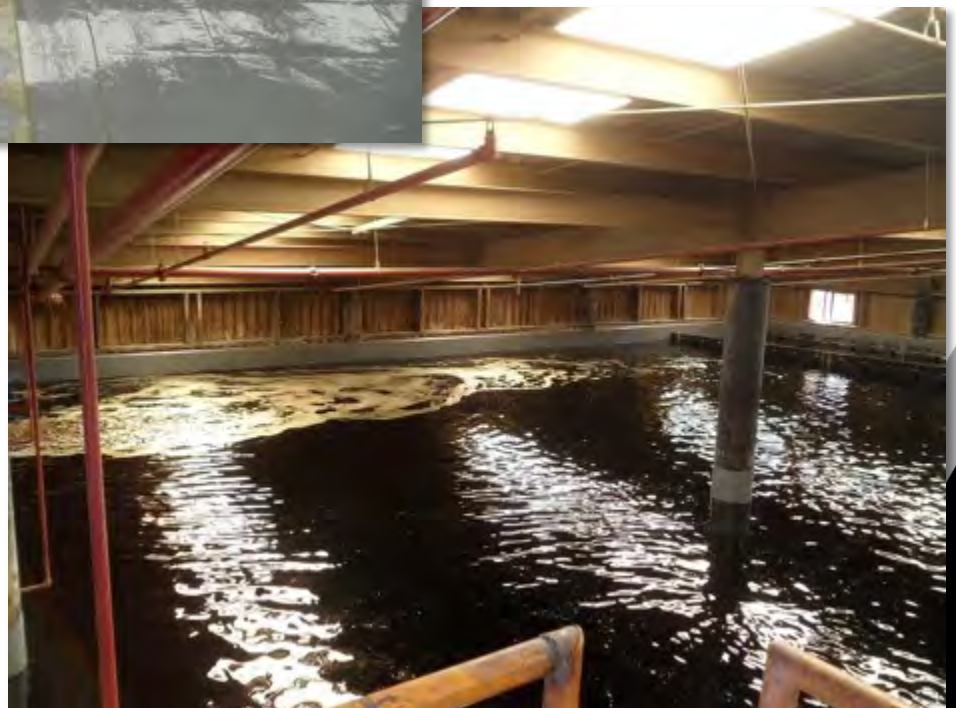
Project Photos: Finish and Operation

- Tanks have been in leak-free operation for over five years.

- An outer coat of QuakeBond epoxy was applied for long term chemical resistance for tanks
- The FRP lining was more cost effective than welded-in-place stainless steel linings that the plant had used on an earlier repair
