REPAIR & STRENGTHENING OF PCCP CONCRETE PIPE WITH CARBON FRP

Name: San Juan Generating Station, PNM
Type: Industrial Facility
Location: Farmington, NM
Completed: October 2007

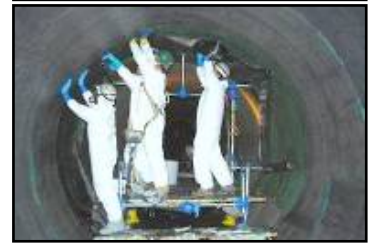
Due to corrosion of reinforcing wires, several sections of 10-ft diameter Prestressed Concrete Cylinder Pipe (PCCP) in this coal burning plant required strengthening. Design requirements called for additional strength in both hoop and longitudinal directions. Access for the pipe was available only through a 30-inch diameter manhole. This required re-design and manufacturing of the equipment.

A special PipeWrap™ Carbon fabric was developed for this project to achieve the strengthening requirements with a **single layer** of fabric – instead of **two layers** as the original design called for. Samples were constructed and tested to demonstrate the feasibility of the solution. 50-inch wide bands of fabric were applied in the hoop direction, with a single overlapping joint along the bottom of the pipe. There was a small steel section in the pipe; that was wrapped first with a layer of glass fabric (shown on the right) to avoid galvanic corrosion. The entire repaired section was coated with a layer of high chemical resistant coating.
