Blast Loading Retrofit of Unreinforced Masonry Walls

With Carbon Fiber Reinforced Polymer (CFRP) Fabrics

Mo Ehsani, Ph.D., P.E., S.E. and Carlos Peña, M.S., P.E.

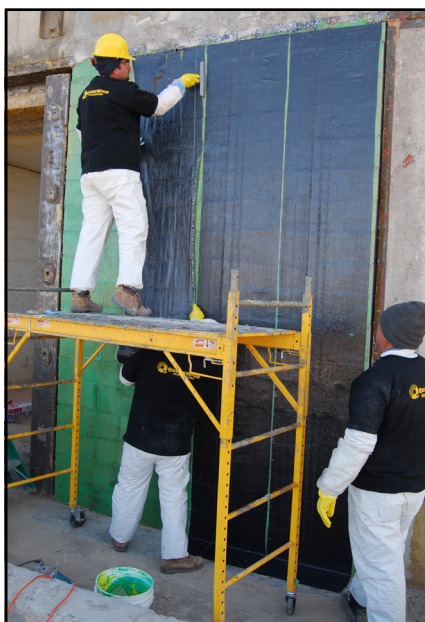
Figure 1: CFRP fabric installation on URM wall

One of the URM walls was retrofitted on both faces with carbon fiber fabric (CFRP), considering the following construction sequence: first, a layer of tack coat was applied to the wall surface. The purpose of the tack coat was to seal the wall surface, smooth out small imperfections and hold up the weight of the saturated CFRP strips; second, the CFRP strips were saturated in epoxy resin and placed on the tack coated surface. Figure 1 shows the installation of the CFRP fabric over the tack coated surface.

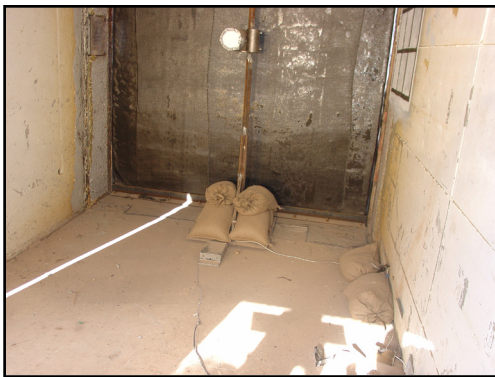
Figure 3: Instrumentation on the interior of the reaction building room

Figure 3 illustrates some of the instrumentation installed on the inside of the room. Visible in the figure is the laser gage mounted on the steel post, the interior pressure gage on the floor (inside the aluminum casing behind the laser stand) and the interior lateral high speed camera window on the left wall. Also visible in this figure is the interior bottom steel angle used as mechanical anchor for the CFRP fabric.

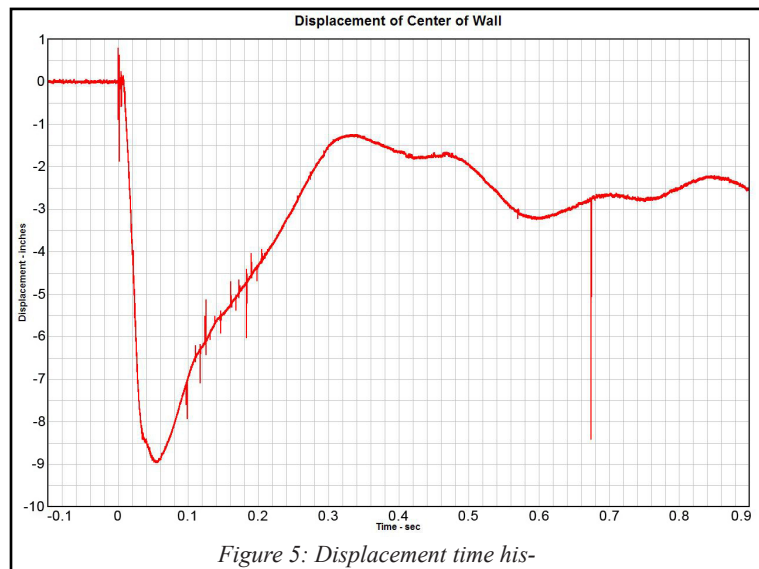
Figure 5: Displacement time his-

2) Peak lateral deformation: The maximum deformation was measured at approximately 9 inches. The deformation time history plot is given in *Figure 5* (negative values indicate wall movement towards the inside of the room). From *Figure 5*, it can be observed that there is no elastic rebound deformation due to the inertial forces. This was most likely caused by the crushing failure of the masonry, which generated an over-damping effect that eliminated the oscillations about the zero deformation line. As a result of the crushing failure of the masonry, a permanent deformation of about 2.5 inches was measured after the blast event. The figure also shows that oscillations of about 0.25 inch in amplitude with periods of 0.15 to 0.2 seconds occur after the first motion. These appear to be due to vibration of the instrument stand, and are unlikely to represent true motion of the wall.

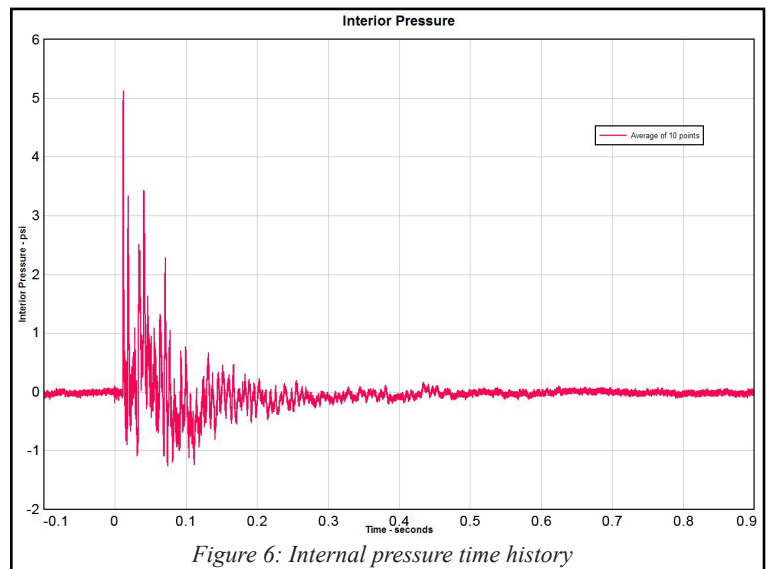
Figure 6: Internal pressure time history

3) Peak interior pressure: The maximum value was measured at 4.2 psi. Blast wave leakage occurred between the gaps on the vertical edges; these gaps increased significantly due to the wall deformations. Therefore, if these gaps had been sealed, the peak internal pressure would have been significantly lower. As a reference, eardrum rupture and lung damage occur at about 5 psi and 10 psi, respectively; therefore, 100% survival rate, with minimal injuries would be expected for any occupant of the room with the CFRP retrofitted wall. As will be shown later, the CFRP contained all the debris and no wall projectiles were seen in the room, which is a highly desirable feature for minimizing potential injuries and property damage. *Figure 6* shows the internal pressure time history. The noisy and chaotic shape of the curve is typical of internal pressure reading in closed rooms.

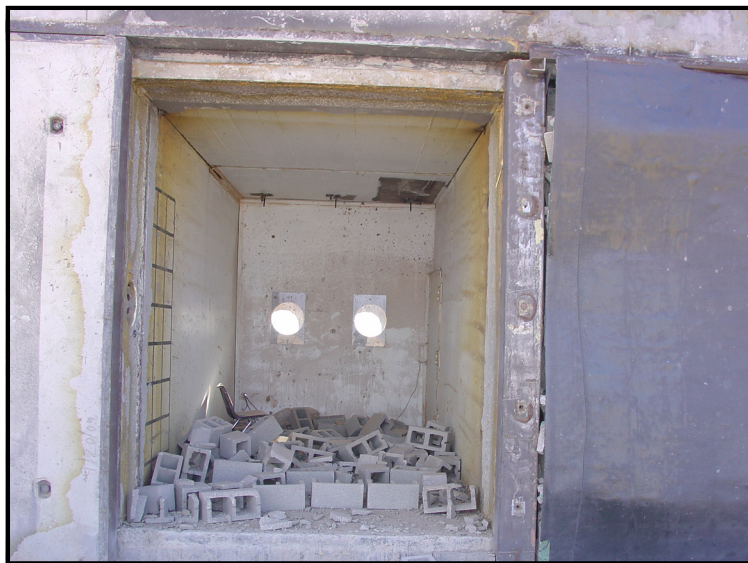
Figure 7: Un-retrofitted and CFRP retrofitted URM walls after the blast test

lations. Also, CFRP anchorage failure occurred on the top edge of the outside face of the wall due to insufficient development length. Under static conditions, a simply supported wall would have very little tensile force demands at the edges, so CFRP anchorage failure is usually not a concern. However, under dynamic conditions, the inertial forces of the disintegrated mass of crushed masonry forced the CFRP to act as a membrane, placing significant tensile demands on the edges. The use of a proper development length would have meant extending the CFRP beyond the steel angle anchoring system and into the parapet of reaction building, which was avoided to minimize residual CFRP fabric adhered to the building exterior. *Figure 7* (See page 20) shows CFRP anchorage failure occurring at the upper left corner of the wall.

Figure 7 also shows the state of the retrofitted and un-retrofitted URM walls after the blast test. The un-retrofitted URM wall suffered catastrophic failure, with masonry debris scattered all the way to the back of the room. Although the internal pressure was not measured on the room enclosed by the un-retrofitted wall, it would be safe to assume that it exceeded 45 psi, considering that the shock

It can be observed from *Figure 7* that the CFRP retrofitted wall remained standing, even though the masonry inside was practically reduced to debris. It can also be seen that all the debris was contained by the CFRP. The high speed camera video taken from the inside shows evidence that no masonry debris projectiles were present in the room enclosed by the retrofitted wall and that all the debris was contained by the CFRP fabric. The inside lateral video camera clearly captured the deformation behavior of the wall during the blast event, including the effects of the crushing failure of the masonry. The lateral exterior video camera illustrated the effect of the arrival of the shock wave on both URM walls.
