Blast Loading Retrofit of Unreinforced Masonry Walls

With Carbon Fiber Reinforced Polymer (CFRP) Fabrics

By Mo Ehsani, Ph.D., P.E., S.E. and Carlos Peña, M.S., P.E.

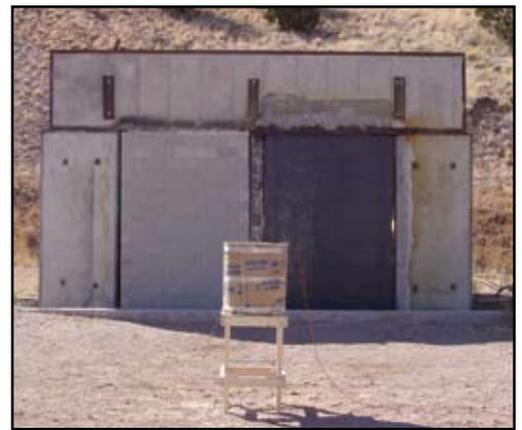
Figure 2: URM wall test specimens ready for blast test.

A blast source consisting of 240 pounds of explosive (equivalent to 200 pounds of TNT) was placed in a cylinder with aspect ratio (length/diameter) equal to 1.0, at a height of 3 feet and at a distance of 30 feet from the URM walls. This blast source was intended to reproduce the effects of a car bomb explosion occurring on a side street in front of the wall. Figure 2 shows both test wall specimens and the blast source.

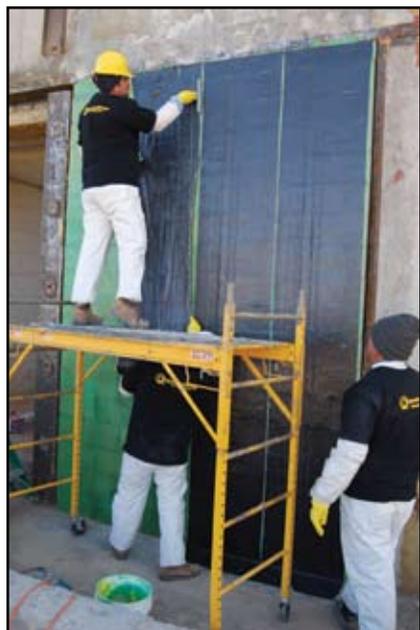
Figure 1: CFRP fabric installation on URM wall.

(CFRP), considering the following construction sequence: first, a layer of tack coat was applied to the wall surface. The purpose of the tack coat was to seal the wall surface, smooth out small imperfections and hold up the weight of the saturated CFRP strips; second, the CFRP strips were saturated in epoxy resin and placed on the tack coated surface. Figure 1 shows the installation of the CFRP fabric over the tack coated surface.

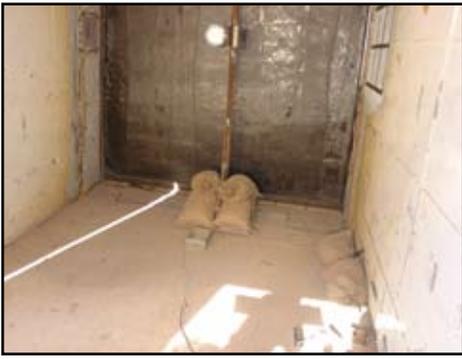
Figure 3: Instrumentation on the interior of the reaction building room.

Figure 3 (page 17) illustrates some of the instrumentation installed on the inside of the room. Visible in the figure is the laser gage mounted on the steel post, the interior pressure gage on the floor (inside the aluminum casing behind the laser stand) and the interior lateral high speed camera window on the left wall. Also visible in this figure is the interior bottom steel angle used as mechanical anchor for the CFRP fabric.

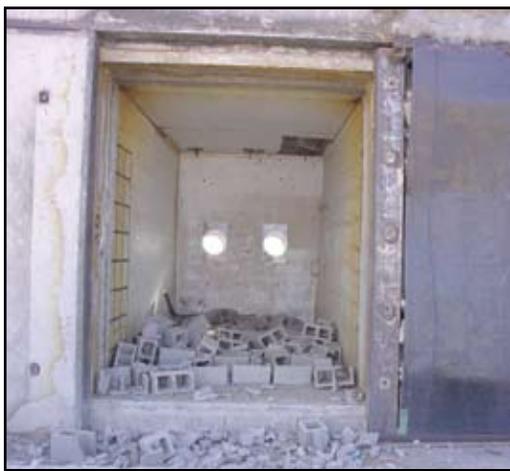
Figure 7: Un-retrofitted and CFRP retrofitted URM walls after the blast test.

As mentioned above, crushing failure of the masonry occurred as predicted by the structural calculations. Also, CFRP anchorage failure occurred on the top edge of the outside face of the wall due to insufficient development length. Under static conditions, a simply supported wall would have very little tensile force demands at the edges, so CFRP anchorage failure is usually not a concern. However, under dynamic conditions, the inertial forces of the disintegrated mass of crushed masonry forced the CFRP to act as a membrane, placing significant tensile demands on the edges. The use of a proper development length would have meant extending the CFRP beyond the steel angle anchoring system and into the parapet of reaction building, which was avoided to minimize residual CFRP fabric adhered to the building exterior. Figure 7 (see page 20) shows CFRP anchorage failure occurring at the upper left corner of the wall.

Figure 7 also shows the state of the retrofitted and un-retrofitted URM walls after the blast test. The un-retrofitted URM wall suffered catastrophic failure, with masonry debris scattered

It can be observed from *Figure 7* that the CFRP retrofitted wall remained standing, even though the masonry inside was practically reduced to debris. It can also be seen that all the debris was contained by the CFRP. The high speed camera video taken from the inside shows evidence that no masonry debris projectiles were present in the room enclosed by the retrofitted wall and that all the debris was contained by the CFRP fabric. The inside lateral video camera clearly captured the deformation behavior of the wall during the blast event, including the effects of the crushing failure of the masonry. The lateral exterior video camera illustrated the effect of the arrival of the shock wave on both URM walls.
