Dynamic In-Plane Behavior of URM Wall Upgraded with Composites

Mohamed A. Elgwady¹, Pierino Lestuzzi², Marc Badoux³
1,2,3 Swiss Federal Institute of Technology, Lausanne, Switzerland.

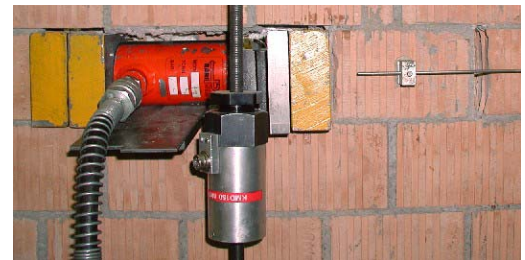
Figure 4. Shove Test.

After the dynamic testing of WRAP-G a shove test was performed under a normal force of 0.35 MPa. This test requires the removal of two bricks and a head joint one brick away on the same course, as shown in *Figure 4*. A loading jack is placed in the cavity and the brick between the cavity and the missing head joint is forced towards the missing head joint until shear failure is achieved. The compressive strength of the masonry governed the test. The test was stopped at 35 kN, corresponding to characteristic shear stresses (f_v) of about 1.6 MPa.

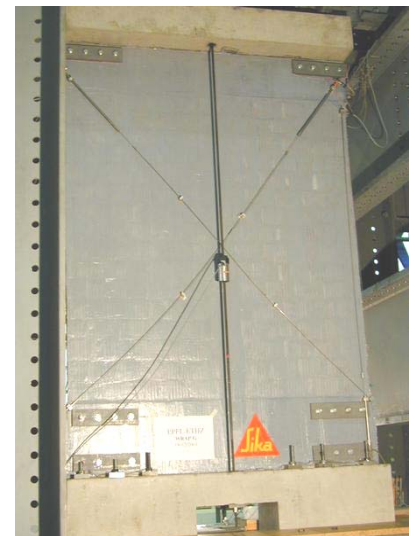
Figure 7. Wall Specimen WRAP-G Upgraded On One Side (West Side) Using GFRP.

The anchorage of externally bonded reinforcement is a common weak point. It is not the goal of the test to test the anchorage of the upgrading system. To ensure that anchorage failure did not occur, steel plates were used to anchor the GFRP to the walls using steel bolts as shown in *Figure 7*.

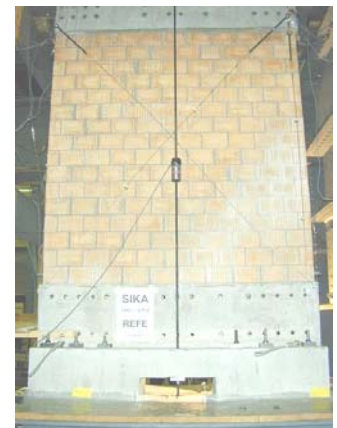
Figure 10. Specimen REFE After Testing

- At the end of the test, wall REFE showed little damage. As shown in *Figure 10* no visible damage or crushing to the brick units or mortar was observed. The test was interrupted in order to preserve the specimen for the subsequent upgraded wall test.

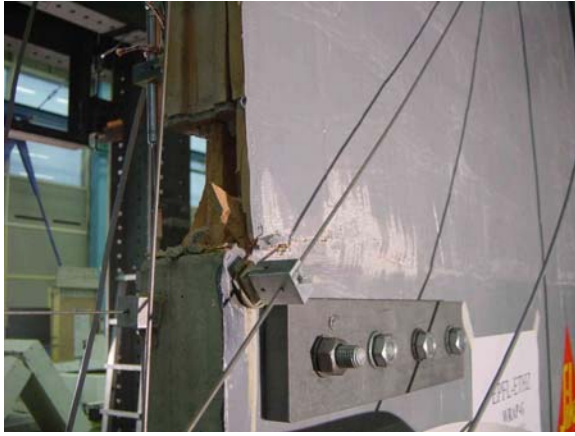
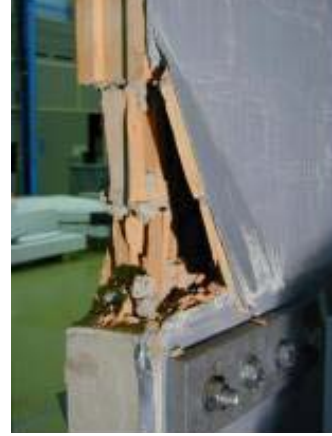
Figure 12. (a) Failure Of The GFRP Fabric At The Base Of The Masonry Wall And (b) Crushing Of The Masonry At The Wall Toe.

- Test runs 1 to 18 produced no visible damage to WRAP-G.
- The delamination process began in a few points during test run 14. This delamination was visible in the form of white spots on the wrap.
- During test run 19, both the horizontal force and the prestressing force decreased slightly. No visible damage was noticed.
- During test runs 20 to 23 both of the horizontal force and the prestressing force increased rapidly.
- During test run 24 the wall started to rock at the base. This rocking was accompanied with crushing of the masonry at the wall corners. The wall failed under a combination of “local buckling” and tear at the wall corner as shown in *Figure 12*.
