## **EXPERIMENTAL RESPONSE OF MASONRY WALLS EXTERNALLY REINFORCED WITH CARBON FIBER FABRICS**

### **ABSTRACT**

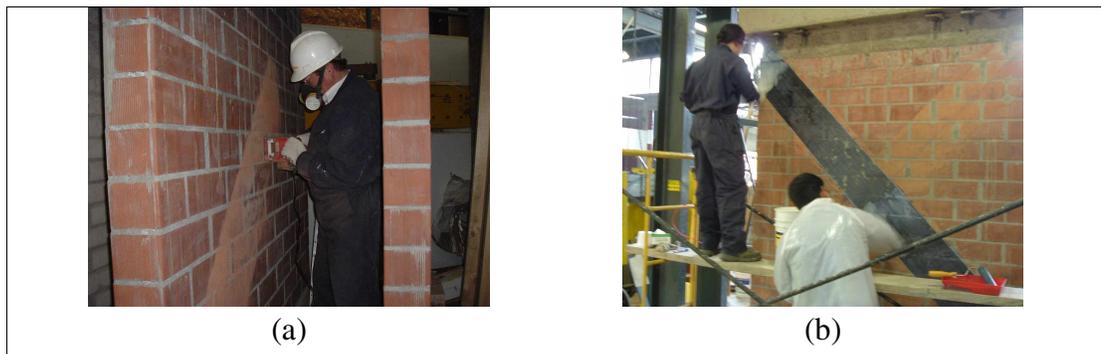
Figure 1. (a) Surface treatment of the walls. (b) Bonding of the FRP reinforcement.

To prepare the surface of the walls the exterior layer of the bricks was removed with a sander until the clay substrate was exposed. The gaps between bricks were filled with a mortar reinforced with fibers to produce a smoother surface. The surface obtained was not planar, but it had rounded irregularities. The fabric was bonded to the surface of the walls using an epoxy resin as recommended by the fabricator. The process of surface preparation and bonding of the carbon fibers is shown in Fig. 1. The configurations of the reinforcement are shown in Fig. 2.

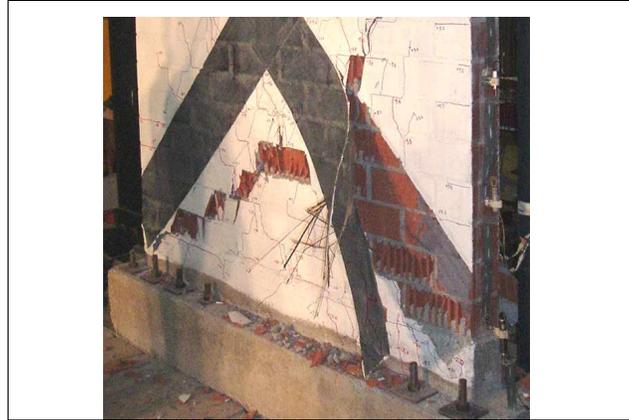
Figure 9. Failure mode of the DRM walls. The bottom bricks were previously damaged.

compressive stress at the bottom ends of the walls due to in-plane bending of the walls damaged the bricks at that location; failure occurred when peeling stresses at the bottom end of a strip broke the previously damaged bricks (see Fig. 9) and the fabric delaminated in up to 50% of its length; then the strength dropped sharply.
