# FAILURE MODES AND FAILURE MECHANISMS OF FIBER REINFORCED POLYMER COMPOSITE BRIDGE DECKS

*Aixi Zhou, Virginia Polytechnic Institute and State University, Blacksburg, VA  
John J. Lesko, Virginia Polytechnic Institute and State University, Blacksburg, VA  
Jason T. Coleman, Virginia Polytechnic Institute and State University, Blacksburg, VA  
Thomas E. Cousins, Virginia Polytechnic Institute and State University, Blacksburg, VA*

## Abstract

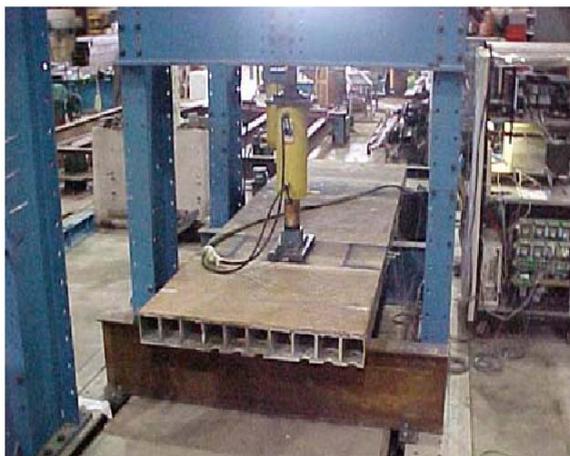
(a) Test configuration using steel patch

**Figure 2.** Test configuration using steel patch and the geometry of the patch [7]

The testing setup for Deck A is shown in Figure 2(a). The deck was supported by three steel I beams spaced 78 inches apart. Load was applied to the deck by hydraulic cylinders that were mounted on a load frame. The load was transferred to the deck through the steel patch, a stack of steel plates that were welded together. The deck was loaded with the increasing of 10 kips per loading cycle. Shown in Figure 2(b) is the geometry of the steel patch according to the ASSHTO LRFD's contact area specifications [7]. The base plate of this assembly measured 11 inches (traffic direction) by 20 inches. The base plate dimensions represented the tire contact area of an HS25 wheel with impact (26 kips or 115.57 kN) as specified in AASHTO LRFD Specifications [6]. The purpose of welding two steel plates to the base plate was to stiffen the base plate so that bending of the base plate was minimized during

loading, thereby ensuring a nearly uniform distribution of load over the base plate contact area [7]. Neoprene rubber pads were inserted in between the steel plate and the surface of the deck to prevent the steel plate from locally damaging the wearing surface of the deck during testing.

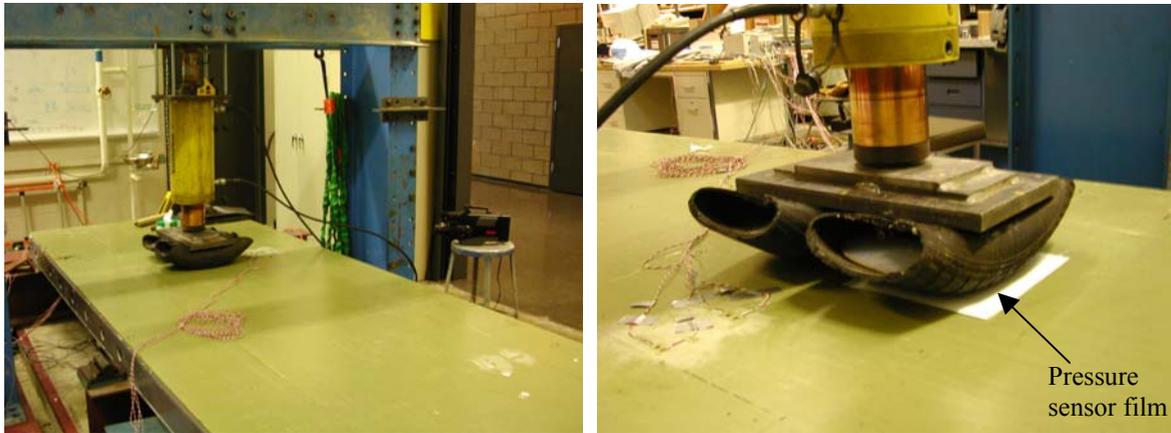
Similar testing setups were used for Deck B. The configuration and the tire patches for testing of Deck B is shown in Figure 3. The tire patches were specially proposed and designed for this deck testing. Firstly, a 9" (22.86cm) wide real truck tire was cut into quarter pieces. Then two pieces were filled with silicon rubber gel. After about 24 hours of curing in room temperature, the rubber-stuffed-tire patches were ready for testing. Before deck testing, the pressure sensitive films were used to capture the contour of normal pressure distributions of the steel patch and the real tire patch under 26 kips (115.57 kN) loading (Figure 4). For Deck B testing, the deck was also loaded with the increasing of 10 kips (or 44.45 kN) per loading cycle respectively.

**Figure 3.** Test configuration using the patch made of real tire stuffed with silicon rubber

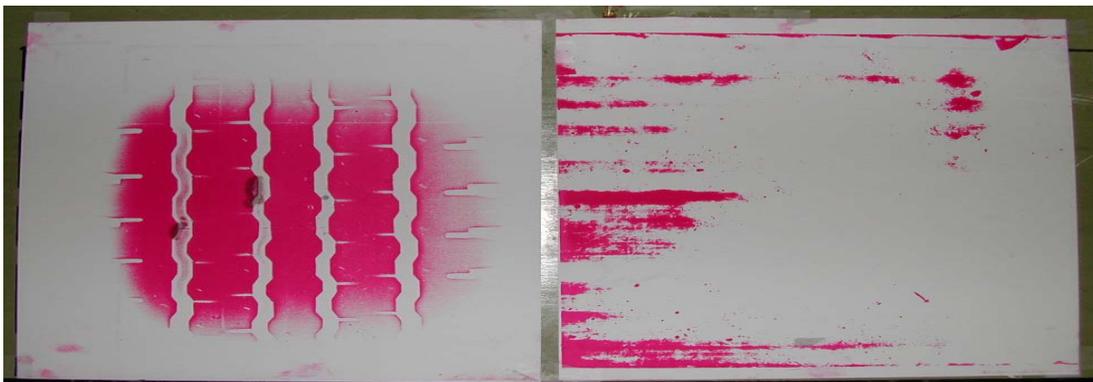
**Figure 4.** Contours of rubber-stuffed tire patch (left) and steel patch (right) using pressure film

The observations from the above numerical analyses and the foot-prints of normal pressure distributions in Figure 4 may provide an explanation of different failure modes at the span center using steel patch and real tire patch: In case of steel patch, the patch was too stiff to deform, which made the transverse stress, vertical stress and the longitudinal-transverse shear stress (and therefore, transverse, vertical and shear strains) dominant around the patch-deck contacting edges before failure. The stress/strain concentration on the edge areas contributed to the punching failure at the span center (Sliding mode in Fracture Mechanics) using steel patch. While in case of real tire patch, the patch was very flexible to deform since the patch was made from rubber. The large deformation of the tire patch in

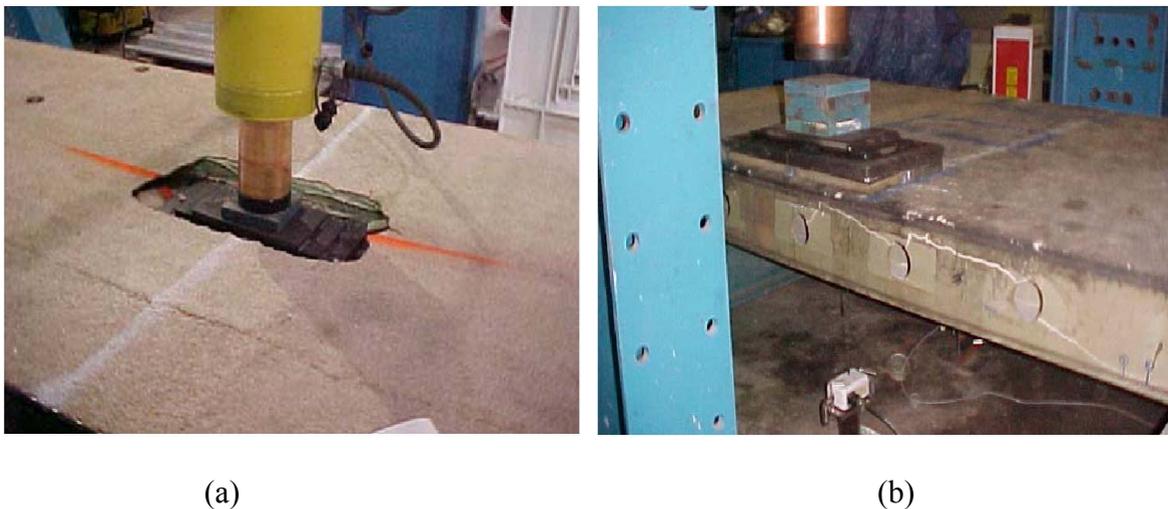
Testing results for Deck A are shown in Figure 5 and Figure 6. The load-deflection curves for four loading cycles for Deck A are shown in Figure 5, where the deflection is represented positive in the longitudinal axis. Debonding noise was observed during the loading cycle when the load reached about 55 kips (244.48 kN) the first time. The deck was failed at 107 kips (475.62 kN). At the center, the failure of Deck A was local punching (Figure 6(a)) right under the steel patch. For the other side of the deck, the loading patch was located at the deck edge of the center of the span. The deck failed at the edge with shearing crack initiating from the underneath of the loading patch (Figure 6(b)).

**Figure 6.** Failure of Deck A using steel loading patch [7]
