# Performance of Double-T Prestressed Concrete Beams Strengthened with Steel Reinforced Polymer

by P. Casadei, A. Nanni, T. Alkhrdaji, and J. Thomas

Synopsis: In the fall of 2002, a two story parking garage in Bloomington, Indiana, built with precast prestressed concrete (PC) double-T beams, was decommissioned due to a need for increased parking-space. This led to the opportunity of investigating the flexural performance of the PC double-T beams, upgraded in the positive moment region with steel reinforced polymer (SRP) composite materials, representing the first case study where this material has been applied in the field. SRP makes use of high-strength steel cords embedded in an epoxy resin. This paper reports on the test results to failure of three beams: a control specimen, a beam strengthened with one ply of SRP and a third beam strengthened with two plies of SRP anchored at both ends with SRP U-wraps. Results showed that SRP can significantly improve both flexural capacity and enhance pseudo-ductility.

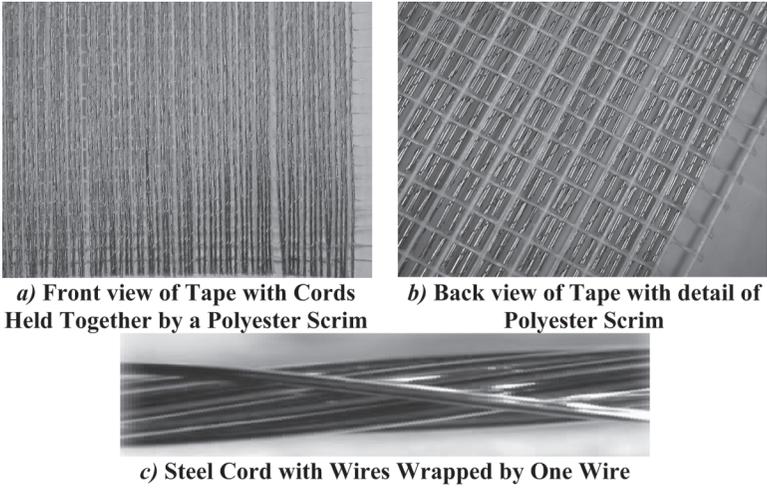
Figure 1 – Example of 12X Steel Cord and Medium Density Tape

A new family of composite materials based on unidirectional high strength twisted steel wires (about 7 times stronger than typical common reinforcing bars) of fine diameter ( $0.20\sim 0.35\text{ mm}$  ( $0.0079\sim 0.0138\text{ in}$ ) see Figure 1), that can be impregnated with thermo-set (referred to as steel reinforced polymer, SRP) or cementitious (referred to as steel reinforced grout, SRG) resin systems is presented in this work (Hardwire 2002)<sup>(7)</sup>. SRP/G has the potential to address the two shortcomings mentioned for FRP, indeed: a) steel cords have some inherent ductility; and b) impregnation with cementitious paste may overcome the problems of fire endurance and lowering down the application cost considerably.

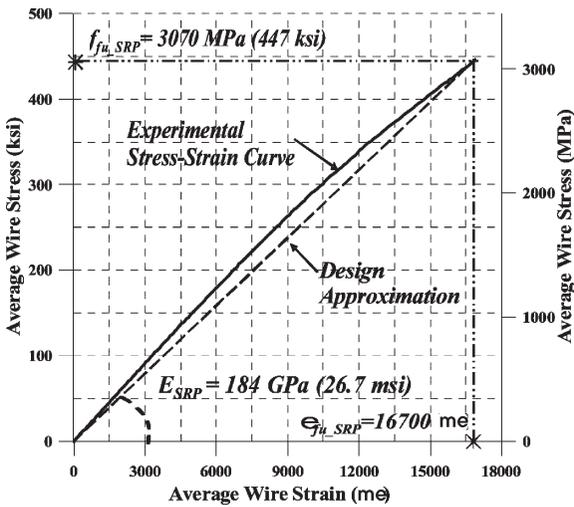
Figure 2 – SRP Laminate Stress vs Strain Behavior

The steel cords used in SRP are identical to those used for making the reinforcement of automotive tires, and manufactured to obtain the shape of the fabric tape prior to impregnation (Hardwire, 2002). The twisting of the wires allows some mechanical interlock between the cords and the matrix, and may also induce an overall ductile behavior upon stretching. The cords are also coated with either brass or zinc making the material potentially free of any corrosion and suitable for different kind of environmental exposure. Characterization work, including durability as well as bond related issues, is currently in progress as necessary for implementation in future design guidelines. Recent test results<sup>(8)</sup> showed that the material does not experience a substantial yielding, but rather a similar behavior to the one experienced by high-strength steel used in prestressed concrete (PC) construction, with a slight non-linear range prior to rupture of the cords (see Figure 2).

The tape was medium density consisting of  $6.3\text{ cords per cm}$  ( $12\text{ WPI}$ ), with material properties defined in Table 3. The typical stress-strain diagram for an impregnated medium density tape, tested following the ASTM D 3039<sup>(12)</sup> recommendations, is reported in Figure 2 (properties based on steel net area).

Beam DT-1 reached the peak load of 387 kN (87 kip) and held it constant with increasing deflection, while SRP progressively delaminated from mid-span towards the support. The strain profile reported in Figure 10 shows how the SRP was not engaged until cracking occurred and as soon as the first crack opened at mid-span, the SRP bridged the crack and strain suddenly increased to approximately  $5500 \mu\epsilon$  (strain-gauge was placed at mid span where the first crack occurred). The maximum strain recorded in the steel tape ( $12300 \mu\epsilon$ ), prior to complete peel-off, shows how the material was well bonded to the concrete substrate. The ductility reported in the load-deflection curve, is the result of the slow peeling propagation rather than to the yielding of the reinforcing steel tape itself. Figure 2 shows in fact an almost elastic behavior till rupture of the SRP laminate.

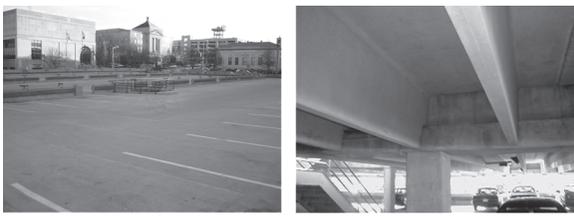
a) Top View of the Deck      b) Bottom View of the Deck

Figure 3 – Bloomington Parking Garage

The parking garage used for the tests was a two story structure constructed in the 1980s (see Figure 3a and b). It consisted of a reinforced concrete (RC) frame, cast in place columns and precast reversed-T PC beams, supporting double-T PC beams, of span length varying from 4.66 m (15.3 ft) to 13.41 m (44 ft).

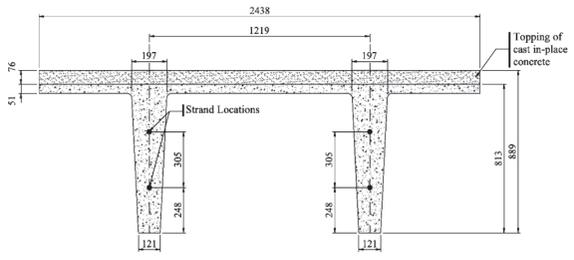
c) Cross Section Geometry Details (SI units 1 mm = 0.039 in)

Since no maintenance or construction records were available for the materials and the layout of the prestressing tendons, a field investigation was carried out. Based on the survey, it was determined that the double-T PC beams were of type 8DT32 (see Figure 3c) according to the Prestressed Concrete Institute (1999)<sup>(9)</sup> specifications with concrete topping of 76 mm (3in), and with an arrangement of the tendons different from current specifications. For the span of 4.66 m (15.3 ft), two straight 7-wire strands were found in each stem, each with a diameter of 12.7 mm (0.5 in), corresponding to an area of 112 mm<sup>2</sup> (0.174 in<sup>2</sup>), the first at 248 mm (9.75 in) from the bottom of the stem and the second spaced 305 mm (1 ft) from the first one. No mild reinforcement was found at any location. Welded pockets, connecting two adjacent beams, were positioned every 910 mm (3ft) at a depth of 76 mm (3 in) from top surface. Concrete properties were evaluated using three cores taken from three different beams at the location of the stem and an average concrete cylinder strength of  $f'_c = 34 \text{ N/mm}^2$  ( $f'_c = 5000 \text{ psi}$ ) was found and its modulus of elasticity was determined according to ACI 318-02 Section 8.5.1<sup>(10)</sup> provisions.

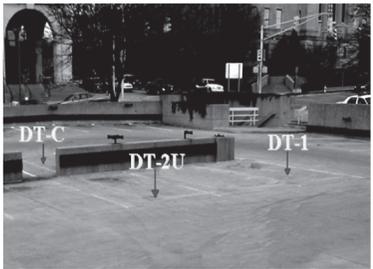
a) Saw-Cut Marks on Top of Deck

Figure 4 – Test Beams (SI units 1 mm = 0.039 in.)

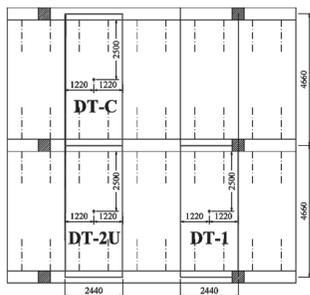
b) Plan View

A total of three double-T PC beams were tested (see Figure 4a and b): beam DT-C is the control beam, beam DT-1 represents the beam strengthened with one ply of SRP and DT-2U the one strengthened with 2 plies of SRP anchored with SRP U-wraps. Figure 4c illustrates the strengthening geometry details for beam DT-1 and DT-2U.

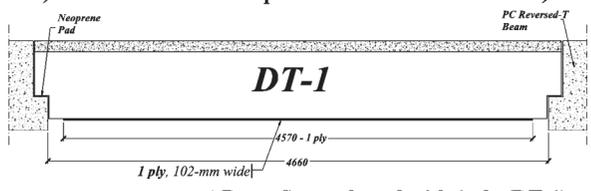
c) Beam Strengthened with 1 ply (DT-1)

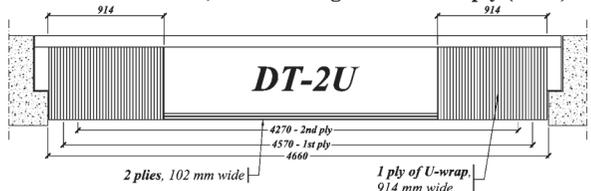
d) Beam Strengthened with 2 plies + U-wrap (DT-2U)

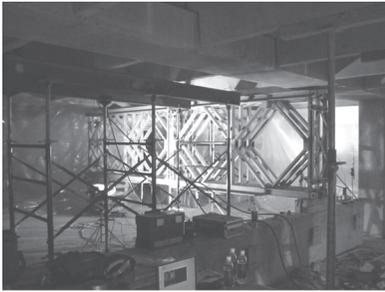
a) Bottom View

Figure 6 – Test Set Up

The experimental setup is shown in Figure 6a and Figure 6b. The beams were tested under simply supported conditions and subject to a single concentrated load spread over both stems at mid-span, that is, 3-point bending at mid-span (see Figure 6c).

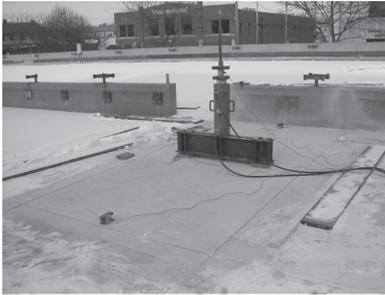
b) Top View

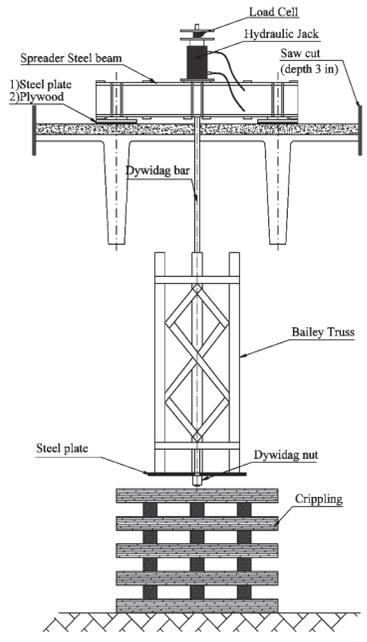
c) Cross Section at Mid-Span

All three tests were conducted using a close-loop load configuration, where no external reaction is required. The load was applied in cycles by one hydraulic jack of 890 kN (200 kip) capacity connected to a hand-pump. The load was transferred to the PC beam in two points through one spreader steel beam (see Figure 6*b*). The reverse-T PC-Ledger beams, on which the double-T beam rests, supplied the reaction. As the hydraulic jack extended, it pulled on the high-strength steel bars, which lifted the reaction bailey-truss below. The reaction truss was built with three bailey-truss frames 6.09 m (20 ft) long assembled as per manufacturer's specifications (Mabey Bridge and Shore, Baltimore, MD) <sup>(13)</sup>, and properly designed to carry the test load (see Figure 6*a*). Plywood was placed at each contact point to protect the concrete. The load was measured using a 890 kN (200 kip) load cell placed on top of the jack (see Figure 6*c*). The preparation work consisted of drilling one hole of small diameter (~50 mm (2 in)) necessary for passing the high-strength steel bar through the flange of the double-T PC beam and isolating each test specimen from the adjacent beams originally joined by the welded-pockets.

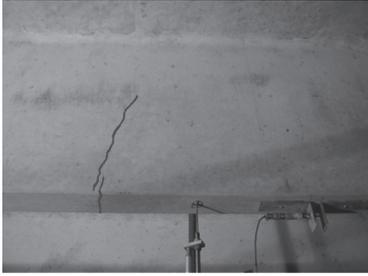
*a)* Initial Crack Propagation

**Beam DT-C**

In beam DT-C flexural cracks were concentrated in the mid-span region where the point load was applied (see Figure 7*a*). As soon as cracking occurred, since no mild reinforcement was present and tendons were placed far away from the bottom of the stem, cracks developed throughout the entire stem and deck (see Figure 7*b*). In beams DT-1 and DT-2U a similar behavior occurred with the difference that the presence of the SRP allowed the formation of additional flexural cracks. In beam DT-1 the SRP laminate started debonding at mid-span initiated by the widening of mid-span cracks (see Figure 7*c*) and then progressed towards the supports (see Figure 7*d*). Complete detachment of the laminate occurred at one end of the beam with part of the concrete substrate attached to the laminate, denoting a good interface bond between the concrete and the SRP (see Figure 8*a* and *b*). In beam DT-2, SRP could not completely peel off due to the presence of U-wraps. Delamination propagated from mid-span towards the supports similarly to Beam DT-1, until rupture of the lower tendon occurred (see Figure 7*e*) and immediately followed by SRP rupture exactly at the location where the SRP U-wrap started (see Figure 7*f*). No shear cracks were noted on any of the three beams.

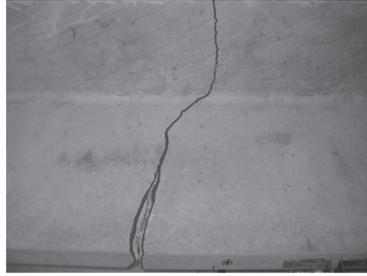
*b)* Crack Propagation Through the Deck

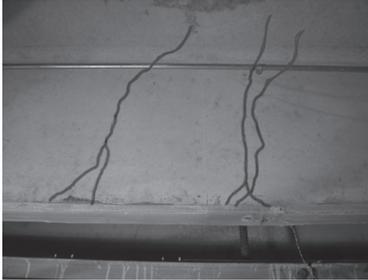
*c)* Crack Propagation Prior to Complete Peeling

**Beam DT-1**

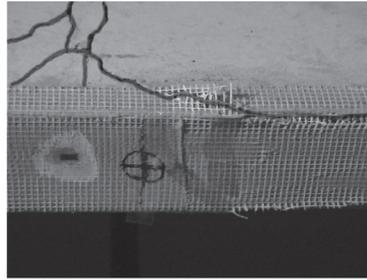
*d)* Debonding Propagation from Mid-Span

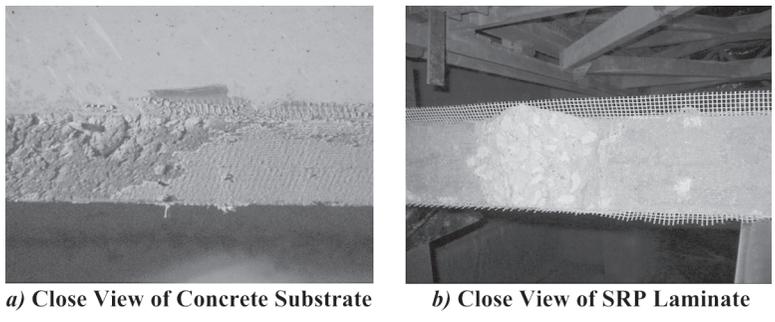
Figure 8 – Concrete and SRP Laminate Condition After Debonding Has Occurred

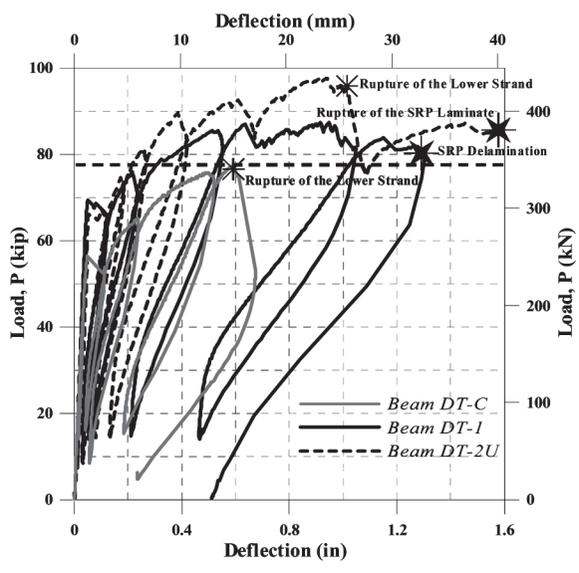
Figure 9 – Load vs Mid-Span Deflection

Figure 9 shows the Load-vs-mid-span Deflection curves for all three beams. The capacities of beams DT-1 and DT-2U increased approximately 12% and 26% with respect to the control specimen DT-C.

Beam DT-C cracked at a considerably lower load (250.8 kN (56.4 kip)), with respect to the other two strengthened specimens. The occurrence of the first crack, at mid-span only, corresponds to the load drop in the Load-vs-Displacement plot. Upon unloading, the beam remained almost perfectly elastic, recovering almost all deflection. At the third loading cycle the lower strand suddenly fractured at a load of 344.3 kN (77.4 kip). For beams DT-1 and DT-2U the cracking load increased of approximately 23% and 17% with respect to DT-C. The lower cracking load for DT-2U may be explained by the fact that the beam had been previously repaired by means of epoxy injection.

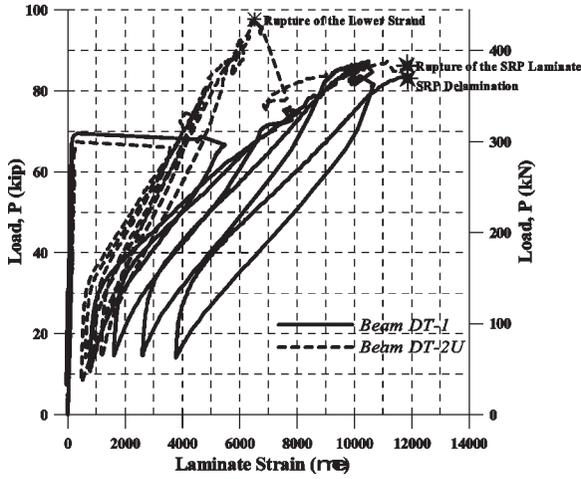
Figure 10 – Load vs Mid-Span Strain

Figure 10 report the Load-vs-Mid-Span Strain responses for beams DT-1 and DT-2U. Two distinct phases, pre- and post-cracking, characterize the behavior of each specimen. Up to cracking there was practically no strain in the SRP. Past the cracking load, the presence of the SRP significantly affected performance.

Past the cracking load (see Figure 10), beam DT-2U behaved almost linearly, although with a lower stiffness, until it reached the load of 400 kN (90 kip) then, stiffness decreased significantly till the peak load was reached. When the load of 434 kN (97.6 kip) was reached, the lower tendon ruptured and a sudden drop in the load-deflection curve was recorded. The strain in the SRP material at time which the tendon ruptured was  $6400 \mu\epsilon$ . At this stage, once the lower tendon ruptured, the SRP laminate was completely debonded except for the region where anchoring was provided by the U-wraps. The test was continued until suddenly the SRP laminate ruptured at 388 kN (87.2 kip). The strain recorded in the SRP laminate at failure was  $12000 \mu\epsilon$ , similarly the values attained in beam DT-1.
