## **PRACTICAL ISSUES RELATED TO THE STRUCTURAL PRESERVATION OF EXISTING BRIDGE STRUCTURES**

**CIES  
99-15**

## REPAIR OF A BRIDGE STRUCTURE AFTER IMPACT LOADING DAMAGE

## **RETROFIT OF EXISTING BRIDGE PIERS USING EXTERNAL PRESTRESSING AND GFRP WRAPPING**

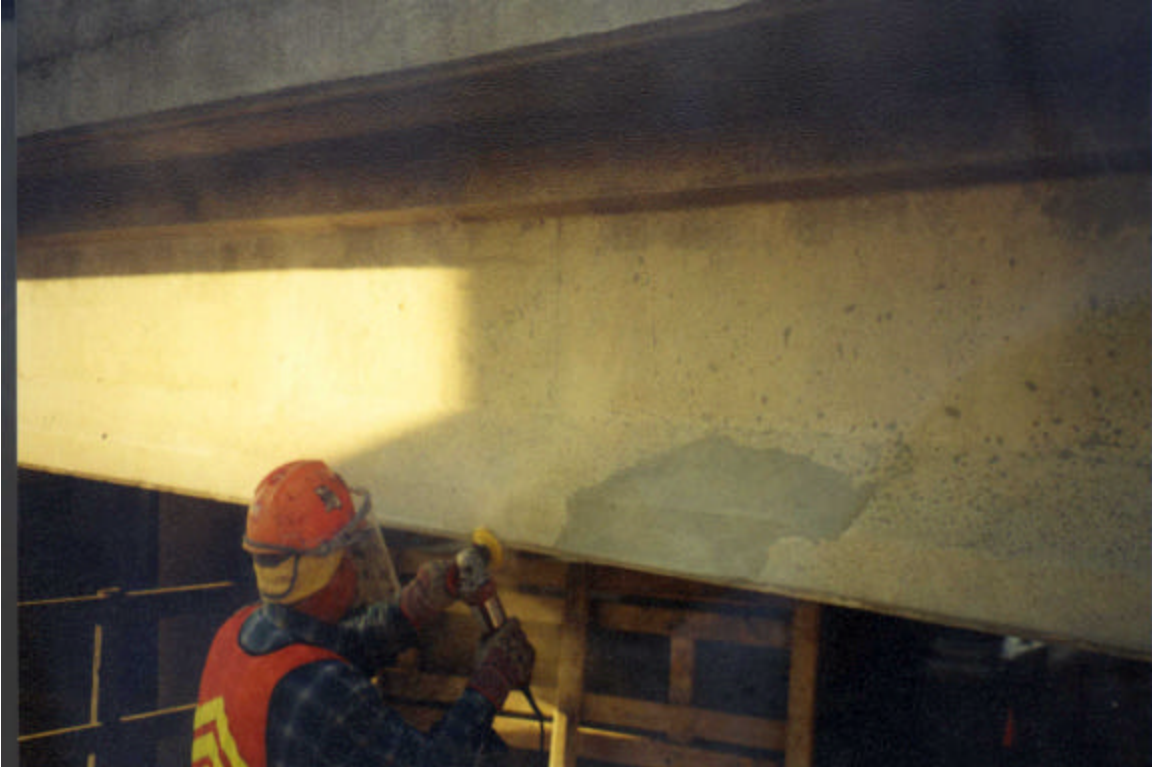
Figure 5.

**Surface Preparation.** The bottom edges of the girder were rounded for proper wrapping (see **Figure 5**). Next, the concrete surface was sandblasted approximately 1.5cm until the aggregate was exposed (see **Figure 6**) and the surface of the concrete was free of loose and unsound materials.

**Figure 5. Surface Preparation – Rounding of Corners**

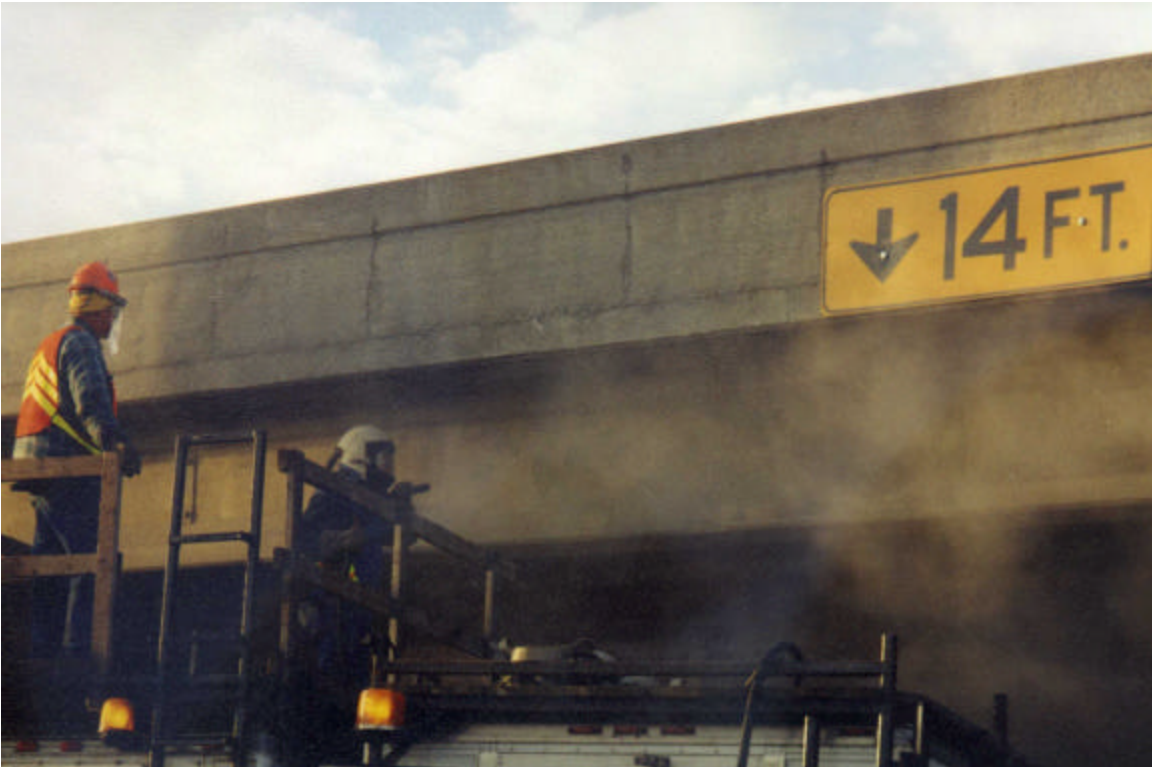
Figure 6.

**Figure 6. Surface Preparation – Sandblasting of Surface Concrete**

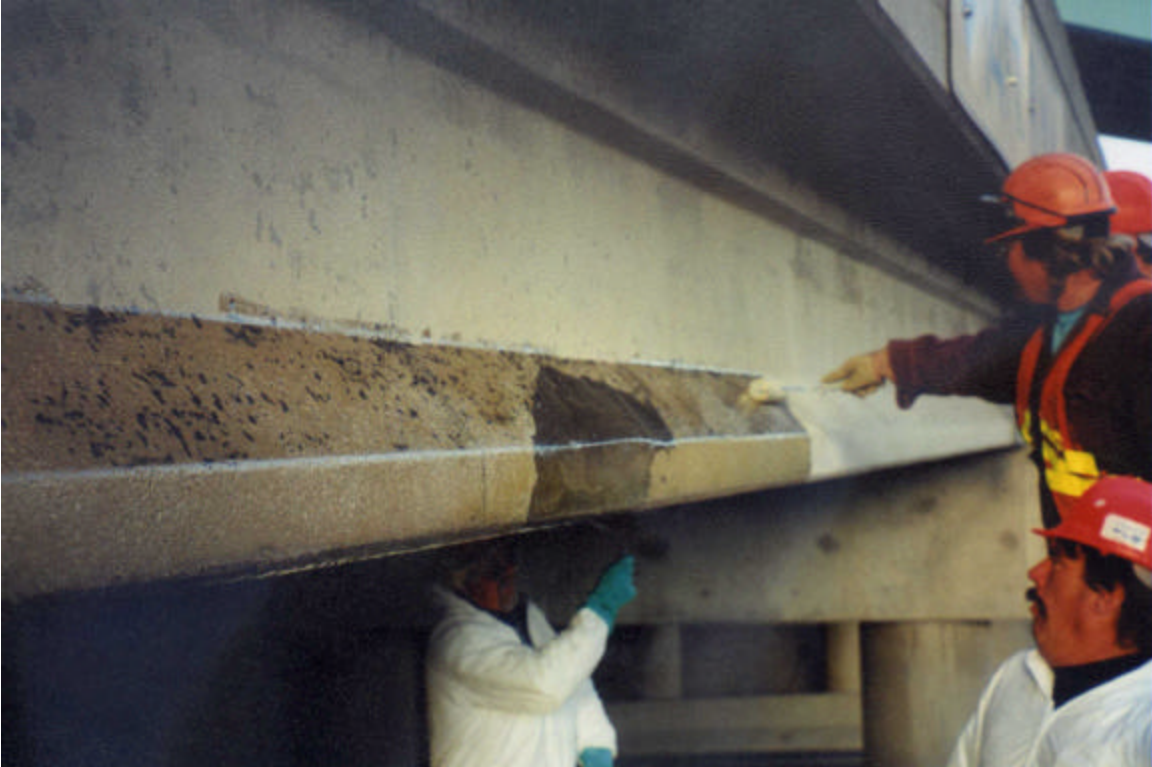
Figure 7.

*Application of the Primer.* A layer of epoxy-based primer was applied to the prepared concrete surface using a short nap roller to penetrate the concrete pores and to provide an improved substrate for the saturating resin (see **Figure 7**).

**Figure 7. Application of Primer**

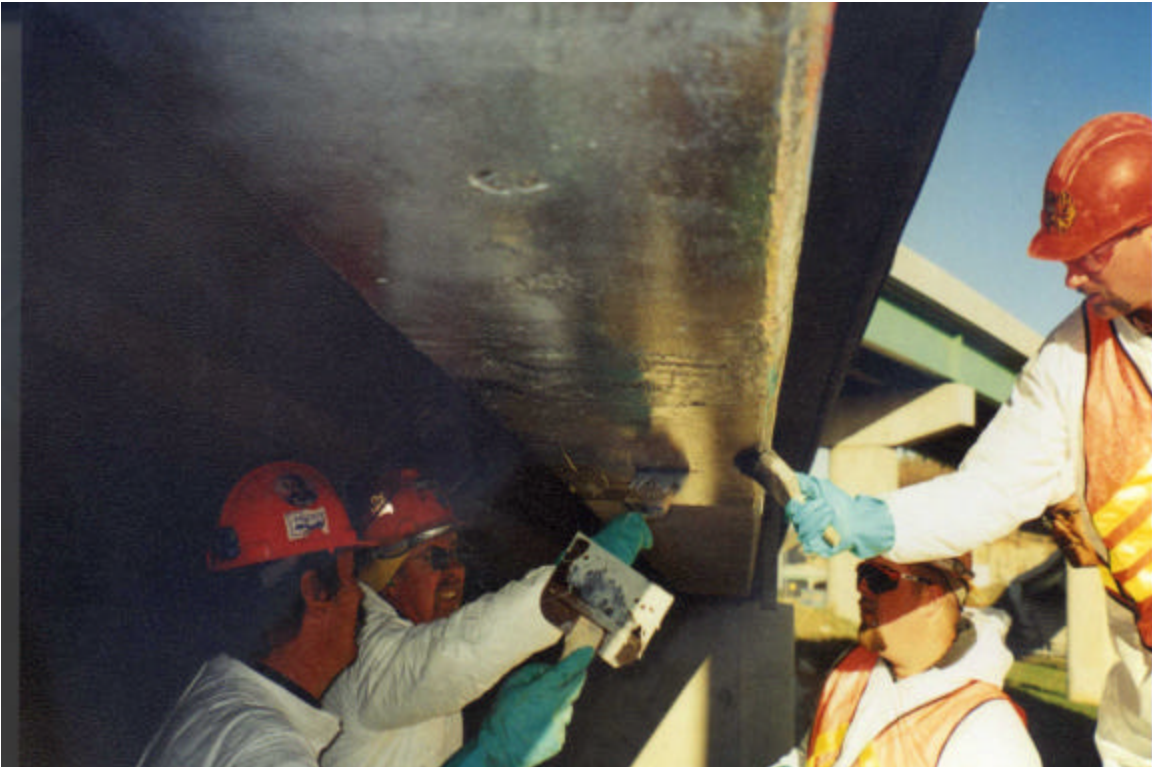
Figure 8.

*Application of the Putty.* After the primer became tack-free, thin layer of putty was applied using a trowel to level the concrete surface and to patch the small holes (see **Figure 8**).

**Figure 8. Application of Putty**

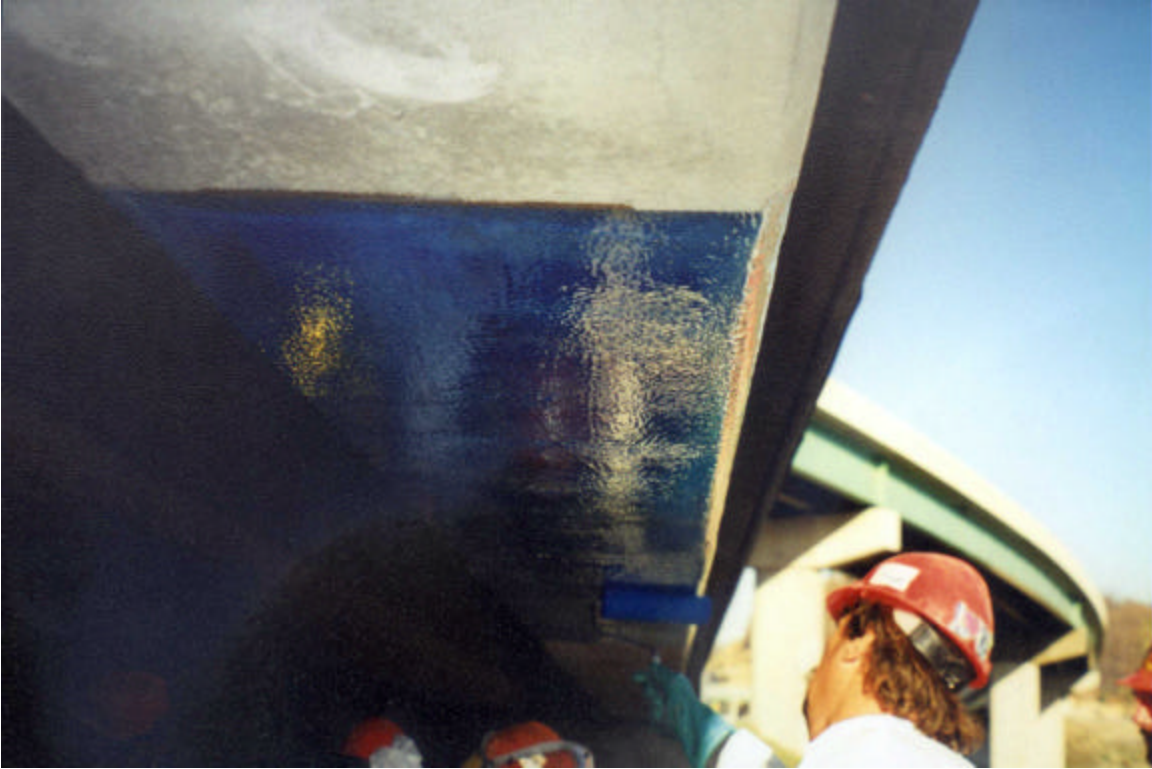
**Figure 9.**

*Application the first layer of the Saturant Resin.* Then the first layer of saturant was rolled on the putty using a medium nap roller. The functions of the saturant are: to impregnate the dry fibers, to maintain the fibers in their intended orientation, to distribute stress to the fibers, and to protect the fibers from abrasion and environmental effects (see **Figure 9**).

**Figure 9. Application of first layer of Saturant**

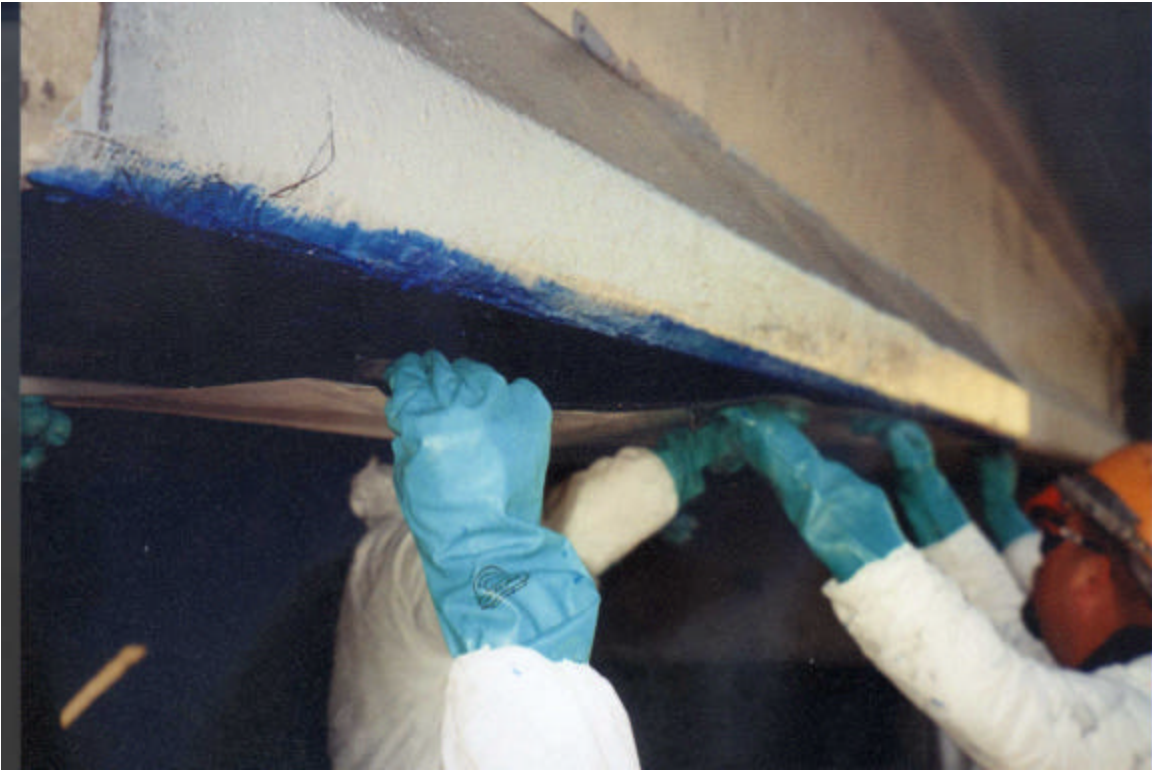
**Figure 10.**

*Application of Fiber Sheets.* After each fiber sheet was measured and pre-cut, they were placed on the concrete surface and gently pressed into the saturant. Prior to removing the backing paper, a trowel was used to remove any air void. After the backing paper was removed, a ribbed roller was rolled in the fiber direction to facilitate impregnation by separating the fibers (see **Figure 10** and **Figure 11**).

**Figure 10. Manual lay-up of CFRP sheets**

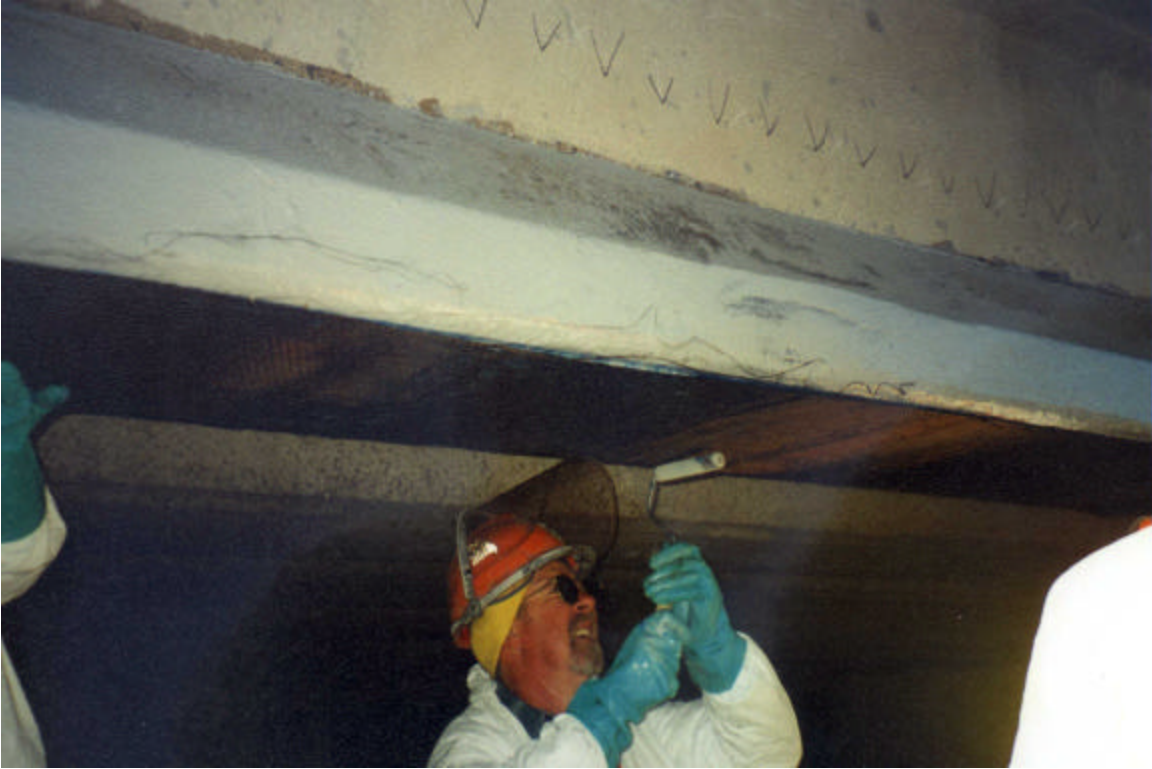
Figure 11.

**Figure 11. Rolling of CFRP laminate to eliminate entrapped air**

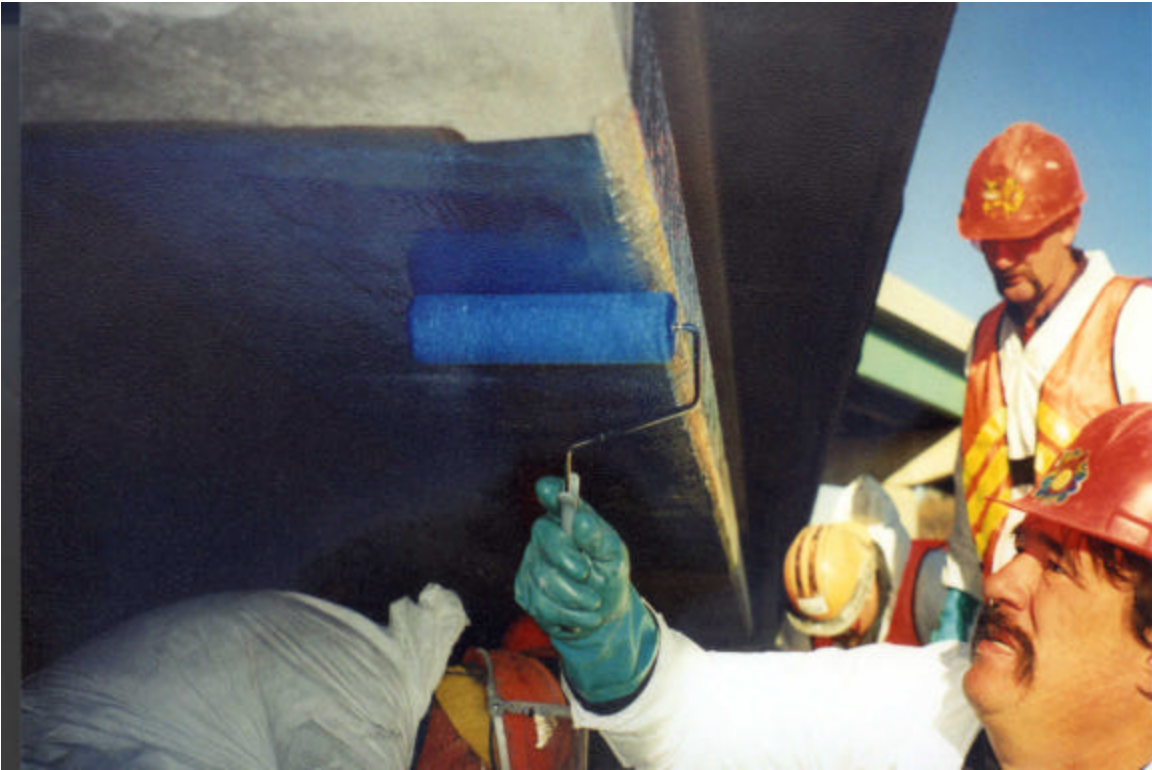
Figure 12.

*Application of the Second Layer of Saturant.* The sheet was then installed and the excessive resin was removed (see **Figure 12** and **Figure 13**).

**Figure 12. Application of second layer of Saturant after placing the CFRP sheet**

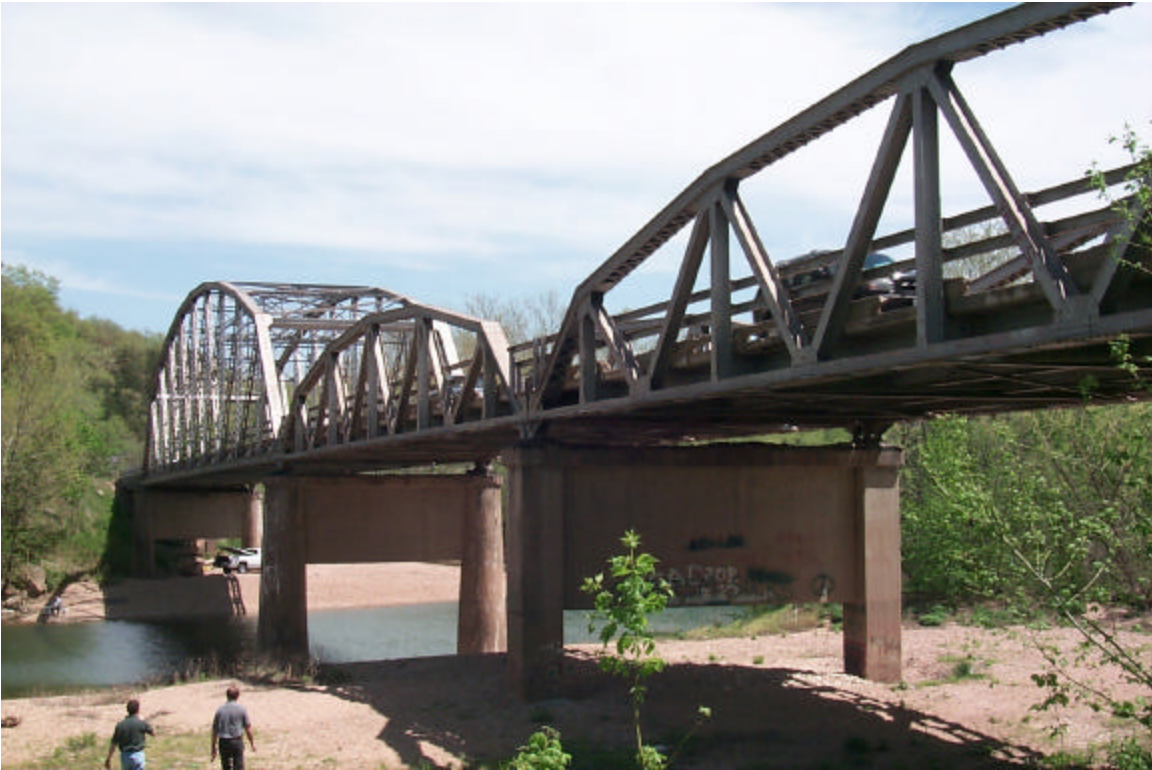
Figure 14.

This bridge consists of one 61.0m main truss span, two 30.5m truss span, and two 10.70m I-girder beam approach spans, as shown in **Figure 14**. The bridge piers that support the 61.0m main span consist of circular-tapered boundary elements connected by shear wall panels (see **Figure 15**). These boundary elements were retrofitted according to the retrofit technique described in this paper. The superstructure is connected at these bridge piers by means of steel rockers mounted at the boundary elements, (see **Figure 15**).

**Figure 14. Bridge Longitudinal Profile**

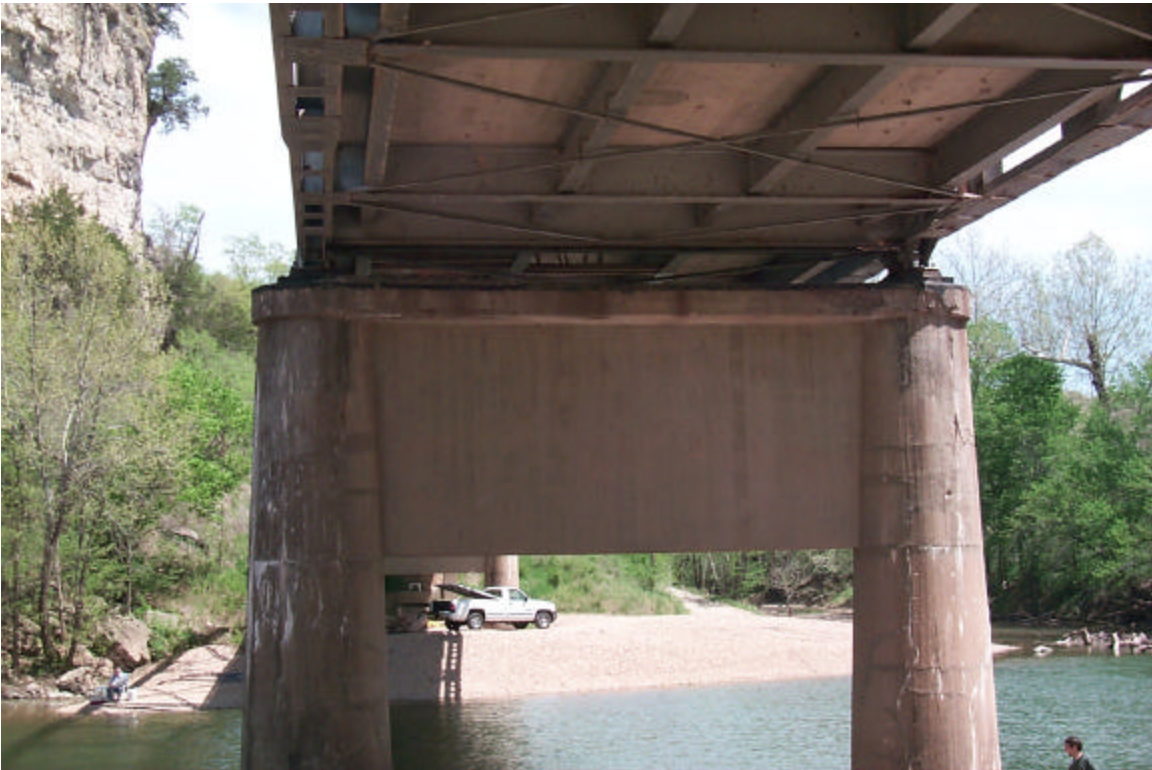
**Figure 15.**

**Figure 15. Main Span Bridge Pier**

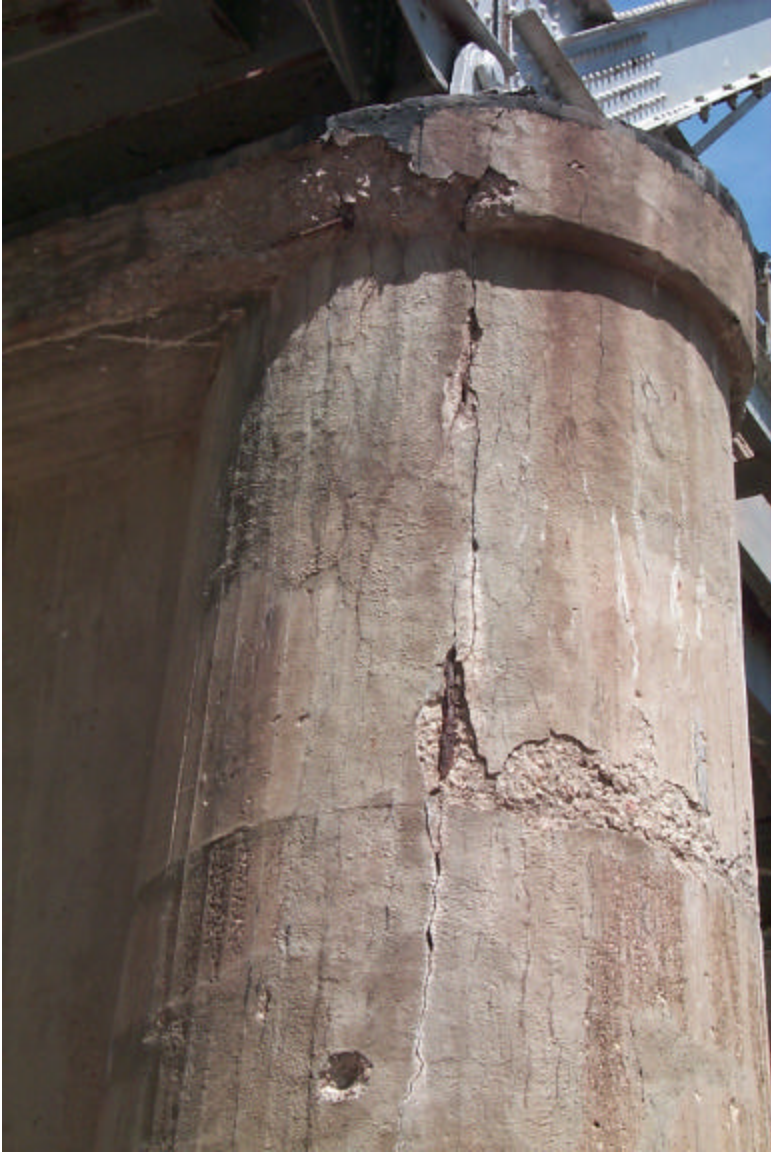
**Figure 16.**

Deterioration of the boundary elements is depicted in **Figure 16**. Weathering has definitely played a strong role in the state of deterioration of the boundary elements, but it is also judged that this process was accelerated by the lack of transverse reinforcement in combination with highly concentrated loads over the boundary elements. Because no transverse reinforcement was provided in the boundary elements there is a lack of resistance to: (i) prevent buckling of the longitudinal reinforcement once the cover concrete begins to spall (6), and (ii) provide shear transfer of the superstructure service loads to the foundation level (6).

**Figure 16. Deterioration of Circular Boundary Elements**

In order to prevent buckling of the longitudinal reinforcement and increase the shear capacity of the boundary elements, which would lead to sudden failure of the bridge piers, it was proposed to retrofit the main span bridge piers by applying external prestressing over GFRP wrapping. Because of the poor quality of concrete in the diaphragm regions, the main advantage of applying first GFRP wrapping directly onto the concrete surface was to cause no further damage to the cover concrete, as the strands are post-tensioned. In addition, by applying the GFRP wrapping will reduce the prestressing curvature friction coefficient; thus, increasing the effectiveness of the strands and reduce the number of required strands.

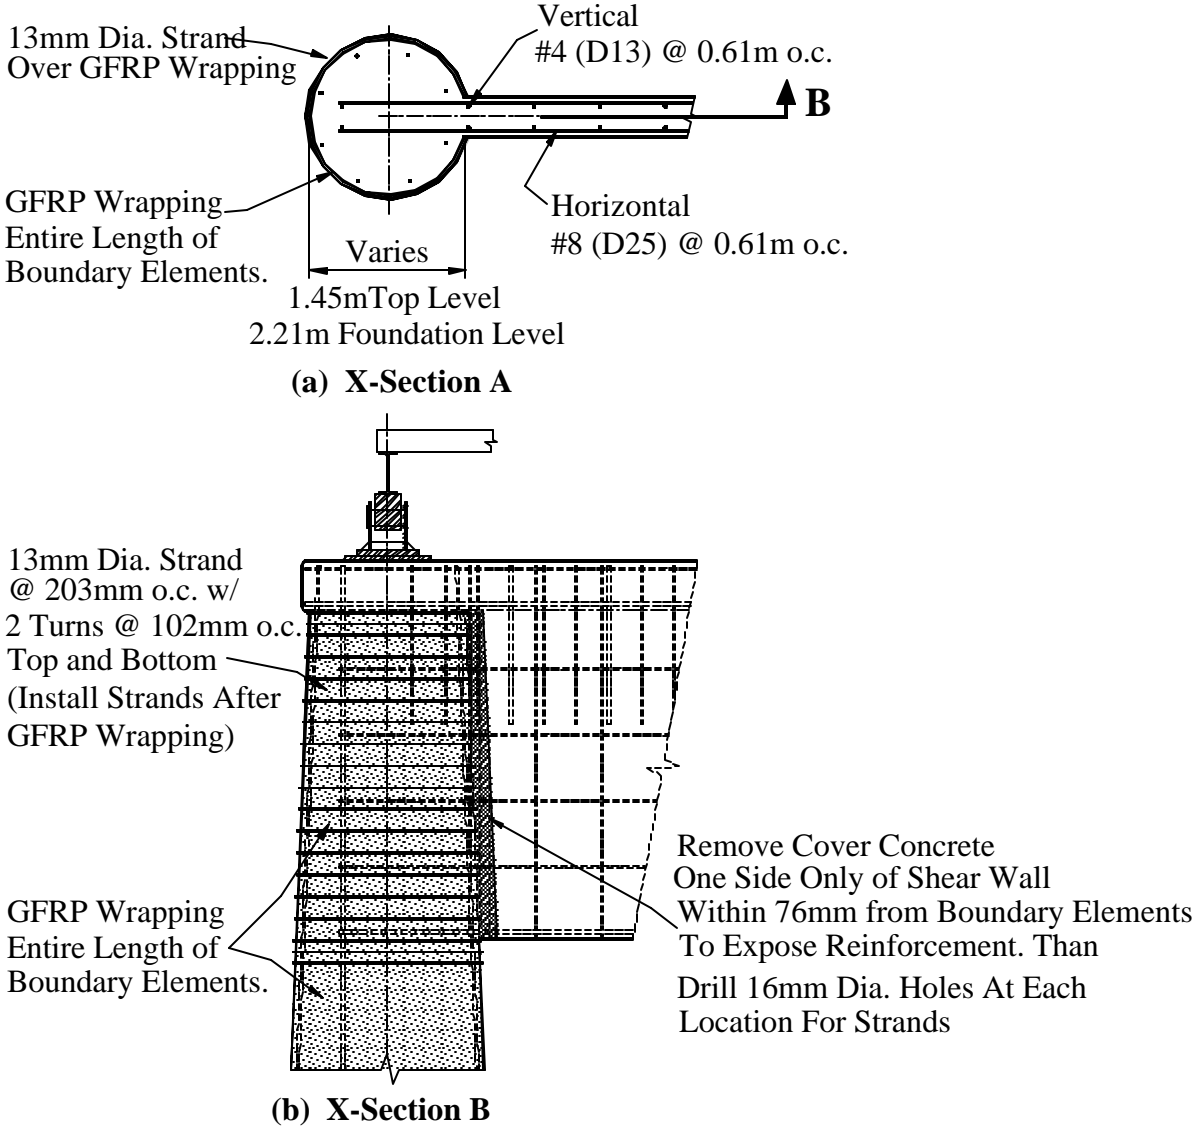
Figure 20.

The first steps in the construction process involved patching of the boundary elements concrete surface to a smooth finish (8, 9), followed by drilling of 16mm diameter holes along the shear wall panels for installation of the fiber wrapping and strands. In order to avoid damage to the shear wall panel reinforcement a 76mm strip of cover concrete along these panels on one face only were removed to expose the reinforcement. Location of the 16mm diameter holes is shown in **Figure 20**.

**Figure 20. Retrofit Criteria**
