III.3 & III.4
Research Results
June 2005

SPLICE LENGTH OF #8 GFRP INTERNAL REINFORCEMENT BARS – YEAR 2

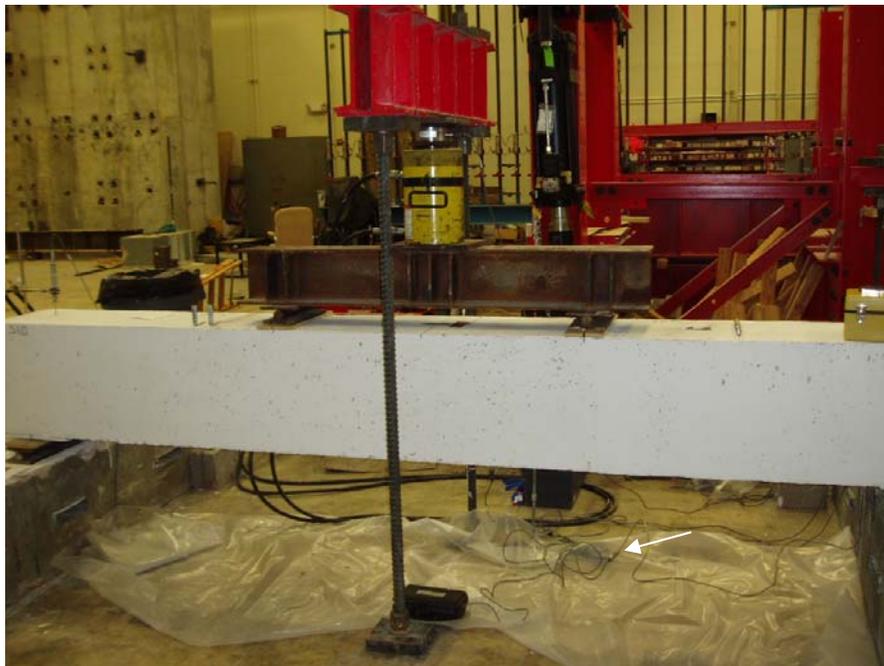
Figure 1 Test Setup

The test setup used for Phase 2 of this research program is shown in Figure 1. Referring to Figure 2 the point loads were placed 44" apart to allow for a constant moment region over the entire splice joints. The load was applied by a hydraulic jack that transferred the load to a steel beam placed on two supports over the tested concrete beams. The applied load was transferred equally to the concrete beams through steel plates placed on wooden strips. The wooden strips were necessary to spread the load uniformly and to keep the concentrated loads from prematurely crushing the concrete.

The applied load was recorded through a single load cell (see Figure 1). In addition, three different types of data recording instruments were used in this experiment, Strain Gages, Linear Voltage Displacement Transducers (LVDTs), and an Extensometer. The strain gages recorded strains from the GFRP bars at different locations (see Figure 4). An additional strain gage was installed on the concrete surface at midspan to measure the

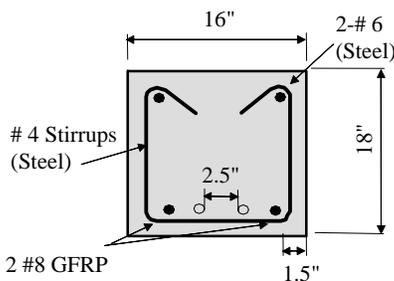
Figure 3 Beam X-Section and Reinf. Layout

Each beam was 12 feet long and spanned 11 feet between supports. The cross section of the beam is shown in Figure 3 and the overall dimensions were 18 inches tall and 16 inches wide.

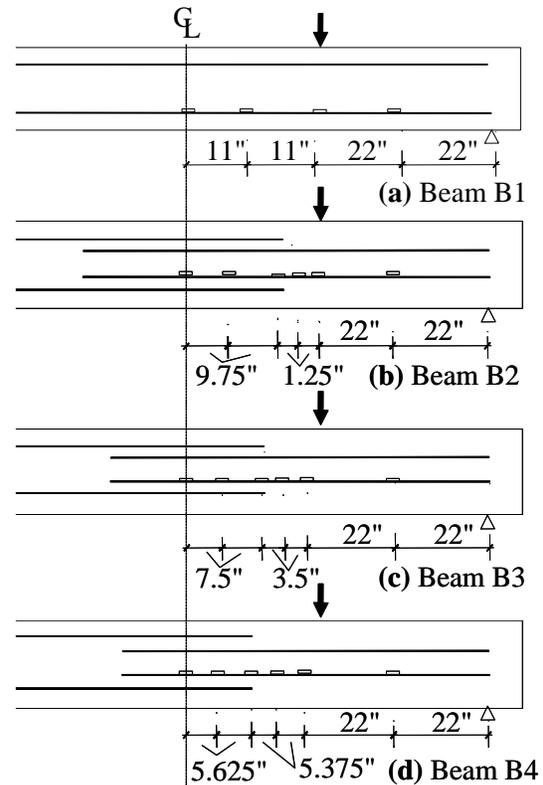
Figure 4 Strain Gages Layout

concrete strains and to compute the experimental curvature in the constant moment region.

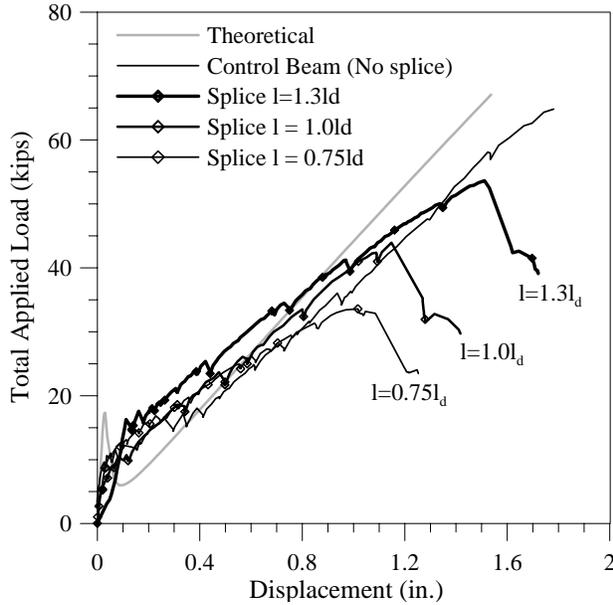
Figure 5 Load – Deformation Response

Figure 5 shows the monotonic load deformation response for the four tested beams along with the theoretical prediction. In examining this figure and comparing results with the control beam it is clear that lap splice failure is evident for beams B2, B3 and B4. This is further corroborated by the crack pattern shown in Figure 6, which shows longitudinal cracks on all three lap splice beams. This crack pattern is indicative of large tensile stresses present in the concrete due to shear stresses transfer between the lap spliced bars.

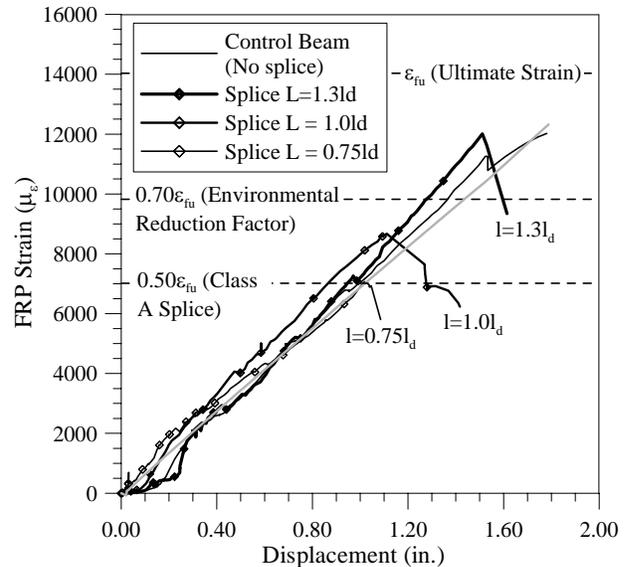
Figure 7 Strain – Deformation Response

Referring to Figure 7 it is clear that at lap splice failure, strains in the GFRP bars, from beams B2 and B3, exceeded those values within the Class A category. This category correspond to strains that are less than or equal to $50\% \epsilon_{cu}$. On the other hand, for Class B categorization none of the three lap spliced beams met the criteria for lap splice since the beams failed at a lower load level than the control beam.
