III.3 & III.4  
Research Results  
June 2005

## SPLICE LENGTH OF #8 GFRP INTERNAL REINFORCEMENT BARS – YEAR 2

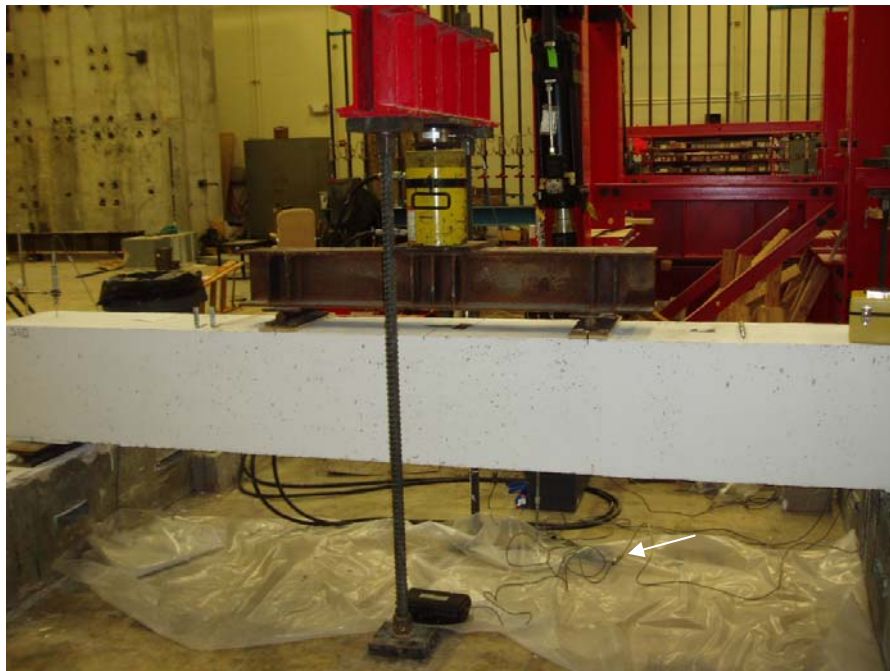
Figure 1 Test Setup

The test setup used for Phase 2 of this research program is shown in Figure 1. Referring to Figure 2 the point loads were placed 44" apart to allow for a constant moment region over the entire splice joints. The load was applied by a hydraulic jack that transferred the load to a steel beam placed on two supports over the tested concrete beams. The applied load was transferred equally to the concrete beams through steel plates placed on wooden strips. The wooden strips were necessary to spread the load uniformly and to keep the concentrated loads from prematurely crushing the concrete.

The applied load was recorded through a single load cell (see Figure 1). In addition, three different types of data recording instruments were used in this experiment, Strain Gages, Linear Voltage Displacement Transducers (LVDTs), and an Extensometer. The strain gages recorded strains from the GFRP bars at different locations (see Figure 4). An additional strain gage was installed on the concrete surface at midspan to measure the

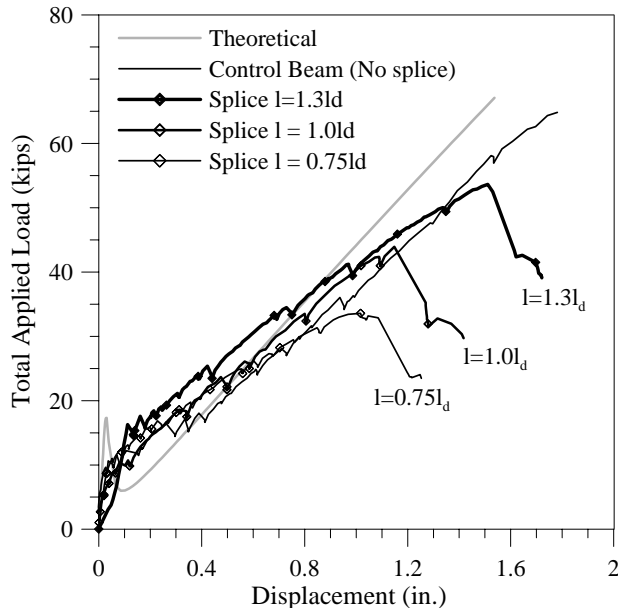
Figure 5 Load – Deformation Response

Figure 5 shows the monotonic load deformation response for the four tested beams along with the theoretical prediction. In examining this figure and comparing results with the control beam it is clear that lap splice failure is evident for beams B2, B3 and B4. This is further corroborated by the crack pattern shown in Figure 6, which shows longitudinal cracks on all three lap splice beams. This crack pattern is indicative of large tensile stresses present in the concrete due to shear stresses transfer between the lap spliced bars.

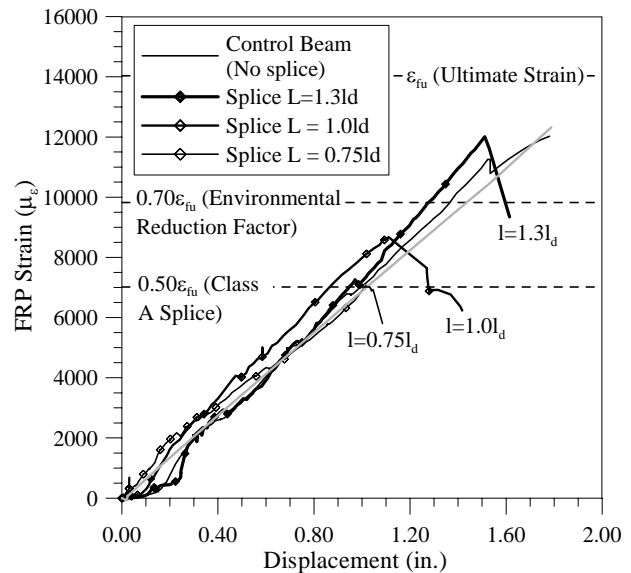
Figure 7 Strain – Deformation Response

Referring to Figure 7 it is clear that at lap splice failure, strains in the GFRP bars, from beams B2 and B3, exceeded those values within the Class A category. This category correspond to strains that are less than or equal to  $50\% \epsilon_{cu}$ . On the other hand, for Class B categorization none of the three lap spliced beams met the criteria for lap splice since the beams failed at a lower load level than the control beam.
