## CIPP of Leaking High-Pressure Gas Main

Sharon M. Bueno — Oct 27, 2011

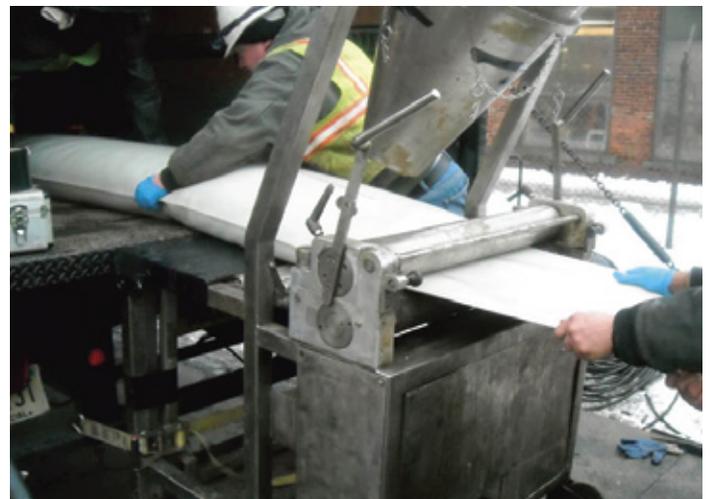
The project would be complicated but with the proper planning and design, Carbone had no doubt it could be done. Planning was critical to the project's success—**particularly figuring out how to reline a critical section of the pipe under two sets of railroad tracks that was divided by a drip pot** (a collection device that holds excess liquids from the old gas manufacturing days created

Since the drip pot couldn’t be removed and replaced with a section of straight pipe that could then be relined, a trenchless method for the removal of the standpipe had to be designed, developed and tested. Additionally, the 24-inch gap across the drip pot could not be lined because it was too long of an unsupported length of liner, so a means of installing the bridge across the gap that could be later lined along with the segment of cast iron pipe was needed.

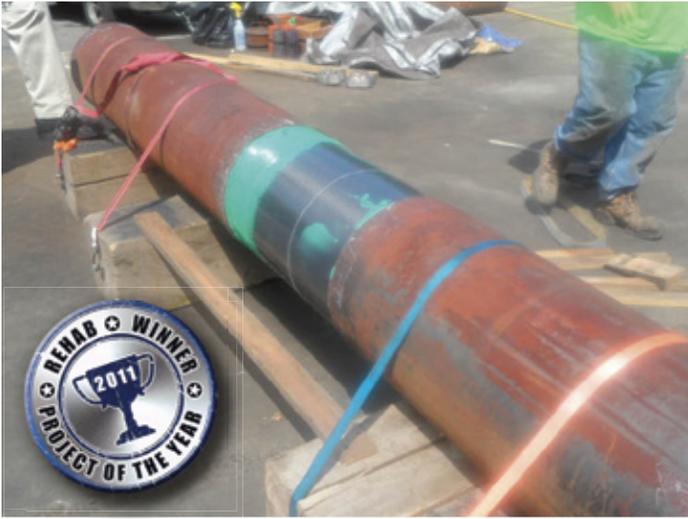
The simulated test of what the **PipeMedic™** carbon laminate sleeve would look like once installed.

The process of cutting the standpipe and installation of the PipeMedic™ laminate was simulated and tested at PPM under the watchful eye of GTI. The GTI test results indicated that the simulated drip pot pipe section met the pressure requirements of industry standards for cured-in-place liners. During the actual project, it took just a few minutes for the robotics system, which had an Aries camera attached, to travel down the main and an hour to cut away the standpipe in several cuts with the cut pipe sections dropping into the bottom of the pot. Using the robotic device, the PipeMedic™ laminate coated with epoxy resins was inserted into the pipe. After the resin cured, the CIPP process for the entire 700-foot pipe was pretty straightforward.

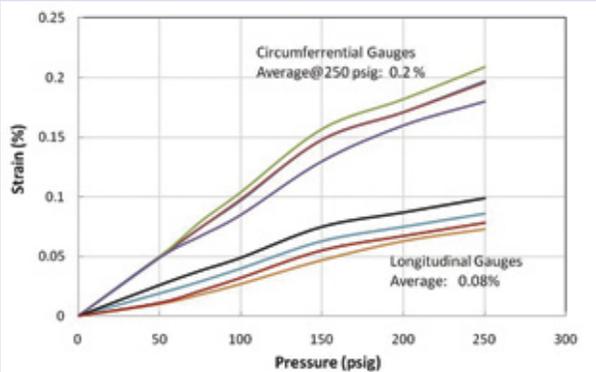
Circumferential and Longitudinal strain in PipeMedic™ laminate for the 16-inch pipe

The measured strains in the laminate were about ¼ the ultimate values, indicating that the PipeMedic™ system could have resisted pressures as much as 900 psi. The loading imposed on the laminate causes a combination of hoop and longitudinal stress. This can be seen from the measured strains. The longitudinal gages that were positioned at four inches from the end of the laminate, recorded an average strain of 0.085% that is 43% of the average strain measured in the hoop direction. This clearly demonstrated the importance of PipeMedic™ laminates constructed with sufficient strength in longitudinal and transverse directions to resist the imposed loads.
