## FRP STRENGTHENING OF CONCRETE SLAB IN HEALTH CARE FACILITY

**Name: Providence Hospital**  
**Type: Health Facility**  
**Location: Anchorage, Alaska**  
**Completed: May 2005**

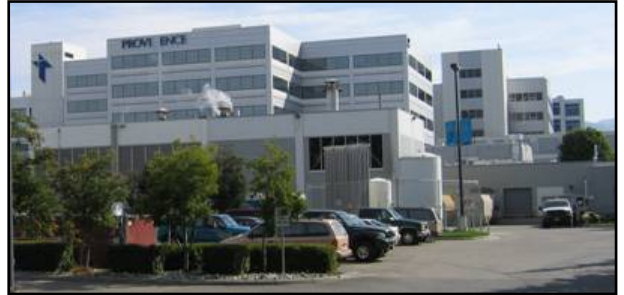
The installation of a high-density filling system generated a live load of 300 psf . The existing floor system did not have the required capacity to withstand this loading and needed to be strengthening. The strengthening had to take place while the hospital was in service.

QuakeWrap® FRP Strengthening System was selected since the strengthening could take place while the hospital remained in operation. In order to restrict the affected area to just the filling room, QuakeWrap® composite carbon plates were installed on the top face of the slab.

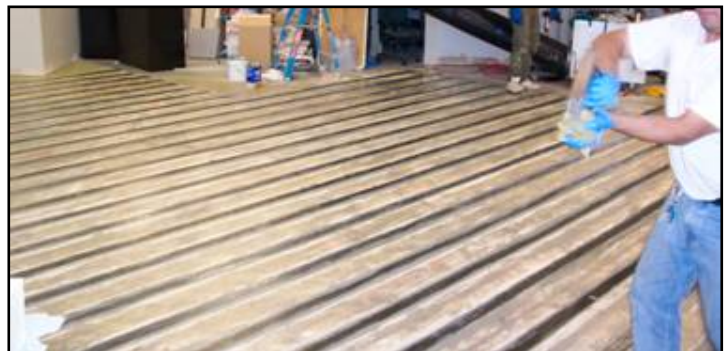
- 1,000 ft<sup>2</sup> of floor was strengthened to resist a live load of 300 psf
- 800 ft of carbon plates (strips) were used
- Strengthening was done from top of slab with minimal disturbance to the hospital operations
