FRP RETROFIT OF CIRCULAR TANK

Name: Buckeye Paper Mill
Type: Tank
Location: Memphis, TN
Completed: June, 2006

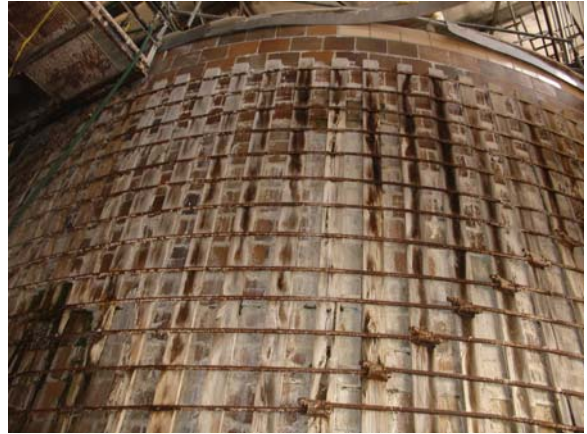
The exterior steel hoop reinforcement of 32 ft diameter and 26.5 ft high ceramic tile tanks exhibited severe damage due to highly corrosive environment in a paper mill tank. A corrosion proof retrofit system was required to substitute the hoop reinforcement.

QuakeWrap™ FRP Repair System was selected since it provided a maintenance free and corrosion proof solution. QuakeWrap designed the FRP layout to meet the original strength of the steel hoop reinforcement.
