## FRP RETROFIT OF CIRCULAR TANK

**Name:** Buckeye Paper Mill  
**Type:** Tank  
**Location:** Memphis, TN  
**Completed:** June, 2006

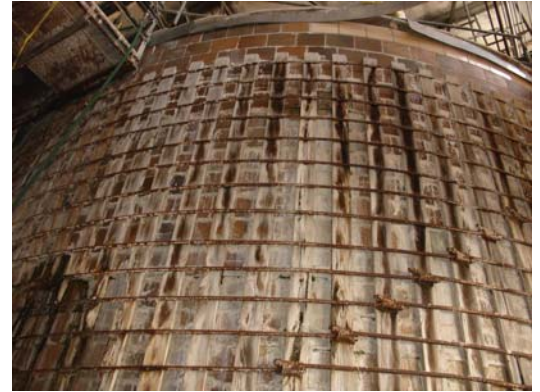
The exterior steel hoop reinforcement of 32 ft diameter and 26.5 ft high ceramic tile tanks exhibited severe damage due to highly corrosive environment in a paper mill tank. A corrosion proof retrofit system was required to substitute the hoop reinforcement.

QuakeWrap® FRP Repair System was selected since it provided a maintenance free and corrosion proof solution. QuakeWrap, Inc. designed the FRP layout to meet the original strength of the steel hoop reinforcement.

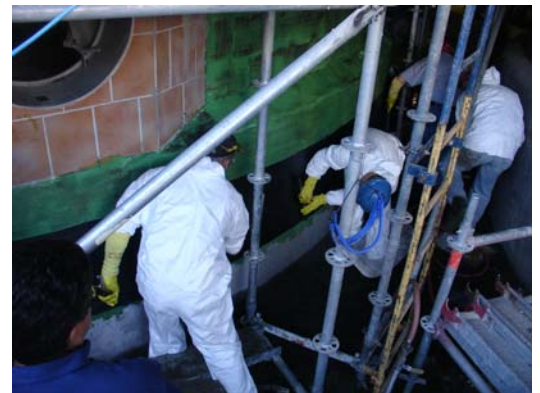
Once the corroded steel hoop reinforcement and the ceramic tile walls cleaned, one layer of carbon fabric with variable overlap was installed.
