## Guest Author – Dr. Mohammad R. Ehsani

Recently, Dr. Ehsani served as a consultant for retrofitting a one-story unreinforced concrete masonry (URM) building shown in Figure (1). The building was retrofitted in the late 1980s by providing new steel columns and by tying the roof joists to the URM walls. However, in the 1994 earthquake, the wall located on the south side of the building was severely damaged. This is a common problem in most buildings which have been retrofitted. In older buildings, connections between the walls and floors are the weakest elements; once these elements are strengthened through seismic retrofitting, future earthquakes impose much larger loads on the walls, leading to the failure of these elements. Hence, there is a great need for simple techniques to strengthen URM walls.

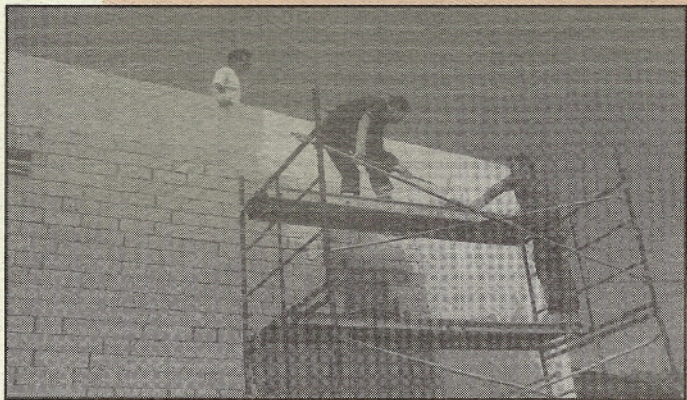
*Figure 2. Application of composite fabrics to the URM wall (Courtesy of Structural Rehabilitation Corporation)*

After the wall surface was sandblasted and cleaned, a thin layer of a two-part epoxy was applied to the wall. The fabric, which was 915 mm wide and constructed primarily of E-glass, was pressed against the wet epoxy, as shown in Figure (2). The fabric included equal amounts of fibres in 0- and 90-degree directions, with a tensile strength of approximately 175 N/mm in each direction. The edges of the fabrics were overlapped so as to provide continuous reinforcement for the wall. A top coating of epoxy and a layer of ultraviolet-protective paint was also applied to the wall surface. The thickness of the wall was increased by only 5 mm as a result of the retrofit. The project was completed on time and at a cost savings of 30% compared to the conventional technique using shotcrete. This is the first reported field application of such a technique. The retrofitted wall at the completion of the project is shown in Figure (3).

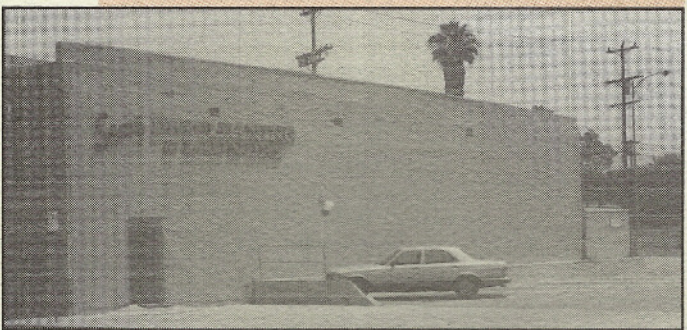
*Figure 3. Strengthened URM wall at the conclusion of the project.*
