CFRP RETROFIT OF MASONRY WALLS

*Jon Vandergrift, Laurene & Rickher, Charlotte, NC
Janos Gergely, UNC Charlotte, Charlotte, NC
David T. Young, UNC Charlotte, Charlotte, NC*

Abstract

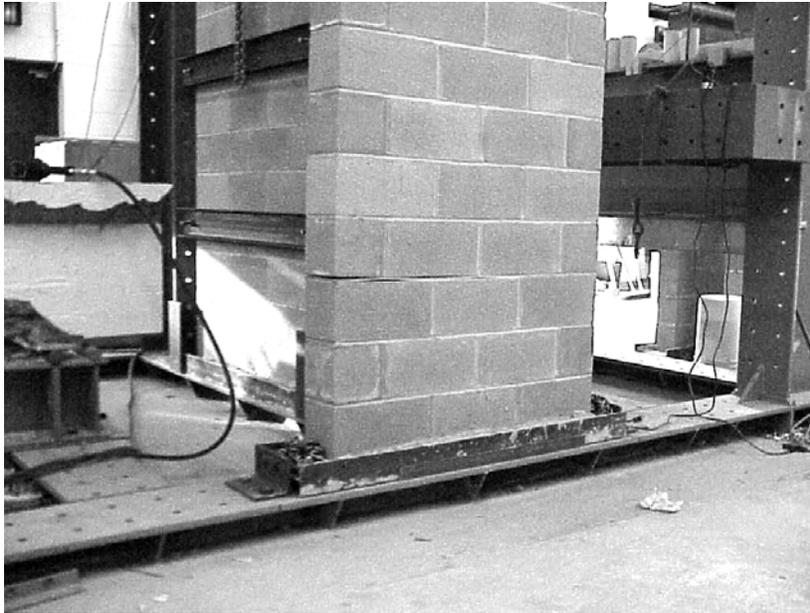
Three shear wall specimens were tested in the as-built condition. The first wall was loaded monotonically, and reached a maximum lateral load of 7.1 kN. Failure was determined as the point when due to extensive mortar joint damage the wall lost its lateral load resisting capacity (as shown in Figure 1). Large cracks developed in the mortar bed joints at the lower section of the shear wall specimen. This failure mode was typical for all the baseline shear specimens.

Figure 1. In-plane Baseline Shear Specimen at Failure

As shown in Figures 1 and 5, the shear specimens were fixed at the bottom of the wall, and can be analyzed as a fixed wall, with no axial load present, and subjected to a cyclic lateral load at the top of the wall. The analytical equations from ACI 440 (2001) and from ICBO AC125 (2001) were modified and used in the present study to correlate experimental data with analytical results. Both of these documents provide equations for beams and/or walls subjected to shear and retrofitted with FRP composites. Equation 1 considers the laminate properties, as well as the wall sectional characteristics to estimate the FRP contribution to the wall shear capacity:

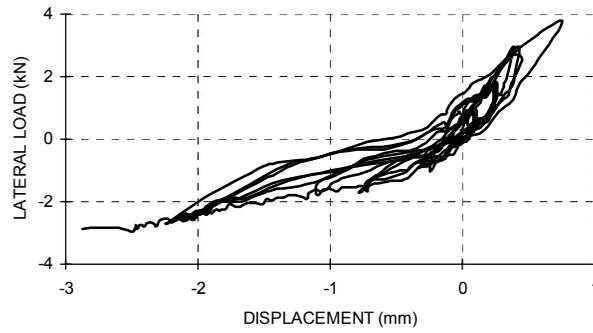
The loading schedule for the other two shear specimens followed a cyclic loading up to the failure point, which occurred at an average lateral load of 3.6 kN (see Figure 2). It is important to note, that this peak load was only half of the force reached in the first test. This suggests that a monotonic load results in less damage in an unreinforced concrete masonry wall than a cyclic load with stress reversal.

Figure 2. Shear Baseline Specimen Results

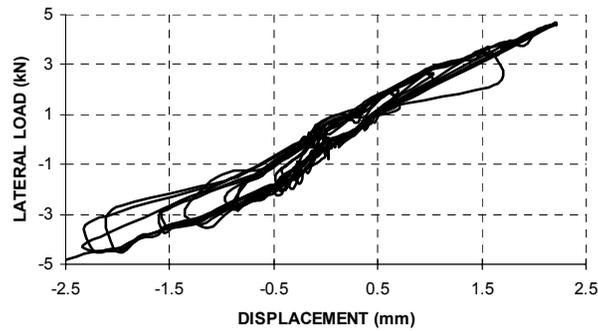
Similarly to the shear specimens, one flexural wall was loaded monotonically, and two were tested with a cyclic load. The behavior of Specimen 1 was close to linear, but once the first crack initiated around the wall's mid-height, the specimen failed at a peak lateral load of 6.4 kN, and at a maximum horizontal deflection of approximately 2.54 mm. The cyclic force used for the other two specimens was gradually increased from 1.8 kN up to the failure point with a 0.9 kN load increment. Even though the walls reached a horizontal deflection of 2.54 mm, their lateral load capacity was lower. As it can be seen in Figure 3, the peak lateral load was only 4.8 kN, proving again that a specimen when loaded in stress reversal loses its stiffness significantly as compared to a monotonically loaded wall.

Figure 3. Bending Baseline Specimen Results

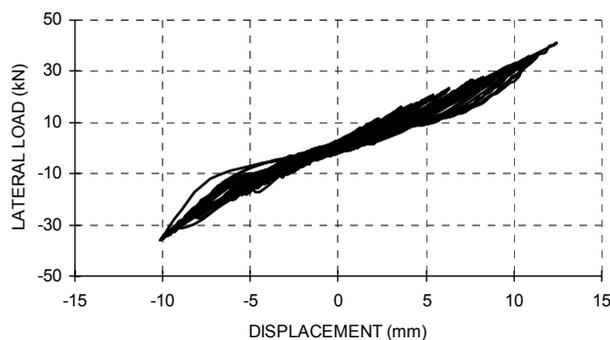
The test setup for the in-plane retrofitted shear specimens was identical to the baseline tests. Strain gages were positioned in the maximum stress zones, and were aligned in the direction of the fibers. The shear wall with the $[\pm 45]$ composite laminate reached a peak lateral load of 41.6 kN and a maximum horizontal deformation of 12.5 mm (see Figure 4). Failure occurred due to extensive damage at the base of the wall. This was clearly the result of excessive masonry shear and anchor stresses developed at the bottom of the wall, which exceeded the wall's capacity, even though the first masonry course was fully grouted with concrete, and shear studs were inserted in the cells (see Figure 5). The peak tensile stress in the composite laminate reached only 0.045%, only a fraction of the composite's ultimate strain of 1.5%.

The $[0_2]$ specimen reached a peak load of 36.7 kN with a corresponding lateral deflection of 18.5 mm. Part of this deflection however, resulted from the wall's uplift and anchor failure. The apparent double stiffness observed during the test was due to the fact that once a large crack developed at the bottom of the wall, additional anchors were added to extend the testing a few more cycles. Since this shear specimen was tested first, the other two retrofitted shear walls received these additional anchors prior to testing. Once again, the strain in the composite was negligible compared to its capacity.

The $[90/0]$ specimen failed at a lateral load of 33.6 kN and a horizontal deformation of 17.3 mm. The maximum composite strain reached 0.07%. Even though this specimen failed at the lowest lateral load level, it still showed a significant improvement compared to the baseline shear specimens (3.6 kN).

Figure 4. Retrofitted Shear Specimen Result

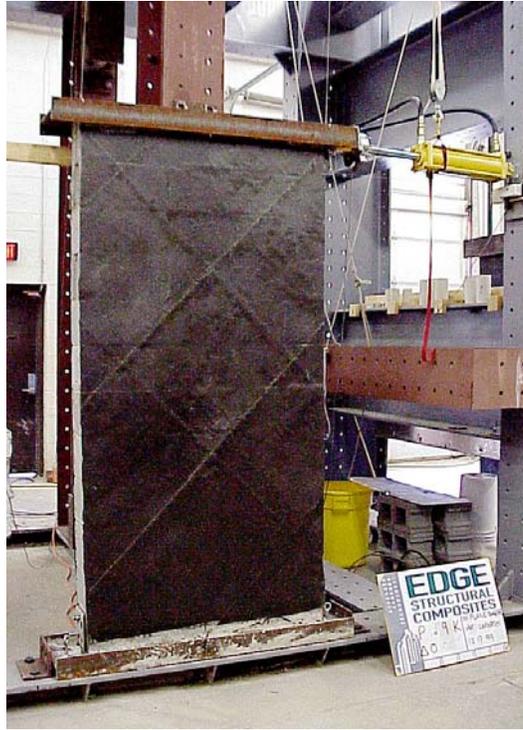
Figure 5. Retrofitted Shear Specimen at Failure

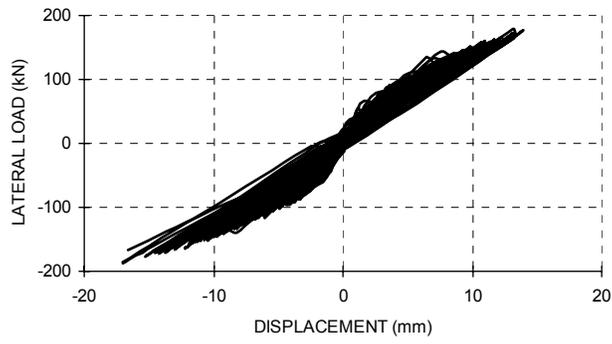
The test setup for the retrofitted bending specimen test was identical to the one described for the baseline specimens. Due to an unexpectedly high load reached during the first retrofitted specimen test, the loading device was damaged and was replaced with a substantially stronger steel member. The load-deformation curve for the wall with a $[0_2]$ composite retrofit is shown in Figure 6. The peak lateral load of 168.5 kN represented an increase of 3400% over the baseline specimen, a result that proves the superior behavior of sandwich composite beams. The maximum strain readings in the composite fiber reached 0.17%, close to one-ninth of its ultimate capacity.

The wall with the $[0/90]$ composite layout reached a 179.6 kN lateral load, and a maximum wall mid-height deformation of 16.8 mm. The peak tensile strain in the fiber was 0.32%. All of these results are very similar to the ones recorded for the $[0_2]$ retrofitted wall, except, the strain level in the composite material. The strain doubled for the latter case to 0.32% for the same lateral load level, which makes sense if one considers that only half of the laminate added strength to the wall. As expected, the $[\pm 45]$ laminates provided the least wall strengthening. The wall failed at a 135.7 kN load and deformations over 24.4 mm.

Figure 6. Retrofitted Bending Specimen Results

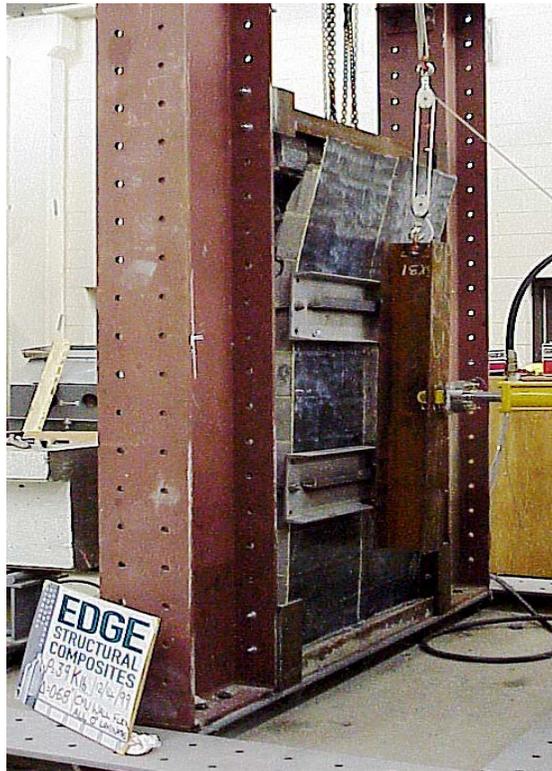
Failure mode for the retrofitted bending specimens was due to extensive shear damage in the masonry wall initiated just outside the loading points. Initial diagonal cracking later propagated during the test, then extended into the composite-masonry interface causing FRP delamination. Ultimately, the masonry units inside the wall crumbled, and suddenly lost its lateral load carrying capacity (see Figure 7). There was so much damage in the wall that the walls during removal from the test setup disintegrated.

Figure 7. Retrofitted Bending Specimen at Failure
