# **EFFECT OF COMPOSITE FIBER WRAPS ON CORROSION OF REINFORCED CONCRETE COLUMNS IN A SIMULATED SPLASH ZONE**

## **Abstract**

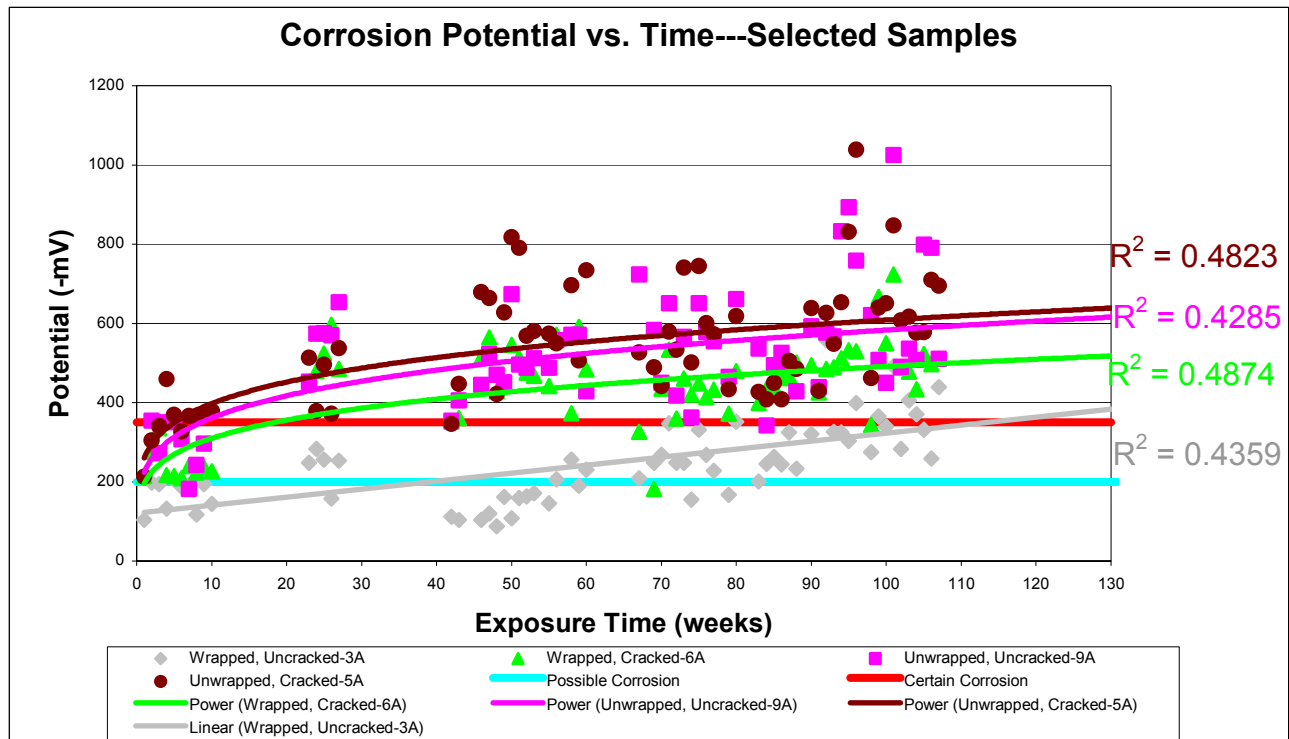
Because corrosion potentials were measured for samples 3A, 5A, 6A, and 9A from the first week of exposure, regression analysis was conducted on this data. As shown in Figure 6, which repeats the same data from Figure 5 for these four samples only, the best regression models were power series for all samples except for the wrapped, uncracked samples, where a linear curve provided the best fit with the data. The R-squared values for these regression models, although not high by traditional standards, are reasonable for the corrosion potentials. The potentials varied by 20 to 100 mV each week, depending on whether the samples had been in a wet or dry tank the prior week. According to the trendlines, an unwrapped column under similar exposure conditions would be actively corroding by 10 weeks, a wrapped, cracked sample would be actively corroding by 20 weeks, and a wrapped, uncracked sample would not be consistently corroding until after approximately 115 weeks of exposure.

**Figure 6.** Data and trendlines for selected samples

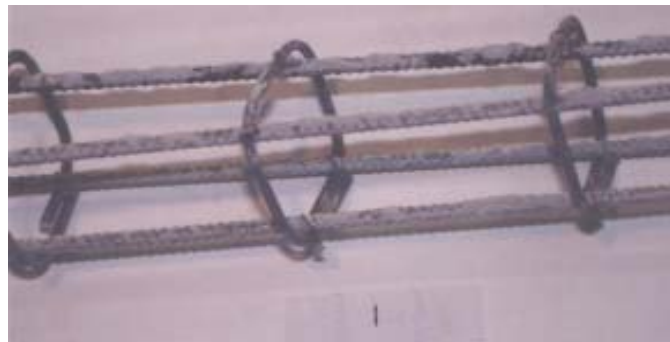
**Figure 7.** Rebar cage after extraction from Column #1 after 2.5 years of exposure

After columns were removed from the immersion tank, rebars were removed and weighed to the nearest 0.01 gram, and the percent mass loss was computed for each bar. Prior to cleaning, a visual assessment was made of each bar and photographs were taken. In the unclean state, surface rust was easy to identify, as were places where the bars remained well adhered to the concrete. Figures 7 and 8 are photos of several of the rebar that underwent 2.5 years of exposure. Column #1 (wrapped, uncracked, 2.5 years exposure) had light to moderate patchy corrosion over all four bars. Column #10 (wrapped after 1 year, uncracked, 2.5 years exposure) showed moderate rusting with some section loss over most of the bars. Column #13 (unwrapped, cracked, 2.5 years exposure) showed severe corrosion, with moderate to severe section loss, including pitting corrosion, and severe rust buildup.

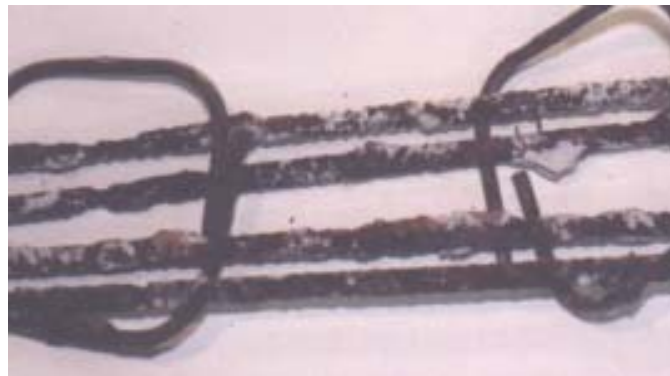
**Figure 8.** Rebar cage after extraction from Column #13 after 2.5 years of exposure
