EXPERIMENTAL TESTS ON SEISMIC RETROFIT OF RC PIERS

ABSTRACT

The main purpose of this paper is to present an experimental campaign of different strategies for the seismic retrofit of reinforced concrete piers, comparing the obtained results with analytical methodologies, and evaluating benefits concerning their structural behaviour under the cyclic loading. The setup of the RC piers experimental tests was specially designed to carry out biaxial bending with axial load, using two orthogonal and horizontal actuators and one vertical actuator (with a slide device to allow the pier top displacements). The numerical simulation of RC piers, representative of the typical bridge construction, as well as the application of a non-linear cyclic analysis methodology to evaluate the structural behaviour and the structural safety improvement of the various retrofit techniques adopted, are presented. The aim is, therefore, to contribute for developing and calibrating a procedure that enables the evaluation of the efficiency of the different retrofit solutions, their possibilities and fields of application.

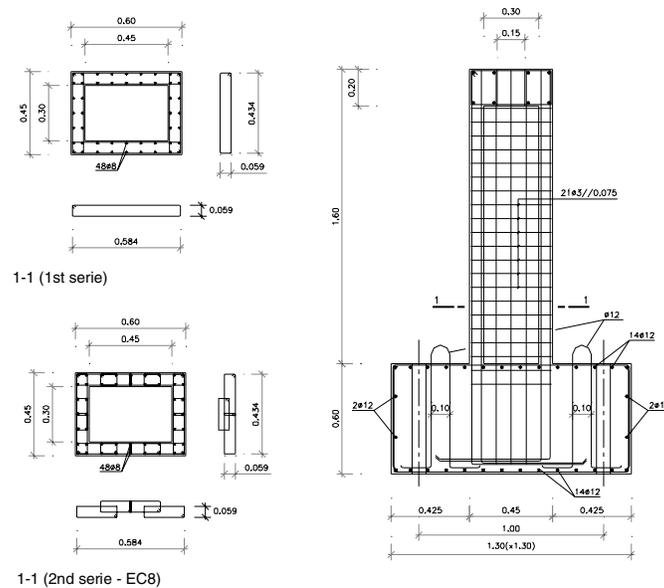
Figure 1: Hollow RC piers

This set of specimens consists of three different hollow rectangular cross sections RC piers: the first, a 450 mm square cross section with 75mm thick walls, is similar to some piers tested at the Laboratory of Pavia University, Italy (Pavese et al. 2004)(the results coming from this specimen tests will be compared with those obtained at Pavia); the second specimen, a rectangular section with 600mm x 900 mm, will be tested in order to understand the third group of twelve specimens of this category with intermediate dimensions (600 mm x 450 mm) which will be divided into two series: the first series will be constructed with the steel reinforcement as shown in Fig. 1 (cross section above), where the transverse reinforcement does not prevent the buckling of the longitudinal bars; and the second series detailed following the EC 8 code (cross section below). The thicknesses of the piers wall remain constant (75 mm). The models are 1/4 scale representations of bridge piers. The hollow piers are named as PO and the first two tested are: PO1 and PO2.

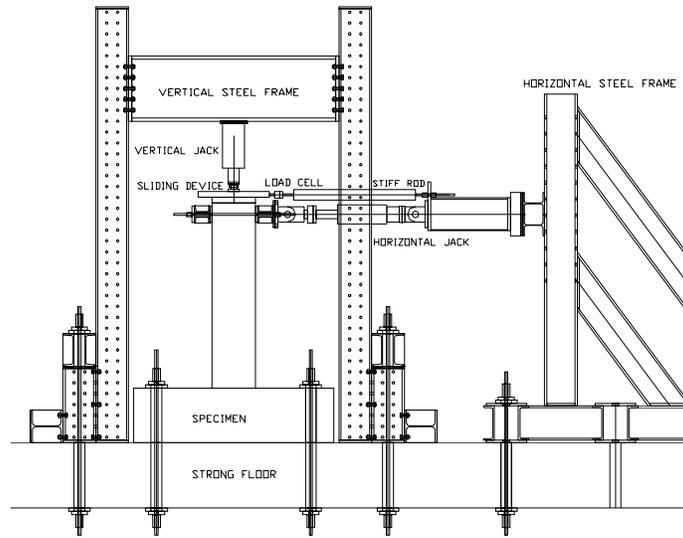
Figure 2: The test setup

The test setup, shown in Figs. 2 and 3, used a 200 kN actuator to apply lateral loads and a 700 kN actuator to apply axial loads. The specimen and frame were bolted to the floor with high strength prestressed rods. A constant axial load of 170kN was applied during the tests while the lateral loads were cycled, under lateral displacement control conditions.

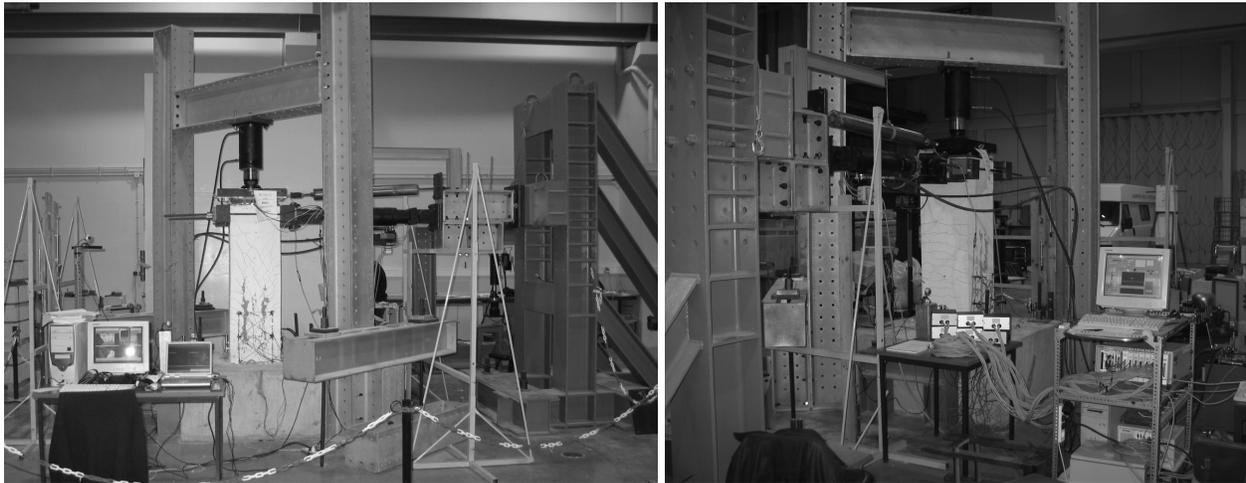
Figure 3: View of the test setup at LESE lab

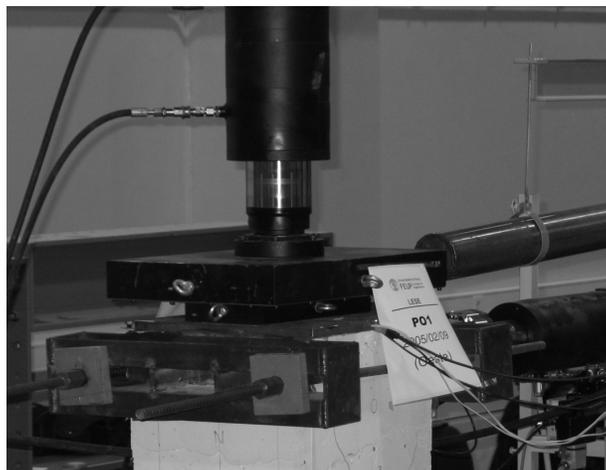
Figure 4: The slide device used to apply axial load

A special device consisting of two steel plates, shown in Fig. 4, was used to minimize the friction created by the axial loads. The lower plate is bonded to the specimen top and the upper is hinged to the vertical actuator, allowing top-end rotations on the specimens during the test, when lateral displacements are imposed, and it is also connected to a high stiff rod with a load cell to measure the residual frictional force, between the two plates.

The setup used within this framework showed a very good performance to carry out bending tests with axial load. The slide device, a steel plate system for the axial force transmission that allows the top displacements of the pier, performed satisfactorily and showed low values of frictional forces, which can be measured and considered on the final results.

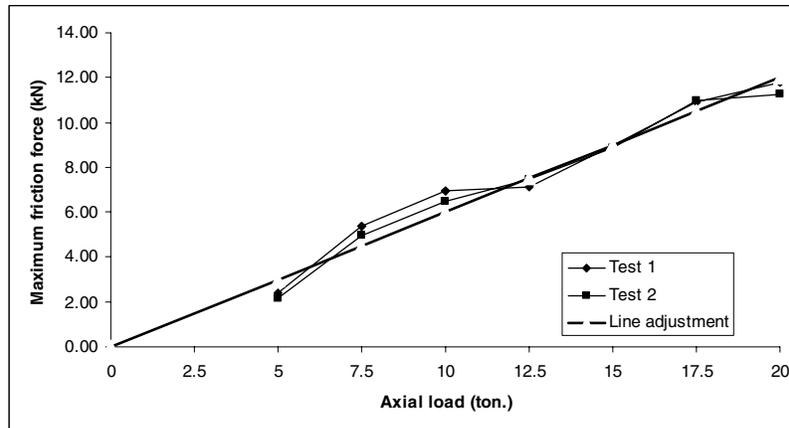
Figure 5: Relationship between the applied axial load and the maximum frictional force

Results of tests performed to determine the relationship between the applied axial load and maximum horizontal friction force are shown in Fig. 5. As it can be seen a frictional coefficient of about 0.06 has been obtained.

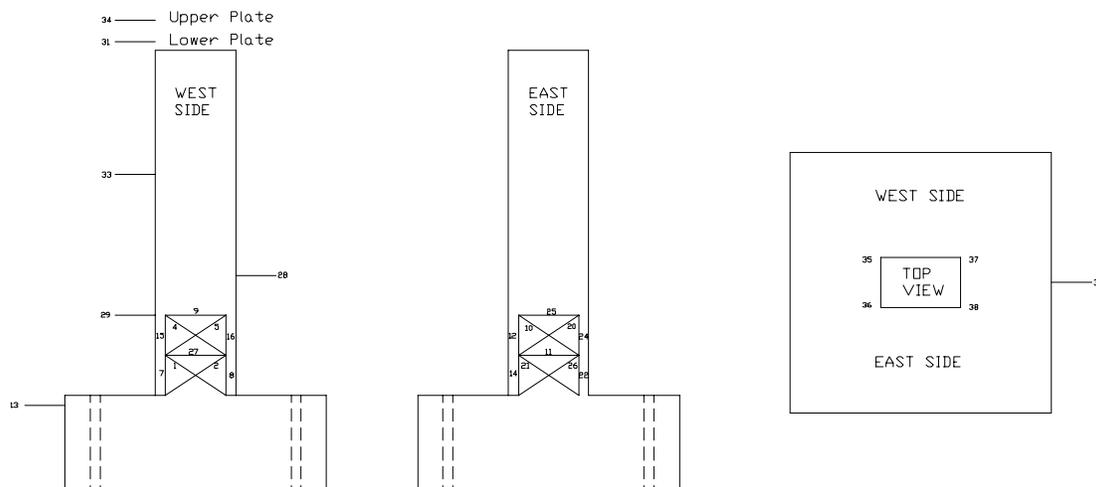
Figure 6: LVDTs location in the test specimen (PO1)

Instrumentation included strain gages attached to the reinforcement and LVDTs to measure curvatures and shear deformations in the plastic hinge regions as shown in Fig. 6. Special software designed for data acquisition and for the hydraulic actuator control has been used, running in LABVIEW computer program

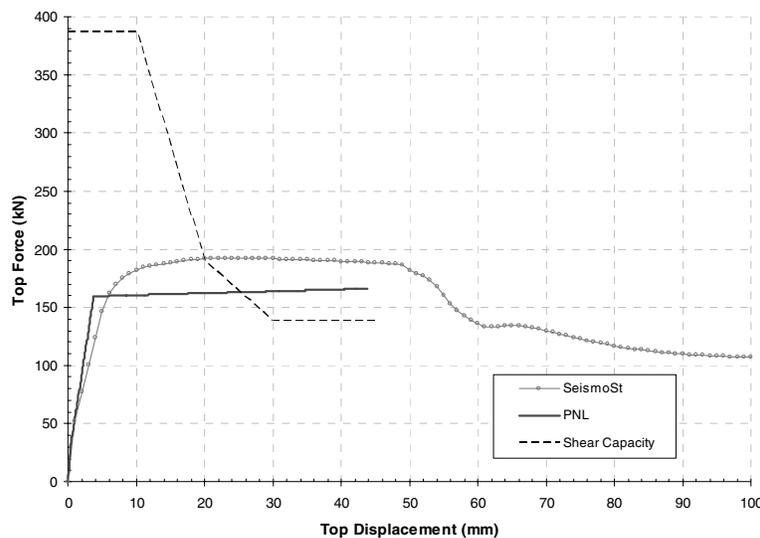
Figure 7: Monotonic numerical curves prediction.

Using the methods above mentioned, monotonic numerical curves prediction for the pier top displacement is showed at Fig. 7. As can be seen the results obtained with Seismostruct shows a lower initial stiffness and higher yielding moment when compared with PNL model. Also computed in Eq. 1 and illustrated in Fig. 7, the shear capacity curve was predicted using the methodology proposed by Priestley et al (1996) for shear strength,

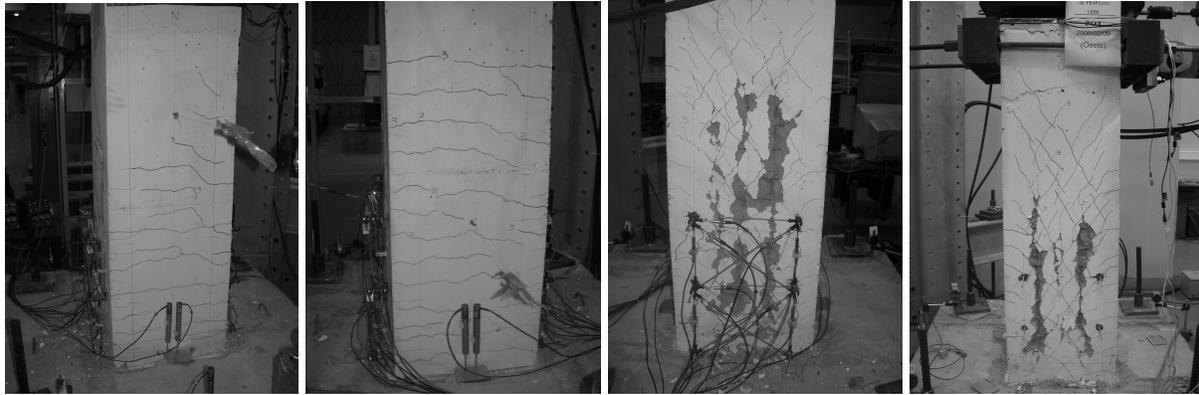
(a) North side (b) South side (c) East side (d) West side
Figure 8: Pier PO1 damage for 2.4% drift.

As shown in Fig. 8, little damage was achieved on the north and south sides, where well distributed cracks were visible. However, the damage was highly concentrated at the lateral sides, east and west, where the cover concrete crushed within the entire pier high. As was expected, severe shear damage was verified during the test with significant concrete degradation due to the lower efficiency of the transverse reinforcement.

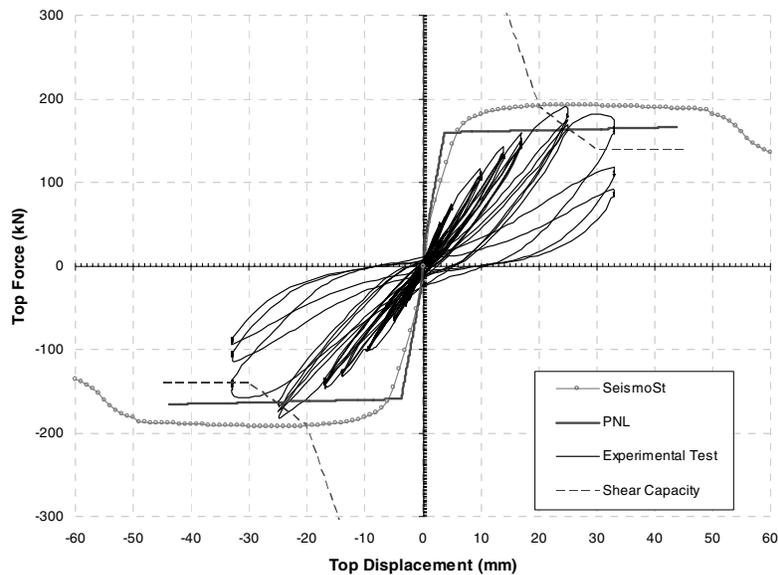
Figure 9: Experimental results and Seismostruct and PNL models monotonic predictions.

The experimental results and the Seismostruct and PNL models monotonic predictions are illustrated in Fig. 9. The envelopment of the experimental cyclic curve is less stiffer than both numerical predictions curves. However, the maximum values of the reached force are reasonable close. From the experimental response reproduced in Fig. 9 and the damage pattern presented in Fig. 8, it is visible that the shear mode failure of the pier was achieved on the 2nd cycle of 33mm amplitude (2.4% drift).

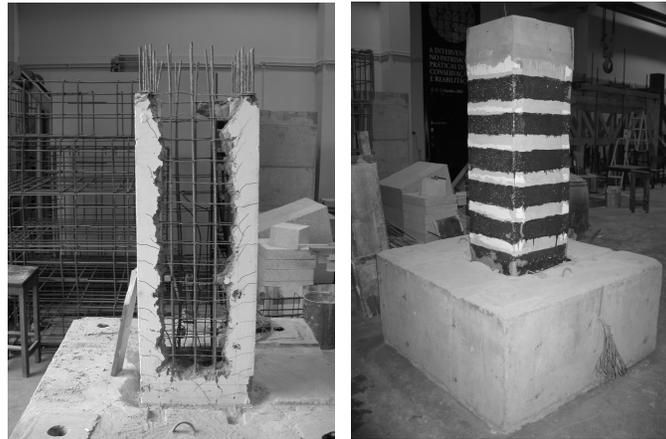
Figure 10: Hollow square section pier (PO1) before and after the shear retrofitting with CFRP sheet.

After the cyclic test of the “as built” specimen took place up to failure, it was repaired and retrofitted by STAP company as can be summarized in the following steps: 1) delimitation of the repairing area; 2) removal and cleaning of the damaged concrete; 3) application of formwork and new concrete (Microbeton, a pre-mixed micro concrete, modified with special additives to reduce shrinkage in the plastic and hydraulic phase); 4) retrofit with the CFRP sheets. To have an idea of the pier damage, the following photographs illustrate the pier during repairing and after being retrofitted with CFRP sheets jackets (Fig. 10).

Resulting from Eq. 2, one layer strip of CFRP sheet of 0.117mm thickness by 100 mm width and 100 mm spaced along the height of the pier was applied, to retrofit the PO1 specimen, as can be seen in Fig. 10.

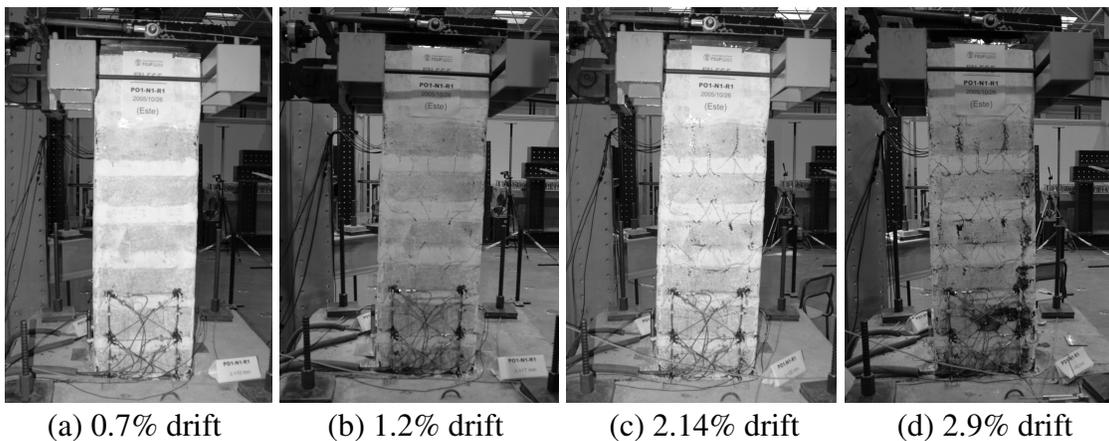
Figure 11: Retrofitted pier PO1 damage from east side view.

The evolution of the damages along the experimental test of the retrofitted specimen is illustrated in Fig. 11, for the east side of the pier. The first cracks, with dimension about 0.1mm, were visible at 0.35% drift, at the pier base. In the subsequent cycles the dimensions of these cracks increased and new cracks were developed along the pier high (Fig. 11a). At the top displacement of 17mm (1.2% drift - Fig. 11b), only the base crack has growth to about 0.5mm. Shear cracks appeared in the next cycles of 1.8% drift and a generalized damage start to become visible. In the right hand side of Fig. 11c (2.14% drift), a vertical crack is visible over almost the entire pier height, which caused global damage to the CFRP sheets. Rupture of some of the fibers was audible. During the cycles of 40mm top displacement (2.9% drift - Fig. 11d) the bottom carbon sheets failed completely, leading to a drastic collapse of the pier on the compression side of the section, with buckling of the longitudinal reinforcement bars, due to a lack of confinement of the concrete (see also Figs. 12 and 13).

As can be seen in Figs. 11 and 12, the retrofitted specimen showed a good behavior in comparison with the “as built”, exhibiting very distributed cracking along the CFRP spacing.

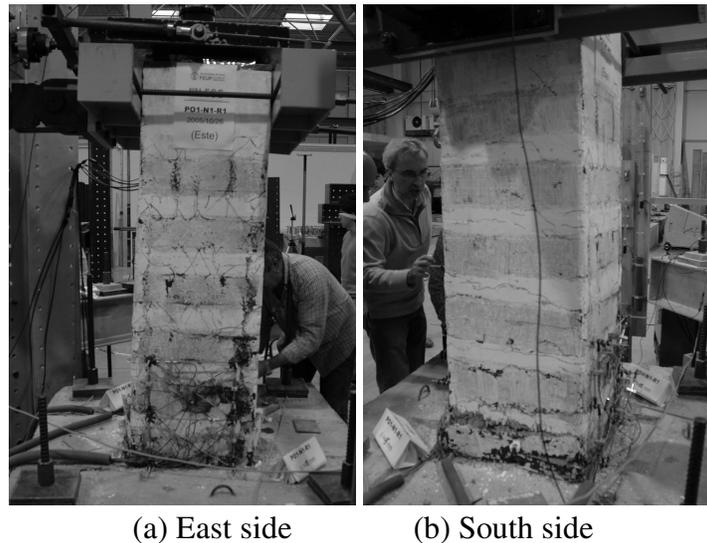
Figure 12: Final damage of the retrofitted pier PO1 for 3.2% drift.

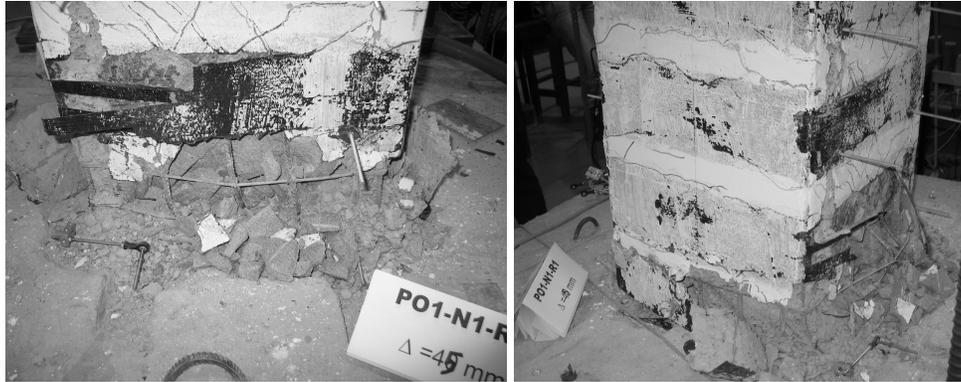
(a) West side

(b) North side

Figure 13: Final damage details.

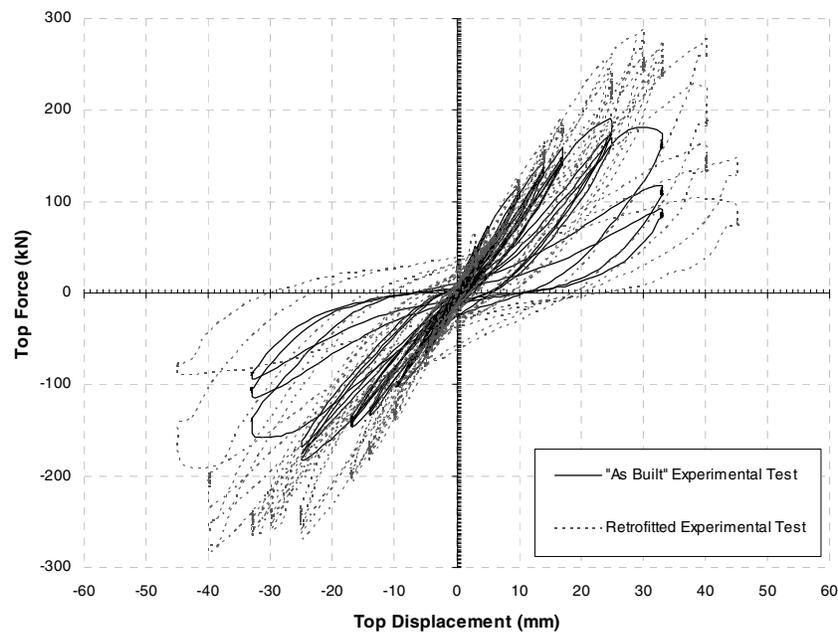
Figure 14: Experimental results of pier PO1 before and after retrofit.

The shear retrofit design, applied on this pier, showed an excellent performance because the shear failure mechanism was partially prevented and a flexural collapse with the buckling of the reinforcement bars was achieved. In Fig. 14 the comparison between the original and retrofitted pier is illustrated.
