# Fatigue strength of fibre-reinforced-polymer-repaired beams subjected to mild corrosion<sup>1</sup>

Khaled A. Soudki, Ahmad A. Rteil, Rania Al-Hammoud, and Timothy H. Topper

**Abstract:** Infrastructure corrosion is an expensive problem worldwide. In the case of reinforced concrete (RC) structures, corrosion reduces the steel cross sectional area and thus decreases the capacity of the corroded RC members. The expansion of the corroded steel also induces tensile stresses in the concrete causing the concrete cover to crack and spall, thus reducing the bond capacity between concrete and steel. This paper reports on a research program conducted at the University of Waterloo that studied the effect of corrosion on flexural and bond fatigue strength. The effect of the addition of fibre-reinforced-polymer (FRP) sheets on the fatigue life of corroded RC beams was also assessed. Eighteen beams (152 mm × 254 mm × 2000 mm) were tested in two groups, with each group consisting of three sets of tests. Group F was designed to study the fatigue flexural behaviour; the repaired beams in this group were strengthened with a flexural FRP sheet along their tension side and confined by intermittent

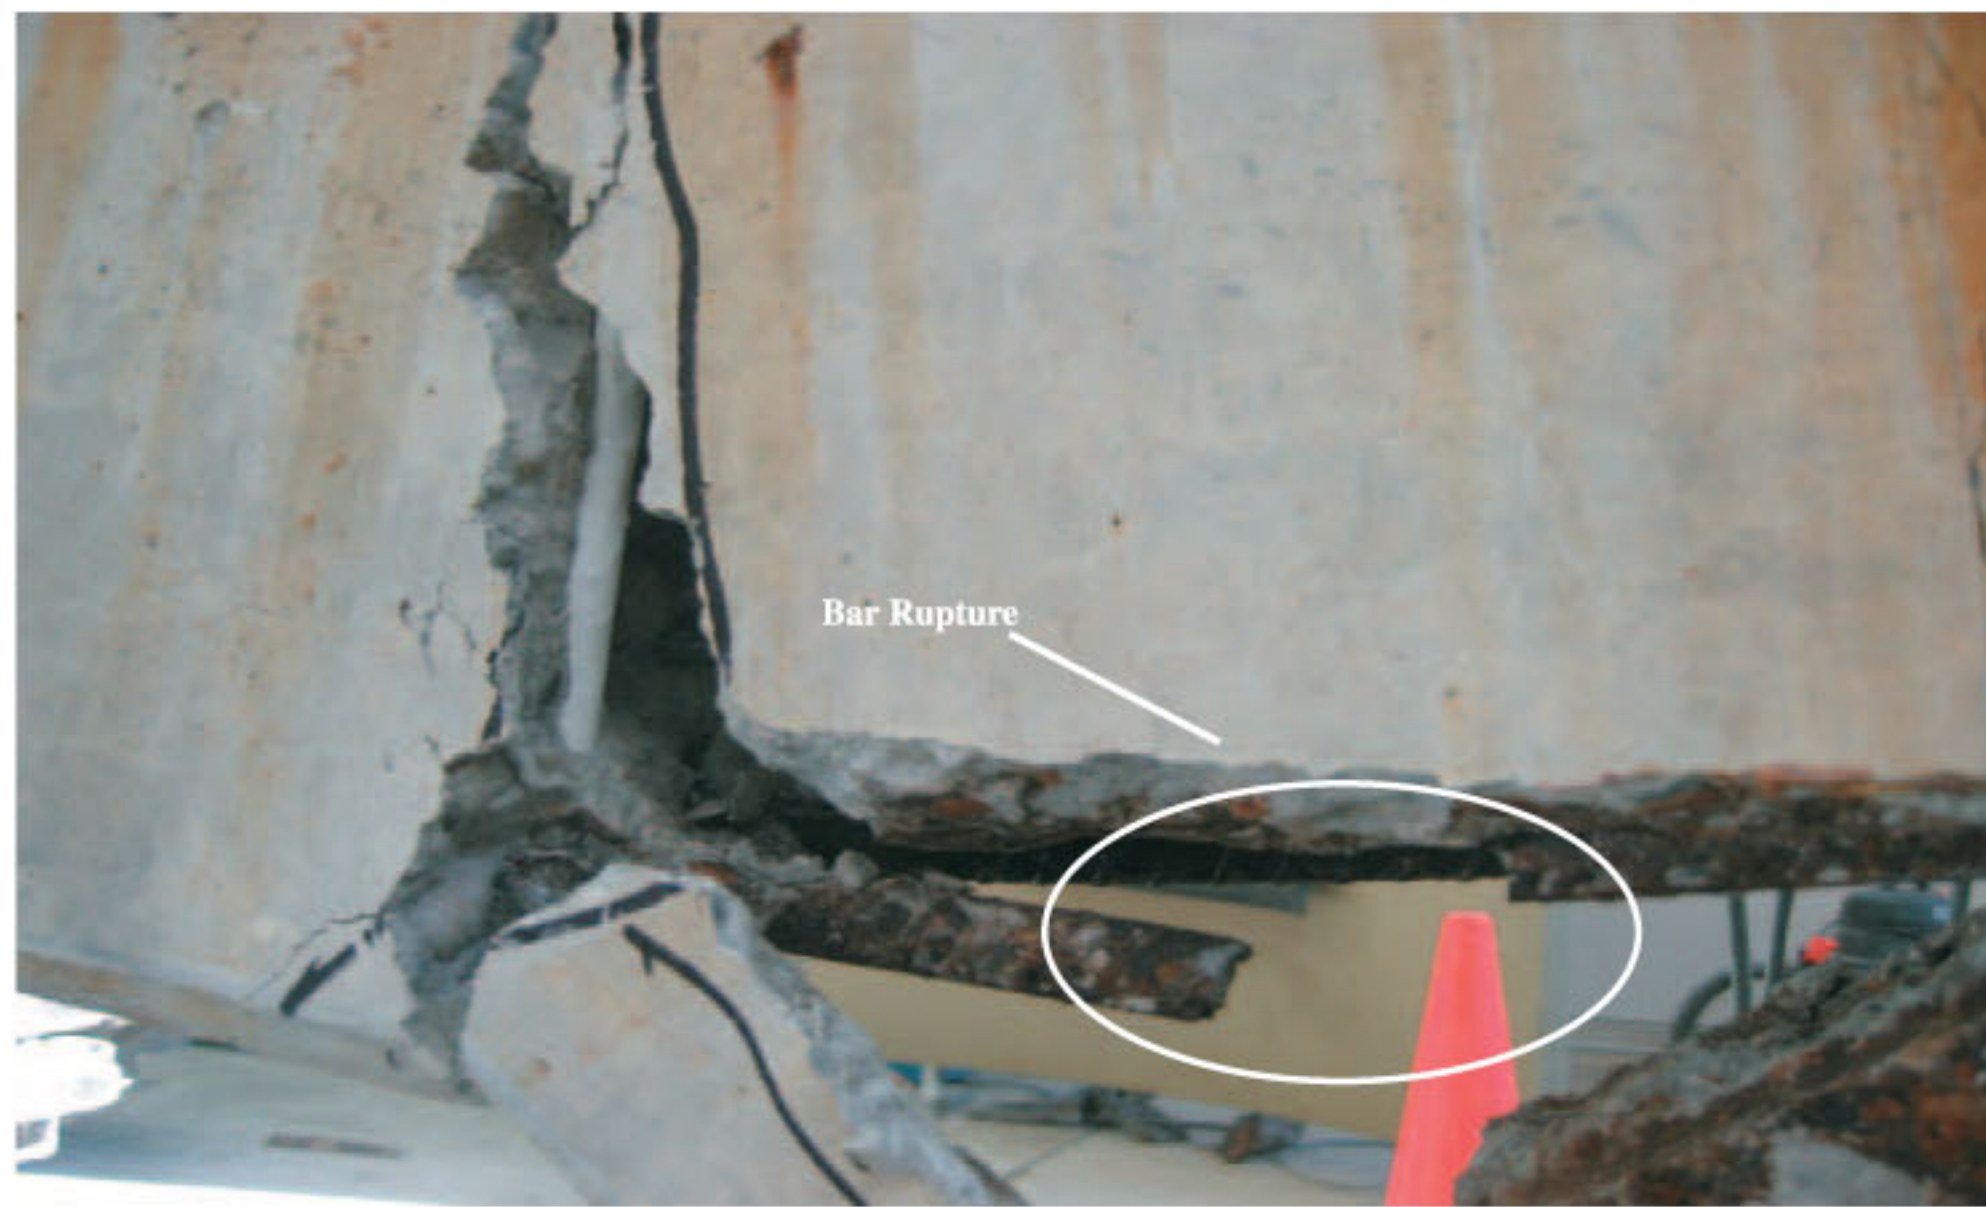
**Fig. 6.** Typical bar rupture of beams in group F (beam F-CD-72).

All specimens tested in this study failed in fatigue. In group F, the failure was in flexural fatigue, which is characterized by rupture of the steel reinforcement (Fig. 6). In group B, the failure was by concrete splitting along the bar in the anchorage zone (Fig. 7). Table 1 summarizes the results for all specimens tested in this study.

All specimens in group F had fatigue cracks that started in the tension steel reinforcement, near one of the ribs in the constant moment region. The cracks then propagated under fatigue loading until the tension bar ruptured. In sets F-C and F-CD (control and corrosion damaged unrepaired beams, respectively), rupture of the first bar caused the beam to fail. However, in set F-CR (corroded and repaired) the rupture of one of the steel bars resulted in redistribution of

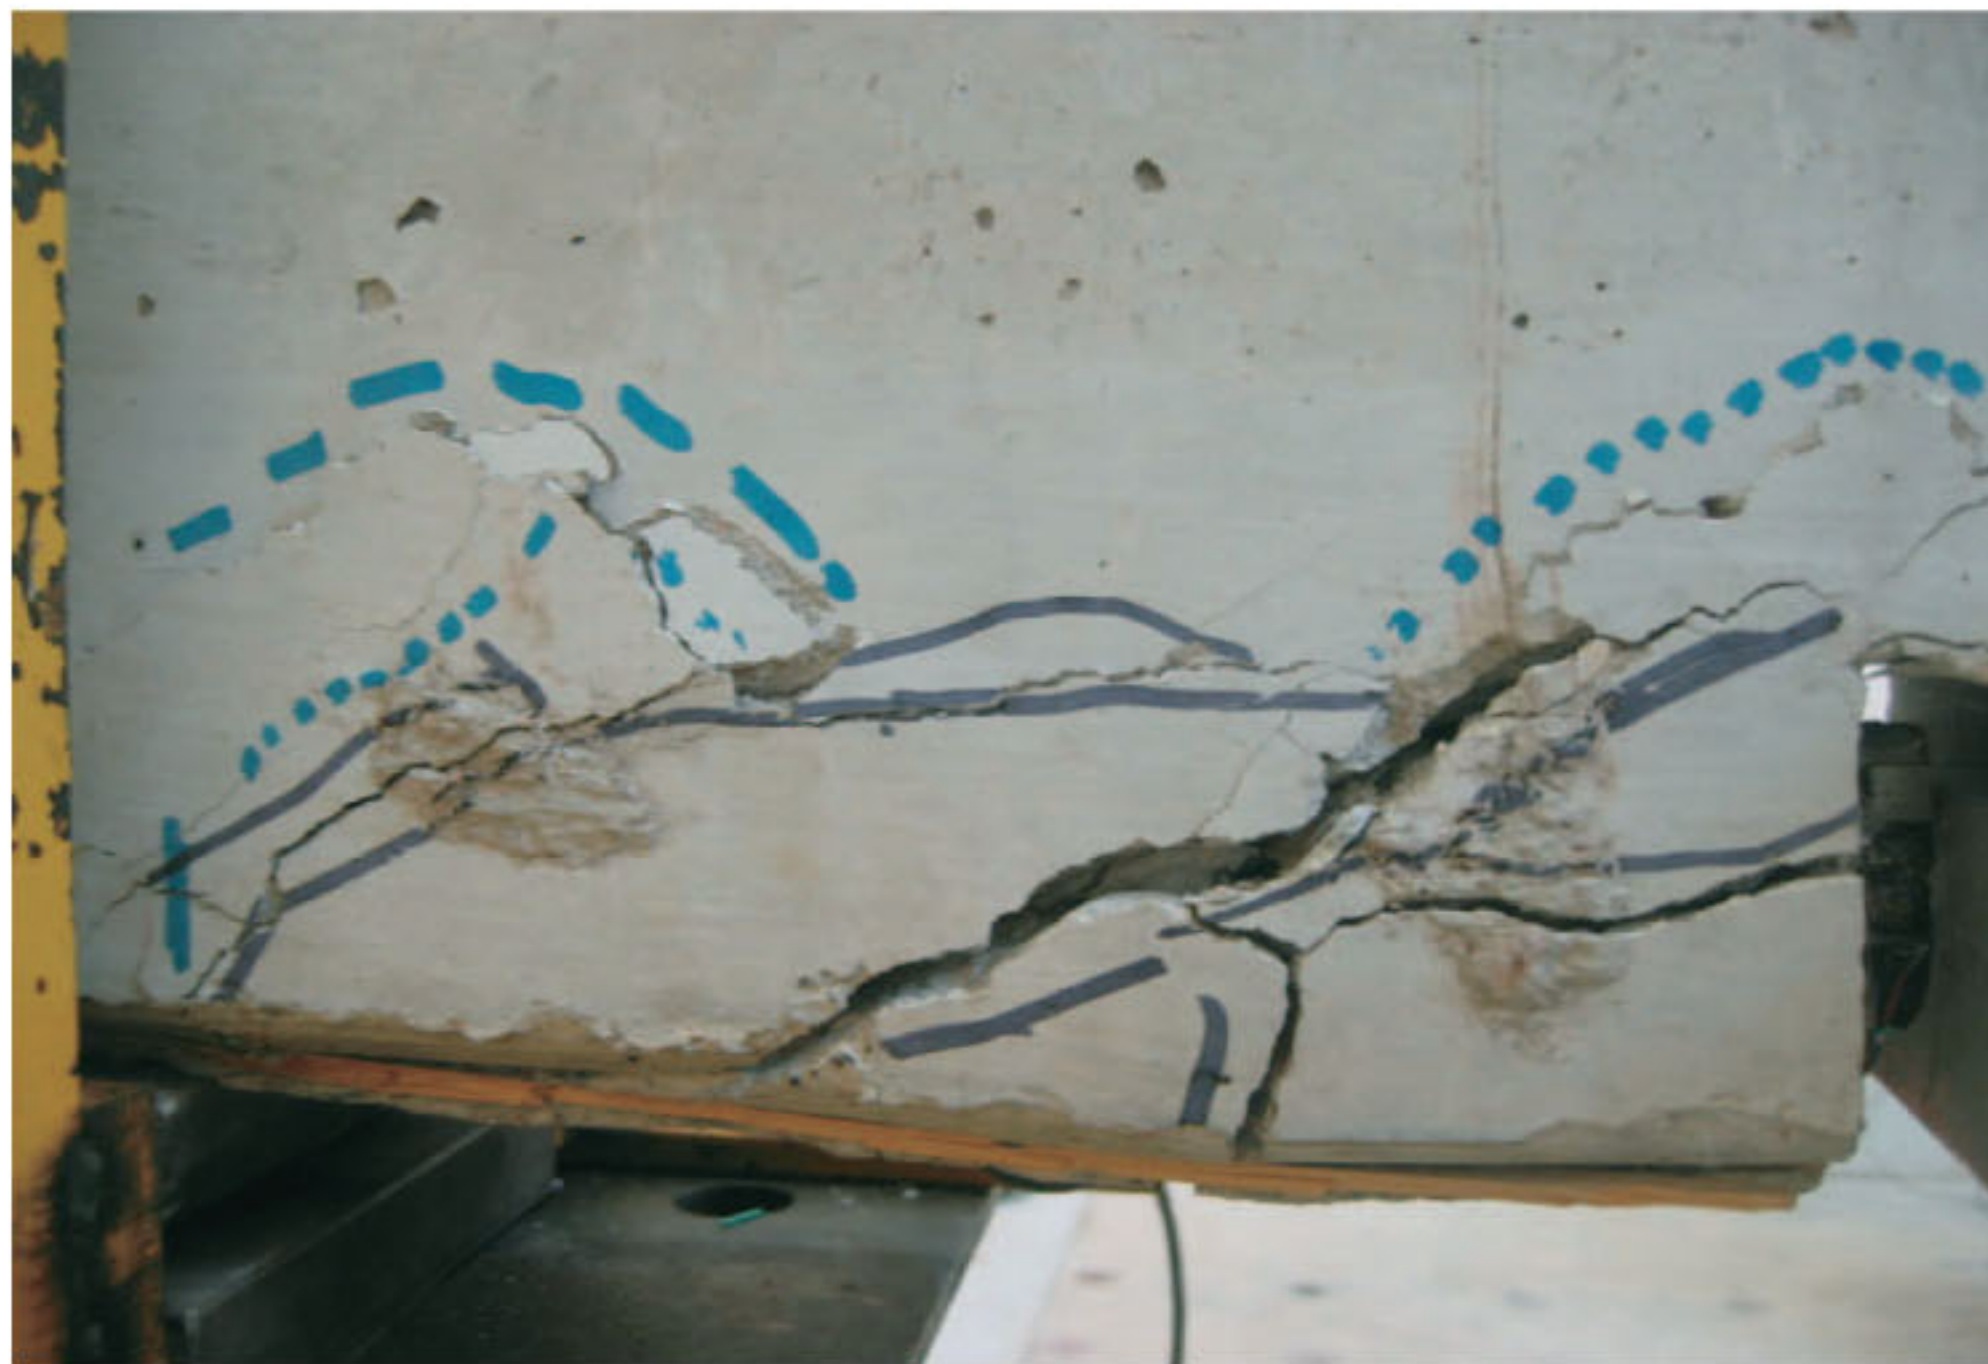
**Fig. 7.** Typical bond failure of beams in group B (beam B-C-55).

All the bond beams tested in group B failed by concrete splitting along the reinforcement bar. For sets B-C and B-CD (control and corroded unwrapped beams, respectively) longi-

tudinal cracks initiated along the anchored zone of the reinforcing bars during the first few hundred cycles, and continued to grow in width and length until failure. In set CR, because of the presence of the CFRP sheets, it was not possible to see the crack patterns and crack propagation during cycling. After the failure of the specimens the CFRP sheets were removed, and an inspection of the cracks under the CFRP sheets showed that cracks were longitudinal. This indicated that failure was also accompanied by bond splitting. However, the width of these cracks was significantly smaller than the ones observed in the unrepaired beams.
