Fatigue Behavior of Reinforced Concrete Beams Strengthened with Different FRP Laminate Configurations

by R. Gussenhoven and S.F. Breña

Synopsis: This paper presents testing results of thirteen small-scale beams strengthened using carbon fiber-reinforced polymer composites tested under repeated loads to investigate their fatigue behavior. The beams were strengthened using different thicknesses and widths of composite laminates to identify parameters that would generate different failure modes. Two predominant fatigue failure modes were identified through these tests: fatigue fracture of the steel reinforcement with subsequent debonding of the composite laminate, or fatigue fracture of the concrete layer below the tension reinforcing steel (concrete peel off). Test results indicate that peak stress applied to the reinforcing steel in combination with composite laminate configuration are the main parameters that affect the controlling failure mode. Tests on large-scale components are required to verify the results presented in this paper.

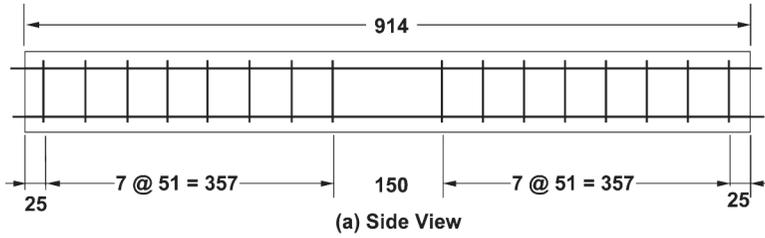
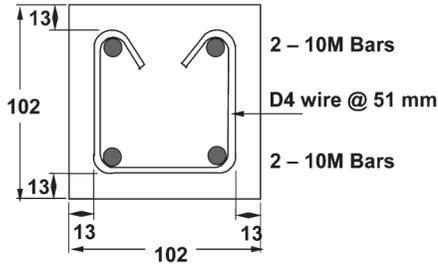
Figure 1 — Specimen geometry and reinforcement

The laboratory specimens had a 102 by 102 mm cross-section with a 914 mm total length. Longitudinal reinforcement consisted of 2 – #10M reinforcing bars with a nominal yield stress of 410 MPa on the tension and compression sides of the beam. Transverse reinforcement consisted of 16 stirrups at a 51 mm spacing placed within the shear spans constructed using gage D4 deformed wire. The transverse reinforcement was designed to avoid shear failures of the beams after flexural strengthening. Concrete clear cover was 13 mm from the exterior face of the beam to the transverse reinforcement on all faces (Figure 1).

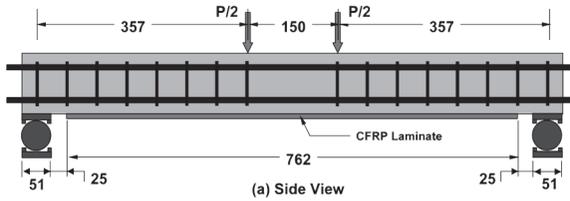
Figure 2 — CFRP strengthening configuration

The CFRP laminates were bonded on the tension face of the beams and terminated 25 mm from the face of each support, resulting in a total laminate length of 762 mm. The laminates were formed by wet layup and cured at ambient temperature for at least seven days before testing. The laminates were either 89 or 51 mm wide, and were formed using one or two plies depending on the specimen group. No supplemental anchorage was used along the composite laminates to allow the possibility of debonding as a failure mode after repeated loading. The typical strengthening configuration is shown in Figure 2.

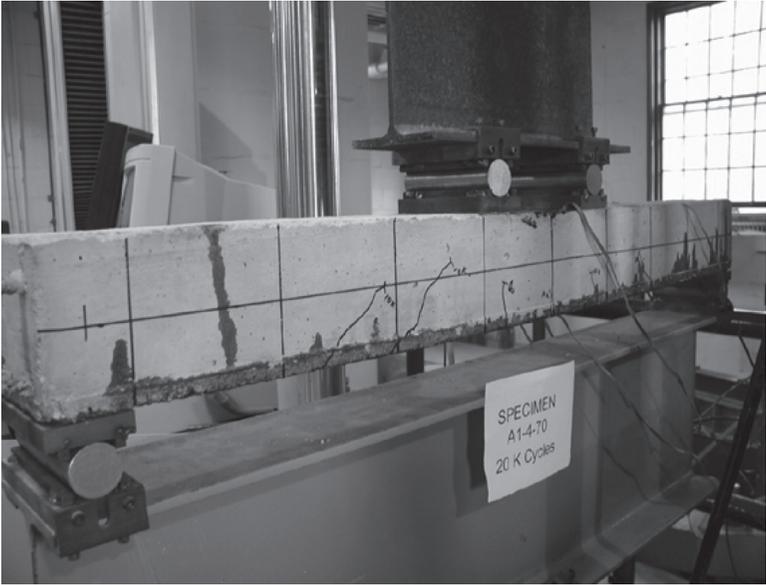
Figure 3 – Experimental setup used in the tests

All members were subjected to 4-point bending using an 8500 Instron testing machine. Load was measured using a 50 kN load cell mounted to the machine piston. The specimens were supported on plates and rollers, which simulated a simply supported condition and rested on a stiff beam mounted on the testing machine load frame. A picture of the experimental setup is shown in Figure 3.

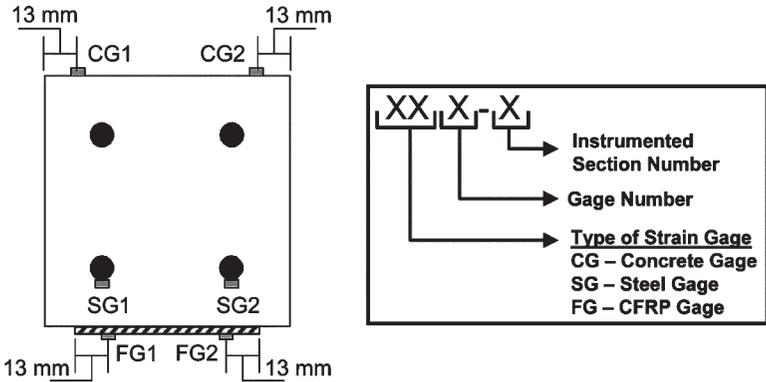
Figure 4 – Specimen Instrumentation

Beam deflections were measured using linear potentiometers positioned at mid-span and at support centerlines to account for flexibility of the supporting beam. A linear variable displacement transducer (LVDT) integral to the hydraulic actuator was used to measure the deflection at the load points. In order to measure the strain profile across the cross section, each beam was instrumented at the mid-span with strain gages to measure the strain on the tension reinforcement, the compression face, and the CFRP laminate for the strengthened beams. Strain gages were applied to both reinforcing bars on the tension side of the beam with a protective coating to prevent damage during concrete placement. Two strain gages were positioned on the compression face at mid-span to measure concrete strains. In beams strengthened with CFRP laminates, two strain

gages were applied at mid-span 13 mm from the exterior edge of the CFRP laminate (Figure 4).

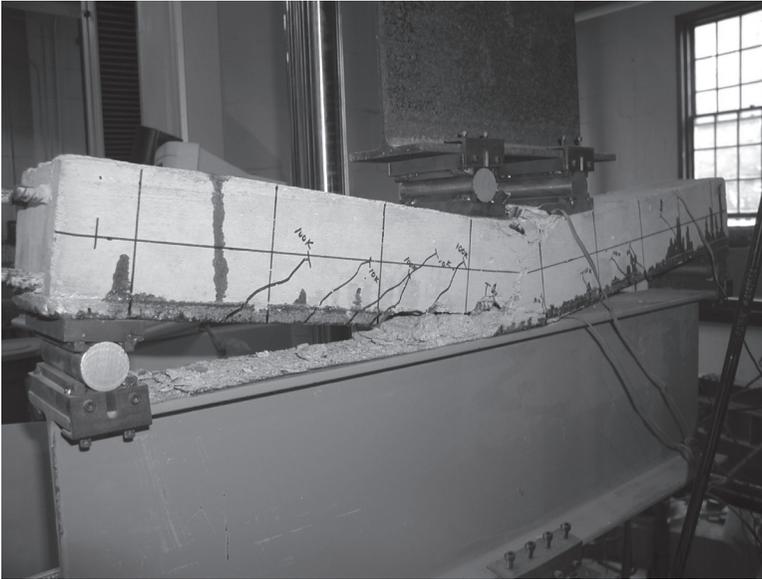
Figure 5 — CFRP debonding after fatigue fracture of reinforcing steel (Specimen A-1-4-70)

Specimens cycled at peak stresses equal to 70 or 80% of the yield stress exhibited one of two failure modes depending on stress amplitude and CFRP laminate configuration. Failure modes in these beams were characterized by fatigue fracture of the reinforcement with subsequent debonding of the CFRP laminate or failure of the concrete cover along the bottom reinforcement. Figure 5 shows a specimen that exhibited steel

fracture and subsequent debonding of the CFRP laminate. In this type of failure mode, after the reinforcing bars fractured the excess force generated in the CFRP laminate triggered loss of bond between the laminate and concrete surface. These beams showed no visible indication of distress prior to fracture of the reinforcement, as the cracks had stabilized and ceased to grow in length.

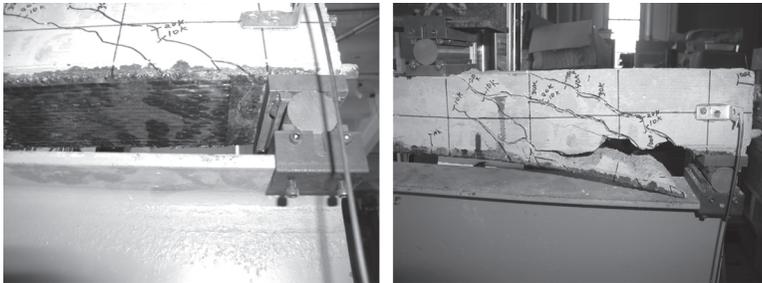
Figure 6 — Damage progression in specimen A-1-4-80; (a) Formation of crack at end of CFRP laminate, and (b) extension of end crack along concrete cover and shear span

Beams that exhibited failure along the concrete cover were characterized by visible indications of damage as loading progressed. Typically a crack formed at the end of the CFRP laminate during early loading cycles (Figure 6a and Figure 7a) and later propagated along a plane just below the tension reinforcing bar level. The end crack propagated sometimes in the form of diagonal cracks within the beam shear span causing severe crack widening to occur within this region (Figure 6b).

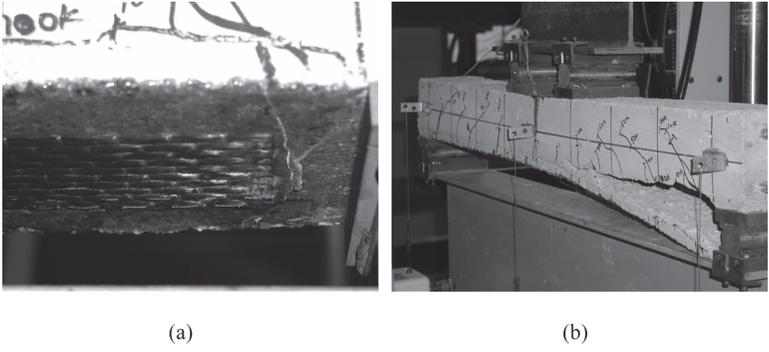
Figure 7 — Damage progression in specimen B-2-2-70; (a) crack initiation at end of CFRP laminate, and (b) concrete cover failure

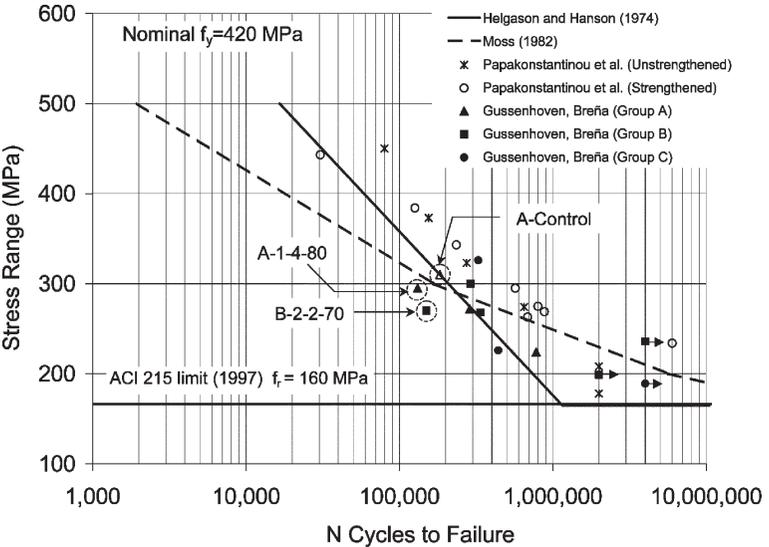
Figure 8 — Comparison between fatigue life models and results of tests

Test data points of the strengthened beams in this study are plotted along with Equations 1 to 3 in the S-N plot shown in Figure 8. It can be observed that the majority of the data points generated in this study fall close to the Helgason-Hanson fatigue life

model. Only two data points fall significantly to the left of Helgason-Hanson model, indicating that these specimens had a lower fatigue life than predicted by this model. Both specimens failed by concrete cover failure, which explains the poor correlation with the model. The apparent slope of data points from the three beam series tested in this research study appears to follow the slope of the model proposed by Moss (1982). This result should not be surprising since the majority of the specimens were controlled by fatigue fracture, which would be consistent with the failure mode captured by this model.

Test results reported by Papakonstantinou et al. (2001) are also shown in Figure 8. These researchers conducted tests of unstrengthened beams and strengthened beams using glass fiber-reinforced composites. The reported failure mode for all their tests consisted of steel fatigue fracture. It should be pointed out, however, that for all the strengthened beams in their study the FRP laminates extended past the supports so FRP debonding was restrained by clamping from support plates near the beam ends. Data points from the tests by Papakonstantinou consistently reached higher fatigue lives than the beams reported in this paper. Data from unstrengthened specimens consistently lie to the right of the Helgason-Hanson model, and there is no clear evidence of an increase in fatigue life from the use of composite laminates. This result is in contrast with observations from other researchers that reported that fatigue life of FRP-strengthened concrete beams was higher than life of companion unstrengthened specimens (Barnes and Mayes 1999).

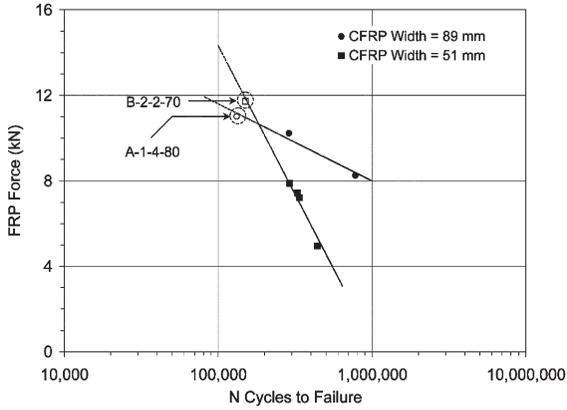
(a) Fatigue life as a function of CFRP laminate force in first cycle

Figure 9 — Effect of laminate width on fatigue life

Laminate width, on the other hand, seemed to have a definite influence on fatigue life of the specimens. Figure 9 shows plots of laminate force as a function of number of cycles to failure. The test data was separated into two groups depending on the laminate width used: 89 mm or 51 mm. As Figure 9 (a) indicates, the two specimens where the highest laminate force was developed during the first loading cycle eventually failed by concrete clear cover peel off. Furthermore, the data follow two distinct trends depending on laminate width, as shown by best-fit lines drawn through the data points. The ratio of laminate force to laminate width was used to generate the data shown in Figure 9 (b). It can be seen that, to achieve comparable increases in fatigue life, a higher decrease in laminate force per unit width was required in specimens with 51-mm laminates compared with those with 89-mm laminates. Fatigue life in specimens strengthened using 51-mm wide laminates increased approximately 3 times (from 150,000 to 440,000 cycles) for a laminate unit force decrease of approximately 0.13 kN/mm, while specimens strengthened with 89-mm laminates had approximately a six-fold increase in fatigue life (from 130,000 to 779,000) for a laminate unit force decrease of only 0.03 kN/mm. This behavior could be attributed to wider laminates being able to

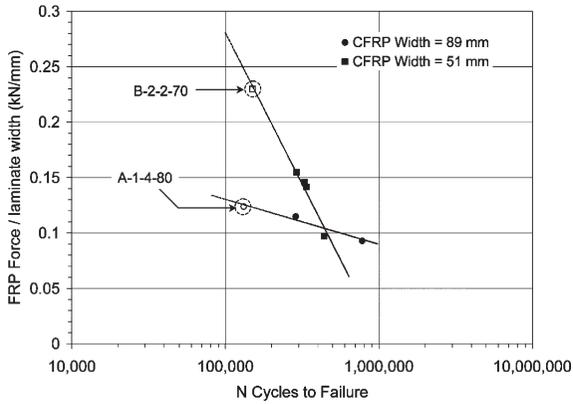
(b) Fatigue life as a function of CFRP laminate force/width in first cycle

restrain crack opening more efficiently than narrower laminates, therefore delaying fatigue failure of reinforcing steel.

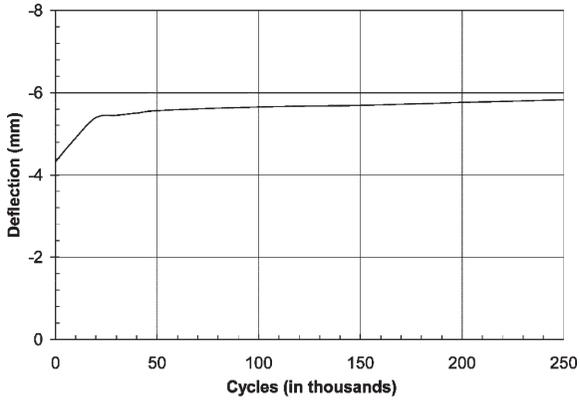
(a) Specimen B-1-2-70

Figure 10 — Variation of mid-span deflection with number of applied cycles

Increase in deflection was used as another measure of damage accumulation with cycling. Mid-span deflection increased markedly during the first 10 to 20 thousand cycles as new cracks formed and existing cracks extended. Crack formation and growth resulted in a reduction in effective moment of inertia of the specimens, which caused an increase in deflections. After approximately 20 thousand cycles deflections did not increase significantly for the majority of the specimens except those failing by concrete cover peel off. Figure 10 shows the midspan deflection comparison between a specimen that failed by steel fatigue fracture (specimen B-1-2-70) and one that failed by concrete peel off (specimen B-2-2-70). Mid-span deflection in specimen B-2-2-70 increased significantly after 100 thousand cycles of loading as a result of initiation of cover peel off. Contrastingly there was only a slight increase in deflection in specimen B-1-2-70 after initial cycling up to approximately 20 thousand cycles. The behavioral trends observed in these two specimens are also representative of behavior observed in other specimens in this research.

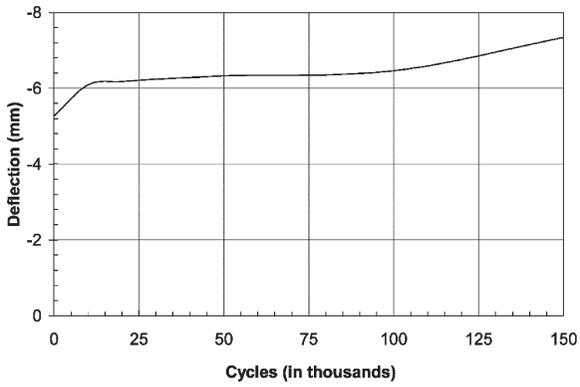
(b) Specimen B-2-2-70

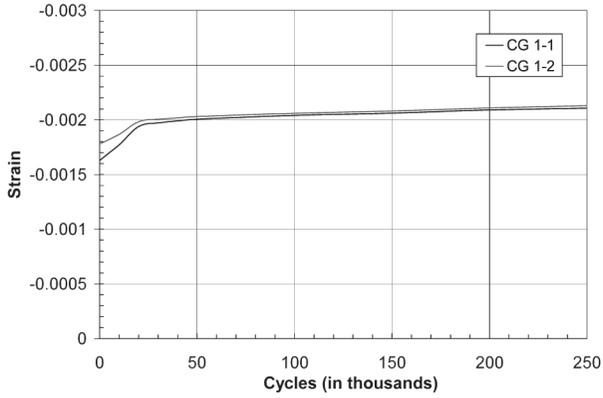
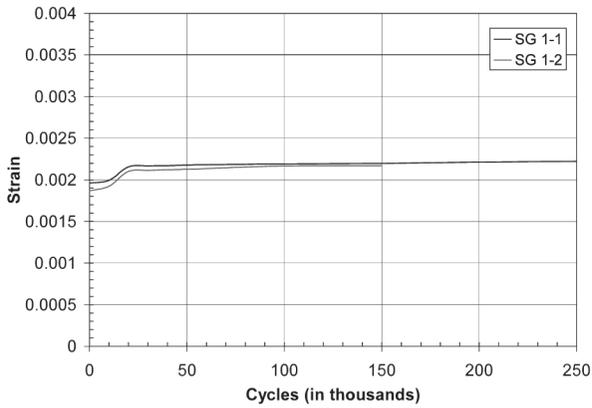
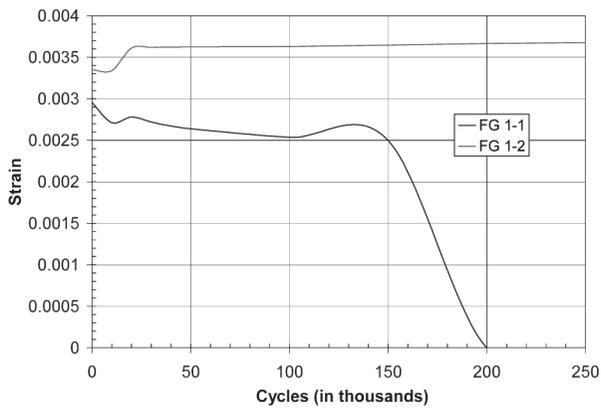
(a) Concrete strains

(b) Steel Strains

(c) CFRP Strains

Figure 11 — Strain variation with cycling (Specimen B-1-2-70)

Strains in the specimens were expected to follow a similar variation as deflection. Figure 11 shows the strain variation in the concrete, steel, and CFRP laminates as a function of number of load cycles in specimen B-1-2-70. In this figure negative values represent compressive strains (concrete strains) and positive values represent tensile strains (steel and CFRP strains). The figure indicates that concrete and steel strains follow the expected variation, that is, significant strain increase during the first few thousand cycles of loading with little increase afterwards. Contrastingly one of the CFRP strain gages exhibited a marked reduction, particularly after 150 thousand cycles of loading. These types of variations were not uncommon in other specimens so definitive conclusions about damage progression could not be made using strain gage data. From these results, it was found that displacement measurements provided the most reliable indicator of damage progression in these tests.
