Innovative Application of FRPs for Seismic Strengthening of RC Shear Wall

by K. Kobayashi

Synopsis: The small holes were drilled at the grid intersection on the concrete wall panel. A bundle of aramid strands was passed through the holes so that it sewed them in cross diagonal directions. As a result, the concrete wall panel was shut up into a net made of aramid sewing bands. Shear capacity increased by more than 25%. FRP sewing bands worked as confinement to the concrete under compressive stress rather than the tensile braces. Its performance is expected to be better than that reinforced by FRP sheet wrapping system, and more strengthening effect will be obtained with less amount of fiber material. This strengthening idea is originally proposed to apply it to the infill-brick wall. The concept and the effectiveness of the idea were verified by the tests on the scaled RC shear wall.

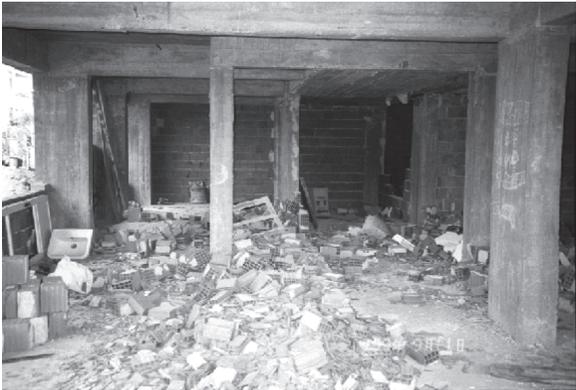
Fig.1—Collapse of the infill-bricks out of the frame

In Kocaeli earthquake^[1] in 1999, the infill-bricks collapsed out of the frame as shown in Fig.1 and a large number of buildings were totally collapsed as shown in Fig.2 because of the poor detail of beam-column connections. This infill-brick wall is non-structural element. The primary objective of this proposed method is to expect the infill-brick wall to carry the horizontal force by keeping the bricks inside the frame and fixing them to the beams and columns. This type of structure is popular in many seismic countries, and it is required to be strengthened with less expensive cost.

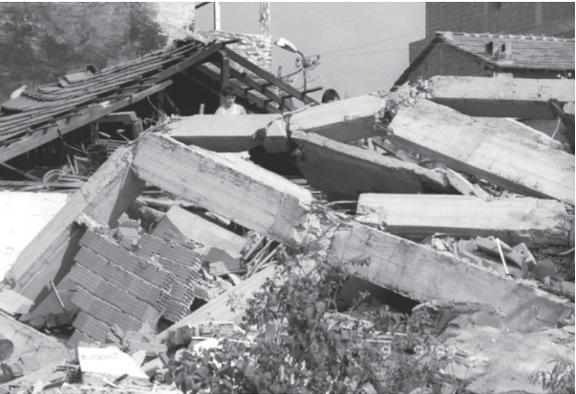
Fig.2—Collapse of the building in the shape of pancake

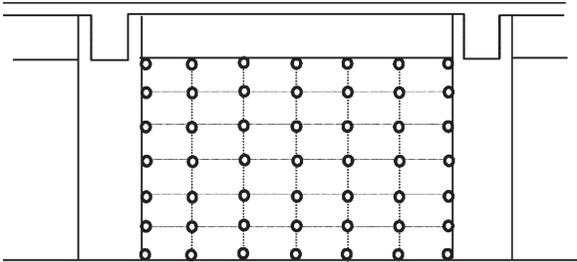
Fig.3—Drilling on the wall panel

The small holes are drilled at every grid intersection on the wall as shown in Fig.3.

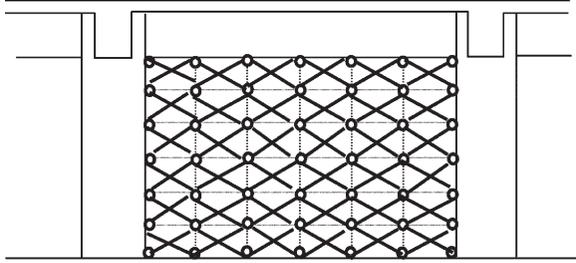
Fig. 4—Installation of FRP bands

FRP bands are installed on every diagonal two-holes as shown in Fig.4. If the FRP band is installed crossing a crack as shown in Fig.5, FRP can take full tension force because of the shape of a band, and the tension force transfers to the next FRP band through the un-cracked part of concrete. The advantages of this idea are:

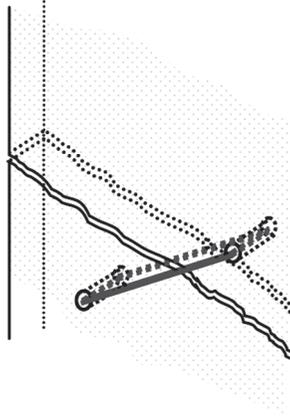
Fig.5—A FRP band over the crack

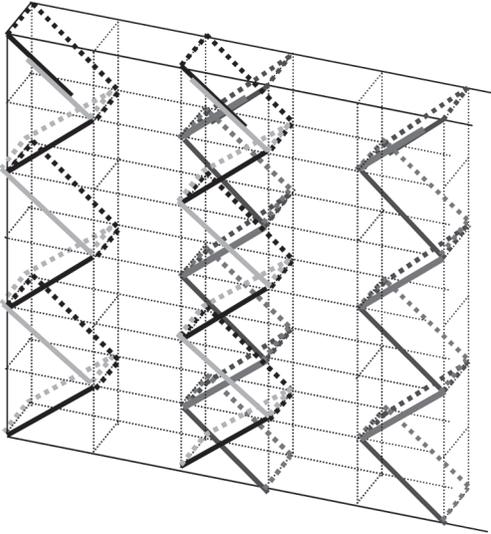
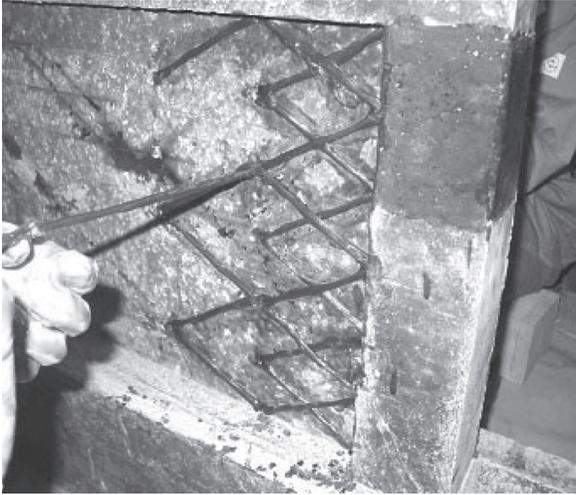
Fig.6—A zigzag sewing path

One sewing path is illustrated in Fig.6. A bundle of strands with resin sew holes in the zigzag path. The advantage of this path is that a bundle of strands do not cross in a hole, but the sewing path is split by the vertical lines. This was discussed in the pilot test.

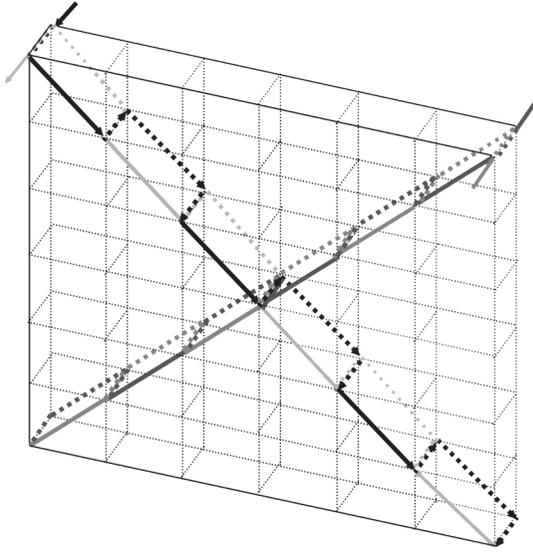
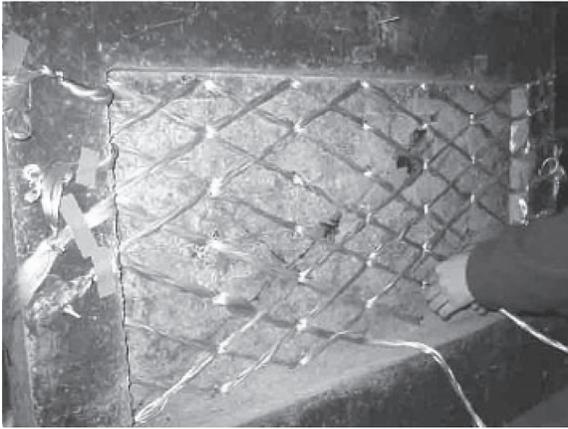
Fig. 7—Diagonal sewing path

Another sewing path is shown in Fig.7. A bundle of strands with or without epoxy resin sew holes in the diagonal directions. The advantage of this path is that a bundle of strands continues in the diagonal directions, and is expected to work as tension braces. It is somewhat difficult to pass a number of FRP bands in one hole. However this will be resolved by braiding the strands before installation.

Repairing and strengthening effect for the damaged RC shear wall--The holes were drilled on the grid intersection on the wall panel of W03N after loading test. Next, the wall panel was kept horizontal, and the epoxy resin was put on the panel and it sank in the cracks. After that, the sewing bands with epoxy resin were installed with the diagonal sewing path shown in Fig.7.

The parameter of the test specimens is the number of aramid strands in a sewing band. No.1 is the control specimen without the sewing bands. No.2 to No.4 have 3, 6, 12 aramid strands in a sewing band. The diagonal sewing path shown in Fig.7 was adopted. The end of strands was winded around the columns in order to ensure the anchorage of sewing bands and to increase the shear capacity of columns. Under the upper beam and on the footing beam, the end of sewing band was not anchored into the beams, and the bundle of strands was spliced on the wall panel to make the completely closed bands.

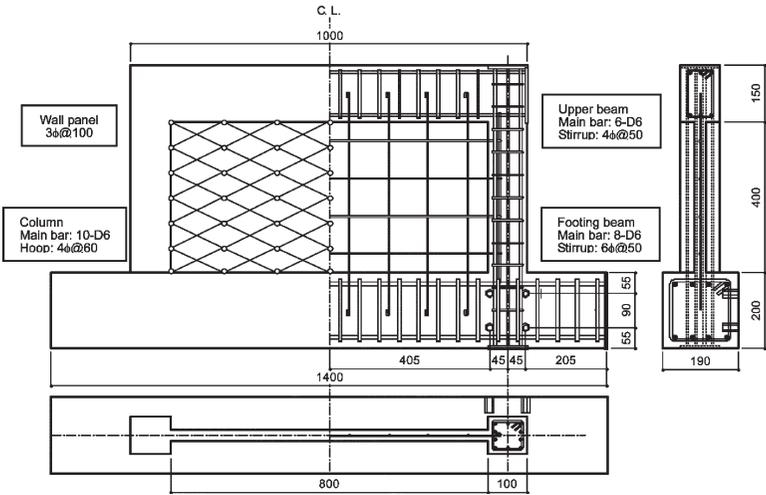
Fig. 8—Dimensions and reinforcing arrangement of the test specimen

proposed method (W03N-R). Three test specimens are listed in Table 1. The dimensions of a specimen and the reinforcing arrangement are shown in Fig.8. Each column has 10-D6 longitudinal bars. The wall panel has the round bars of 3mm in diameter at the interval of 100mm both horizontally and vertically.

dimensions of wall panel and columns are same as those of the pilot test specimens shown in Fig.8. To increase the flexural capacity, four longitudinal bars of D6 were added at the center of each column. To obtain the low strength normal concrete with high viscosity, one third of cement was replaced by the stone powder in the concrete mixing, and successfully the concrete with 26N/mm^2 in compressive strength and with 8cm of slump was obtained. To distribute the horizontal force on the top of wall panel, the dimension of the upper beam was increased to 190mm in width and 150mm in depth. The steel reinforcement in the wall panel and the steel shear reinforcement of the columns were same as those of the pilot test specimens.

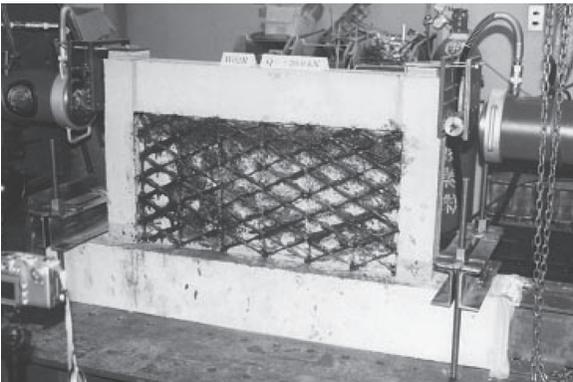
Fig. 9—Loading setup

Two oil jacks were set up on both side of specimen at the height of 425mm from the footing beam as shown in Fig.9. To introduce more shear force before reaching flexural capacity, the oil jacks were set up at as lower point as possible. The horizontal load was alternatively given by pushing the end of the beam.

The loading setup is same as that show in Fig.9, and the horizontal load was alternatively given at the center of the upper beam that is 475mm high from the top surface of the footing beam.

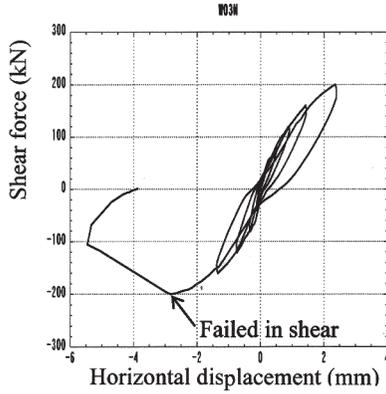
Fig.10—Applied load-horizontal displacement relation (W03N)

Strengthening effect for the existing RC shear wall—Figure 10 shows the relation between the horizontal force and the horizontal displacement of W03N. It failed in shear mode at -200kN of shear force. The flexural capacity is 220kN in calculation. When the shear force reached -200kN, a critical shear crack was generated on the wall panel, and the specimen suddenly lost the bearing force. The shear cracks were induced on column top and bottom too.

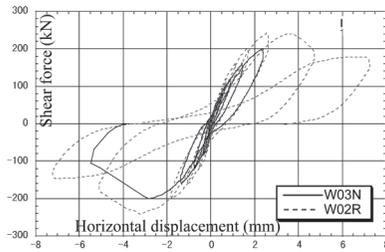
Fig.11—Applied load-horizontal displacement relation (W02R)

by the aramid sewing bands, and the shear crack did not open and the crushed concrete didn't peel off. The horizontal load vs. displacement curves showed a stable behavior as shown in Fig.11, though the bearing force decreased.

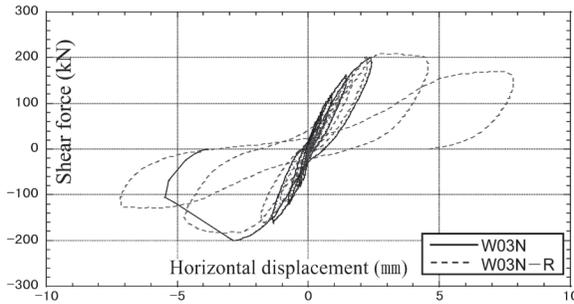
Fig.12—Applied load-horizontal displacement relation (W03N-R)

The column tops and bottom were wrapped with CF sheet without repairing the cracks. But the closed wrapping was not achieved because of the wall. The capacity and the rigidity completely recovered in both positive and negative loading directions. The capacity didn't increase. However the failure mode changed from that of W03N. The shear cracks on the column tops expanded, though the column tops were reinforced with CF sheet. Maybe this is due to no-injection of epoxy resin into the shear crack on the columns and no-closed wrapping of CF sheet. The column top deformed with shear force, and the crack developed along the interface between the wall panel top and the upper beam bottom. The shear crack at column bottom didn't expand. In the same way as that in W02R, the top corner of wall panel was intensively pushed to one direction. However the wall panel did not crush, and the slip failure occurred at the interface between the wall panel top and the upper beam bottom. The bearing force decreased gradually because the slip failure gradually progressed. The increase of the shear capacity may also depend on the strengthening method of columns, and the way to give horizontal force in the loading test.

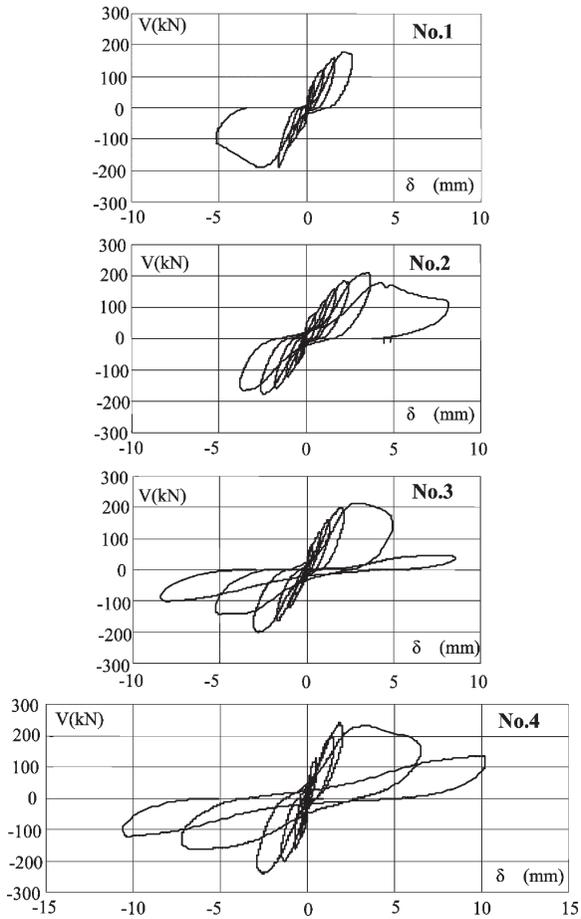
Fig. 13—Horizontal load – displacement relations

The relations between the horizontal load and the horizontal displacement are shown in Fig.13. The control specimen (No.1) failed in shear mode. The critical shear cracks occurred and the mid-center of the wall panel crushed. The shear cracks occurred on columns, but they did not determine the shear capacity. No.1 reached the maximum load at the horizontal displacement of 2.6mm and quickly lost the bearing force. Figure14 shows the cracking pattern after loading test.

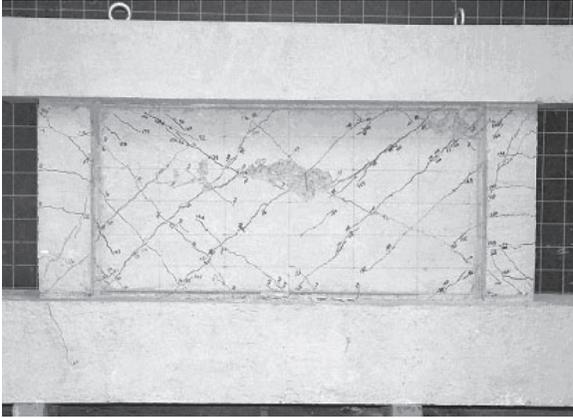
Fig. 14—Cracking pattern of No.1 specimen

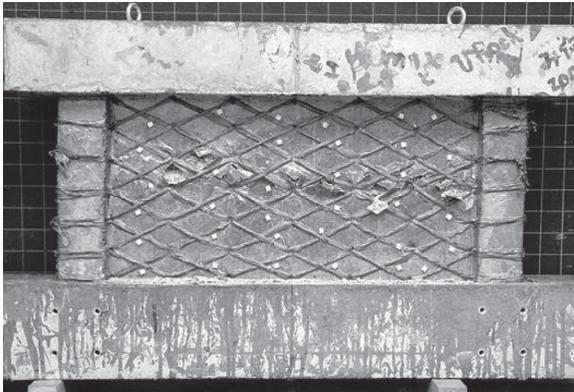
Fig. 15—Ultimate failure mode of No. 4 specimen

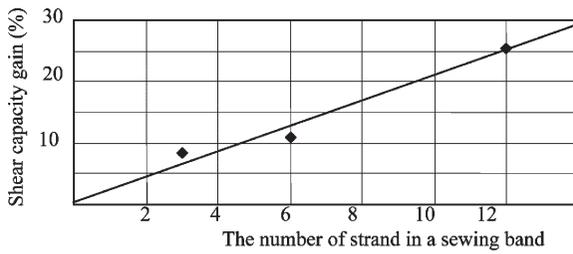
Fig. 16—Shear capacity gain

No.2 with a sewing band made of three strands got some shear capacity gain and didn't fail in the loading cycle where No.1 failed. After reaching the maximum load at the horizontal displacement of 3.5mm, the crush of wall panel was observed in very limited unit areas surrounded by the sewing bands. The applied load gradually decreased and the loading was stopped when it decreased to a half of the maximum load. No.3 and No.4 showed same behavior as that of No.2, and the maximum load and the deformation capacity increased according to the number of strands in a sewing band. The failure pattern of No.4 is shown in Fig.15. The test results are summarized in Table 4. Figure 16 shows the relation between the shear capacity gain percentage to the control specimen and the number of strands in a sewing band.

The shear capacity increased almost in proportion to the amount of fibers in a sewing

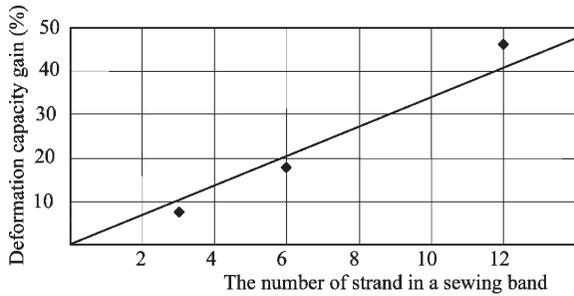
Fig. 17—Deformation capacity gain

band, but it may have a limit because the crush of the wall panel will govern the capacity when the amount of fibers in a sewing band increases. Figure 17 shows the deformation capacity gain vs. the amount of fibers in a sewing band. The deformation capacity was defined as a displacement where the applied load decreased by 15% from the maximum load. It also increased almost in proportion to the amount of fibers in a sewing band, but it must have a limit because of the same reason for the shear capacity gain.

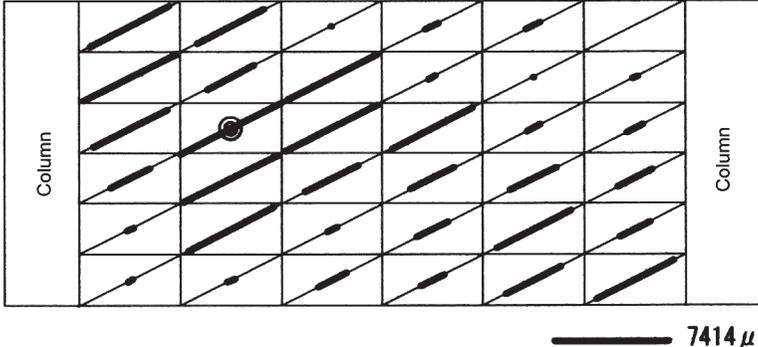
Fig. 18—Strain distribution on the sewing bands of No.3 specimen

The strain gages were installed on the sewing band on each grid. Figure 18 shows the strain distribution of No.3 at the maximum load. The strain gages in the diagonal region of the wall panel showed a large value over 10000×10^{-6} . Figure 19 shows one example of the strain history to the loading cycles on a sewing band that is marked in Fig.18. When reaching the maximum load, the strain increased quickly, and immediately after the maximum load the strain increased more. It corresponds to the failure mode that the crush of wall panel occurred in the areas surrounded by sewing bands and the sewing bands were well resisting to swelling of the crushed concrete.

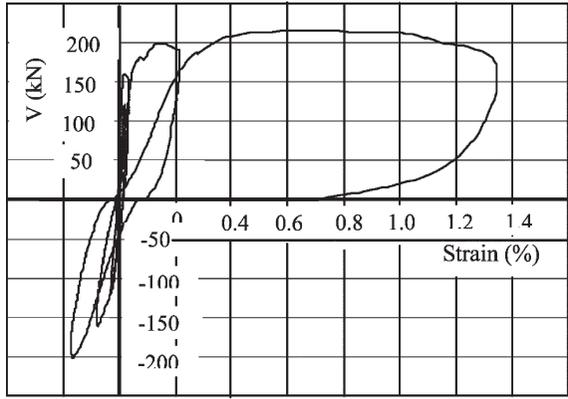
Fig. 19—A strain history to the loading cycles

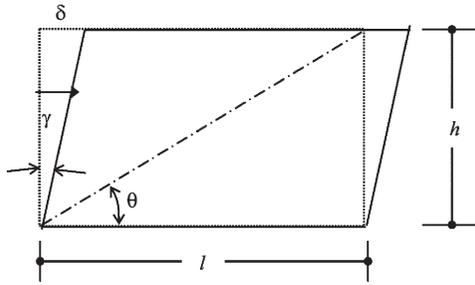
Fig. 20—Assumed deformation of the wall panel

The wall panel is assumed to deform into a parallelogram as shown in Fig.20. The strain in the diagonal direction is

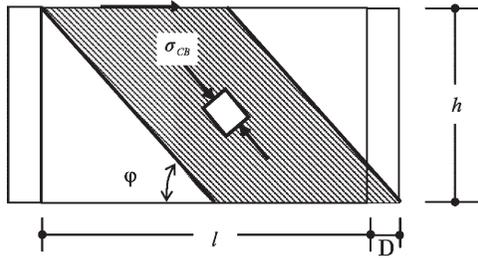
Fig. 21—Truss action on the wall panel

The horizontal force can transfer through the strut as shown in Fig.21. If the strut has the dimension shown in Fig.21, the contribution of the strut to the shear capacity gain is
