OUT-OF-PLANE STATIC AND BLAST RESISTANCE OF UNREINFORCED MASONRY WALL CONNECTIONS STRENGTHENED WITH FIBER REINFORCED POLYMERS

University of Missouri-Rolla

03-46

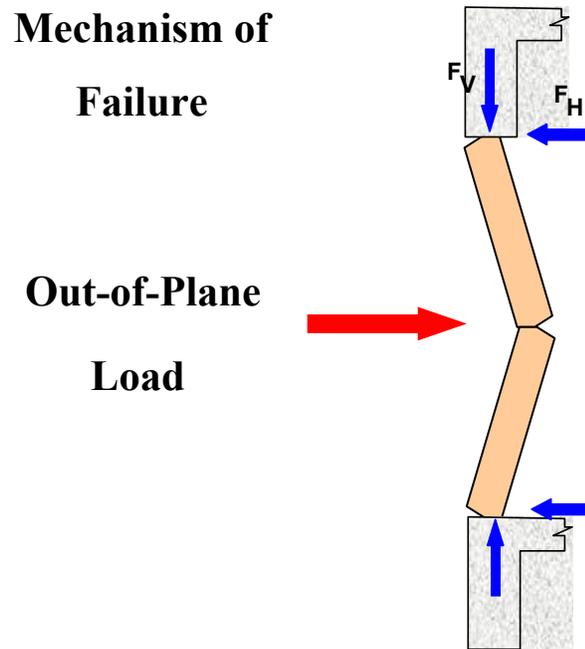
A shear force is also developed at the support locations (Tumialan 2001). Figure 2.1 illustrates the arching action mechanism.

Figure 2.1. Arching Action Mechanism (Tumialan et al. 2000)

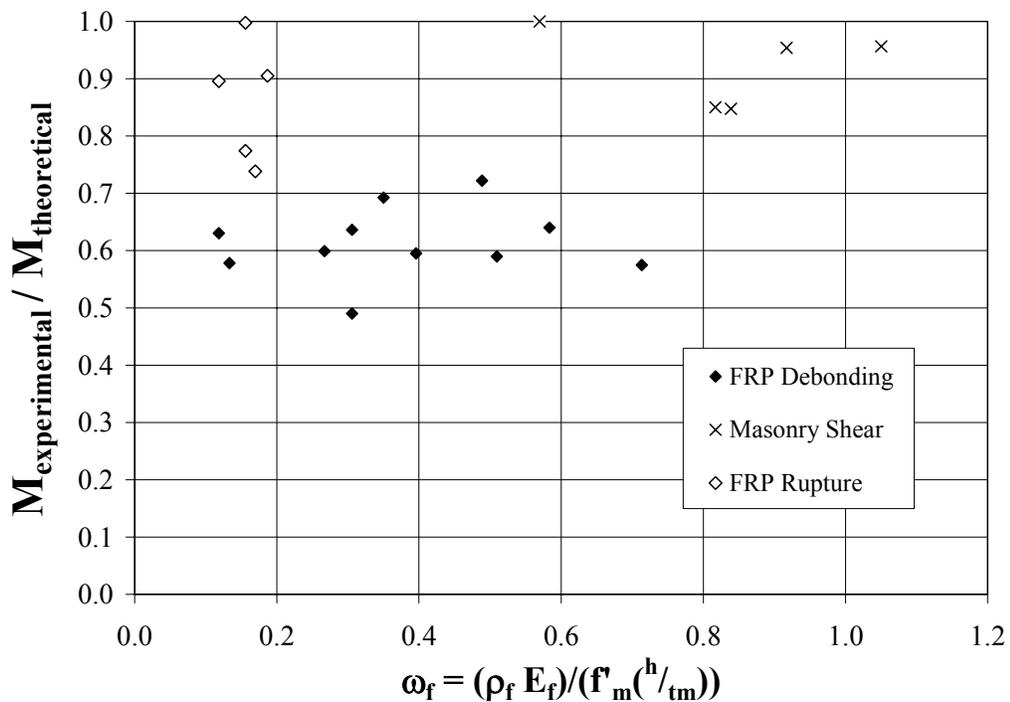
illustrated in Figure 2.2. The parameters include ρ_f , the flexural reinforcement ratio, E_f , the modulus of elasticity of the FRP, f'_m , the compressive strength of the masonry, and h/t_m , the slenderness ratio of the wall (Tumialan et al. 2003).

Figure 2.2. Moment Capacity versus Reinforcement Index (Tumialan et al. 2003)

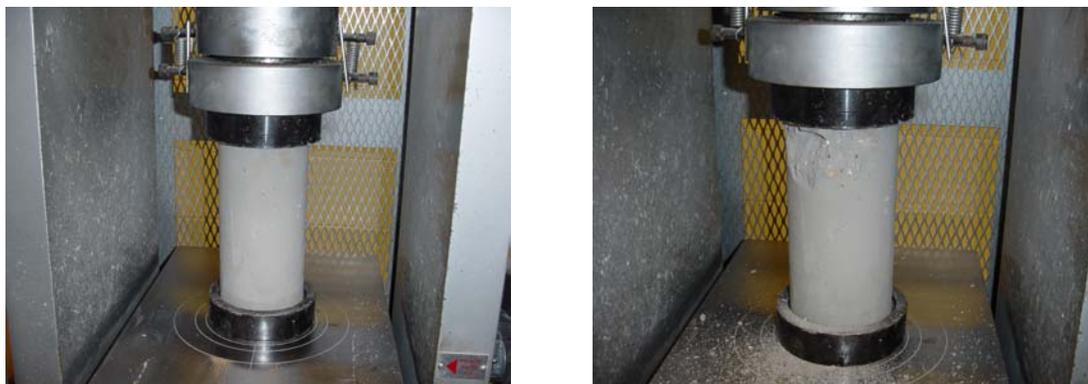
Figure 3.1. Testing of Concrete Cylinders

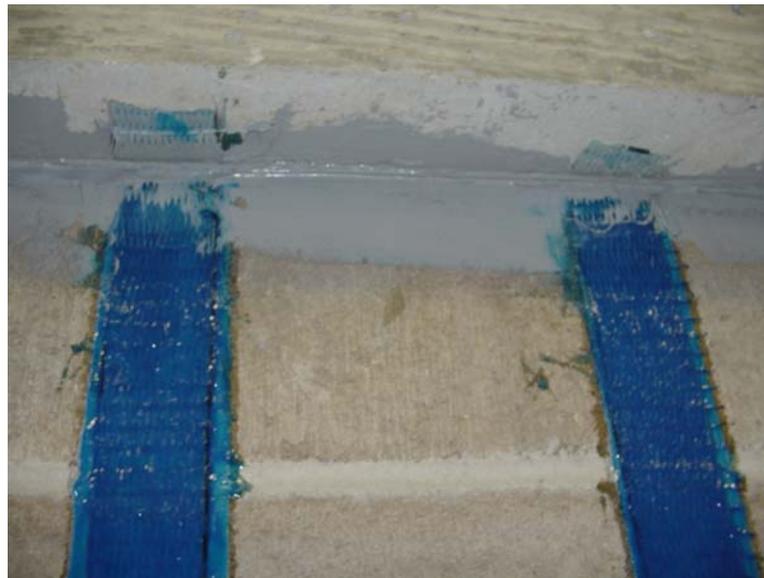
Figure 4.22. Completed GFRP Laminate Anchorage System

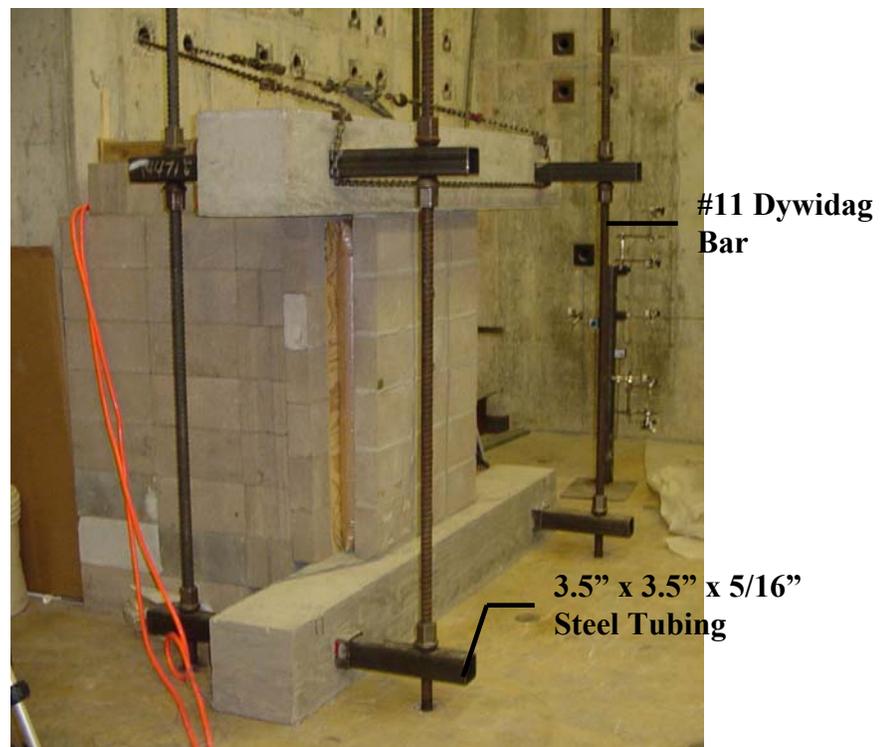
was connected to the fill line at the bag's fill port. A pressure gage was connected to the other end of this line to allow the pressure in the bag to be measured. A chain was anchored to the strong wall and placed around the top boundary element in an attempt to limit any translation of the top boundary element. The test setup is illustrated in Figure 4.23.

Figure 4.23. Test Setup

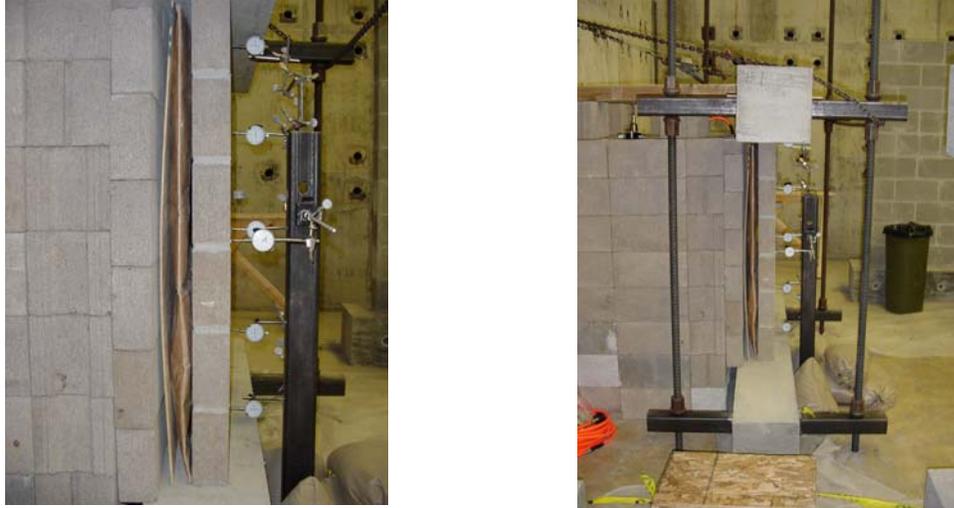
are the locations where the gages were applied. Strain readings were taken using individual strain indicators for each gage. To measure deflections, two methods were used. Dial gages were used to accurately measure deflections during the initial loading stages of the test. Six dial gages were used to measure deflection. Five gages were placed in the middle of the wall vertically, two at the ends, one at midspan, and two at the quarter points. To ensure the load was distributed uniformly in the horizontal direction, and additional deflection reading was taken near the walls edge at midspan. The dial gage setup is shown in Figure 4.25. During testing, safety became an issue where the physical reading of deformation was no longer safe. At this point, the gages were removed and a digital high power video camera is used to record precise ruler measurements. A precise ruler was attached to the CMU fill material as shown in Figure

Figure 4.25. Dial Gage Setup

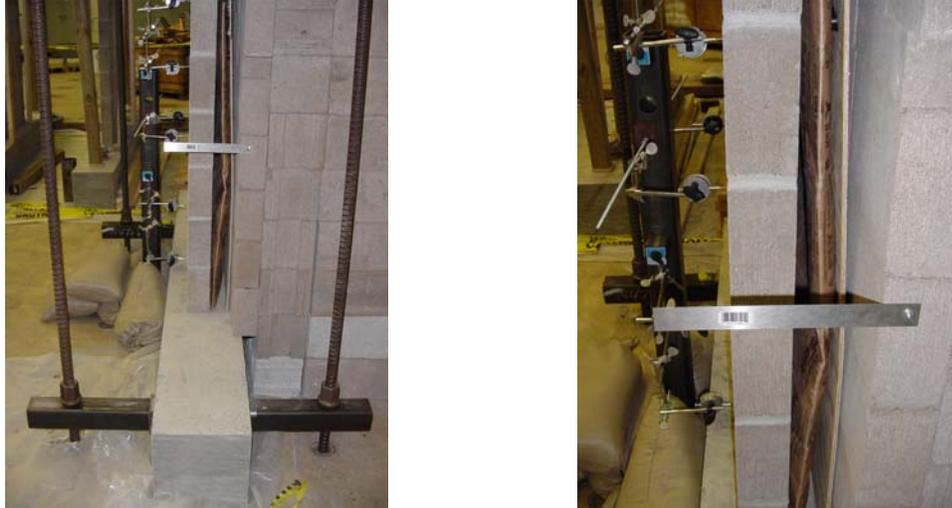
4.26. The ruler was accurate to 0.0625 in (1.59 mm). A video camera records as the wall is tested, and the wall's movement relative to the precise ruler can be observed and recorded.

Figure 4.26. Precise Ruler for Deflection Measurement

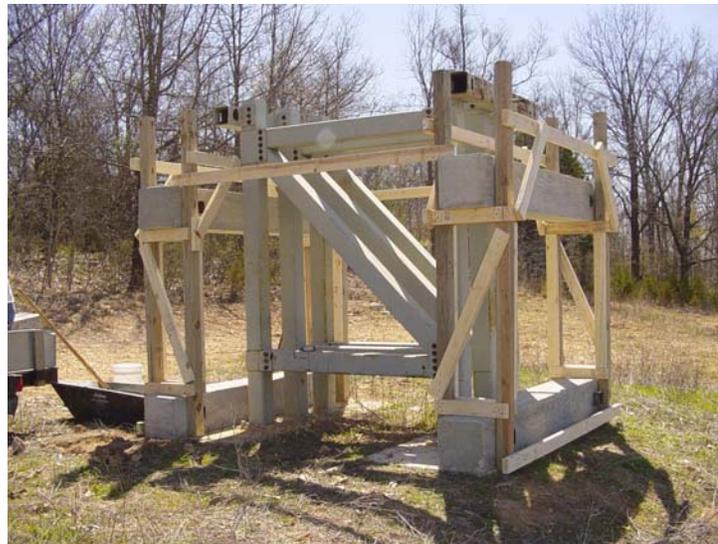
Figure 4.27. Frame and Boundary Setup

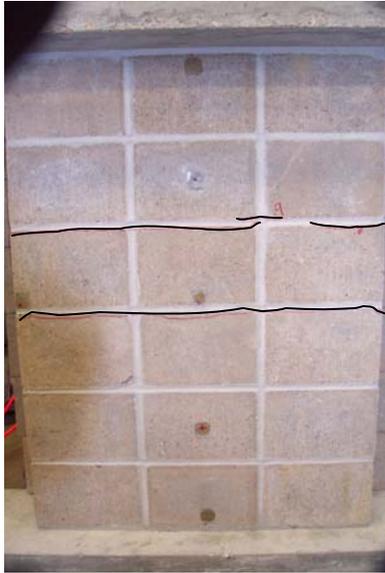
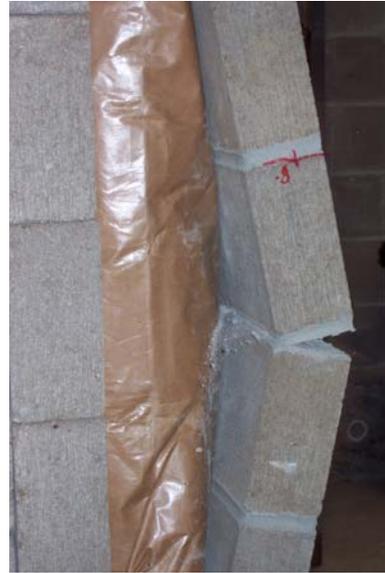
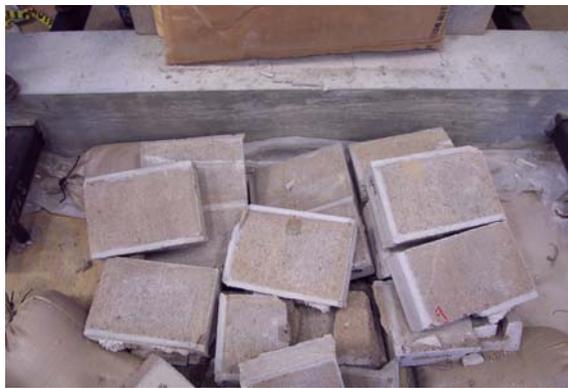
(a) Cracking

(b) Arching Action

(c) Failure

Figure 5.1. Wall #1 Failure

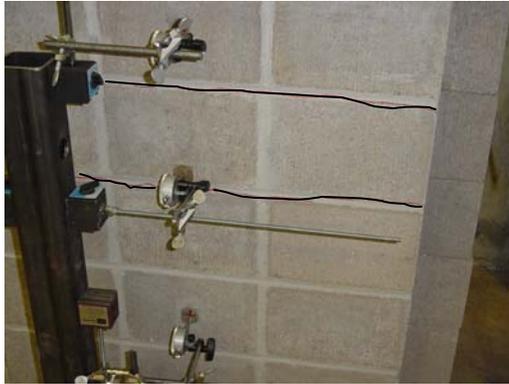
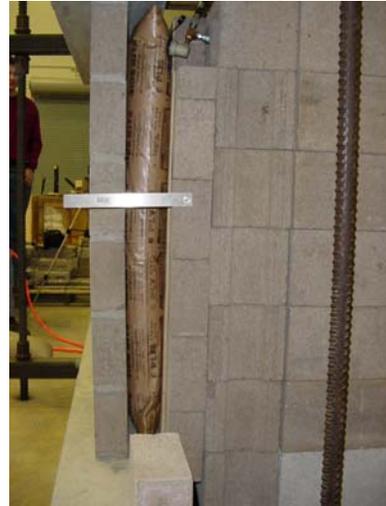
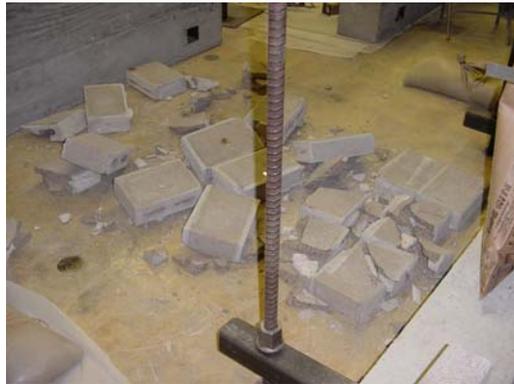
5.1.2. Wall #2. Wall #2 was an unreinforced control with a shear retrofit. This wall performed much the same as Wall #1. Initial cracking was at the fourth course and occurred at 3.1psi (21.4 kPa). Midspan cracking occurred at 4.0 psi (27.6 kPa) and

development of arching action occurred as shown in Figures 5.2a and 5.2b respectively. Loading continued until failure (Figure 5.2c) with an ultimate load of 6.6 psi (45.5 kPa) and a deflection at failure of 0.74 in (18.8 mm).

Figure 5.2. Wall #2 Failure

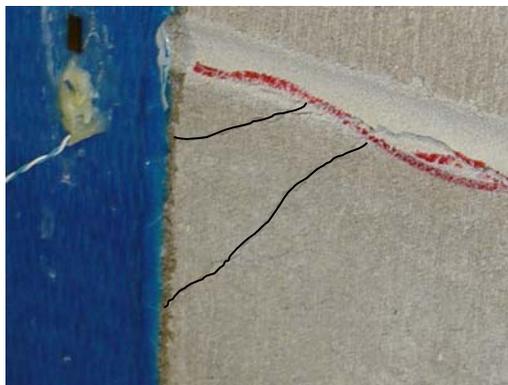
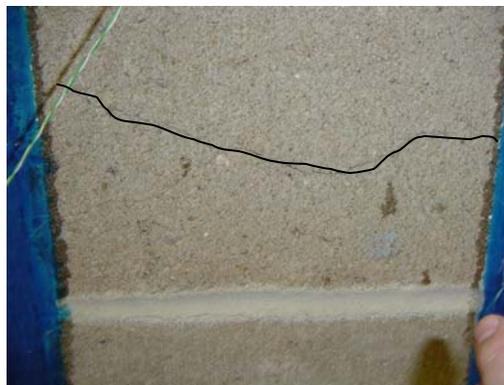
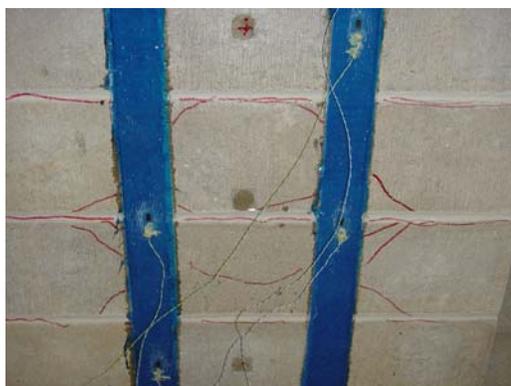
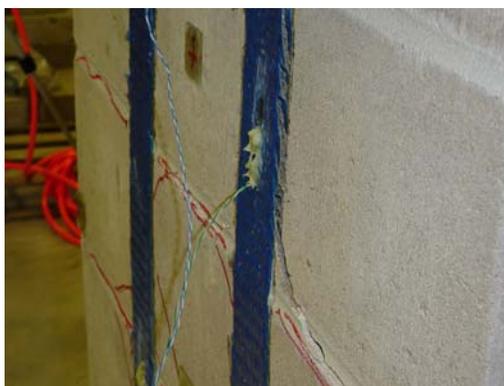
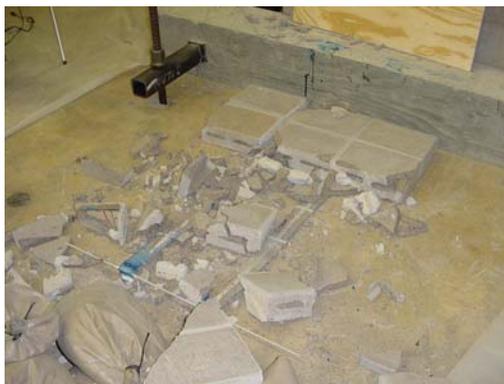
(a) Propagation of Cracks

(b) Crack Through Block

(c) Cracking

(d) Delamination

(f) Masonry Attached to Laminate

Figure 5.3. Wall #3 Failure

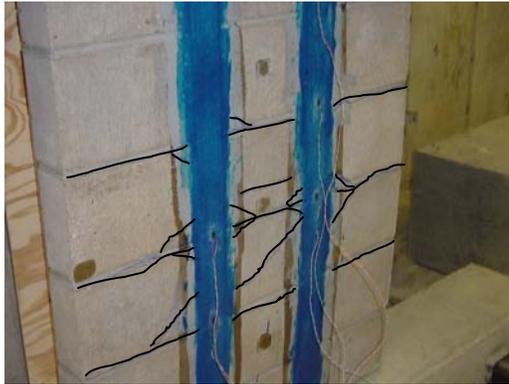
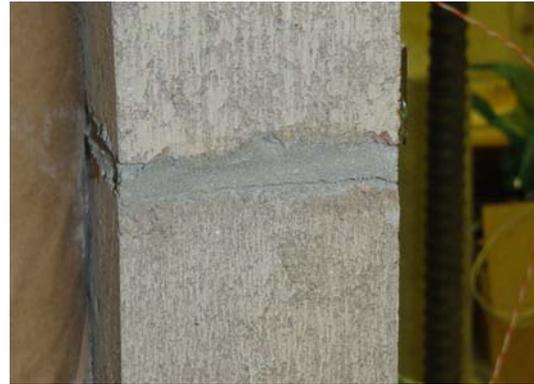
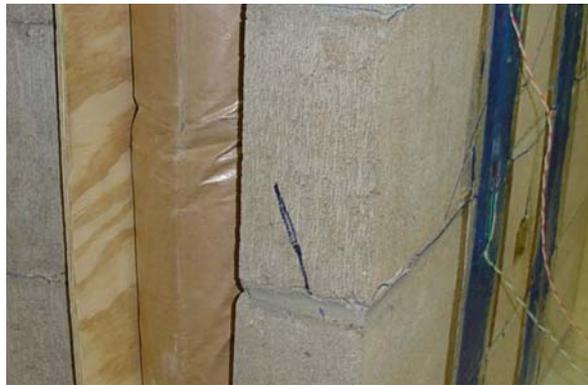
(a) Cracking

(b) Arching Action

(c) Crack on Side of Block

Figure 5.6. Wall #7 Failure

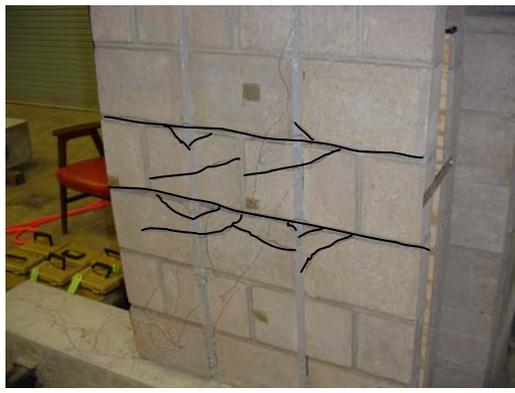
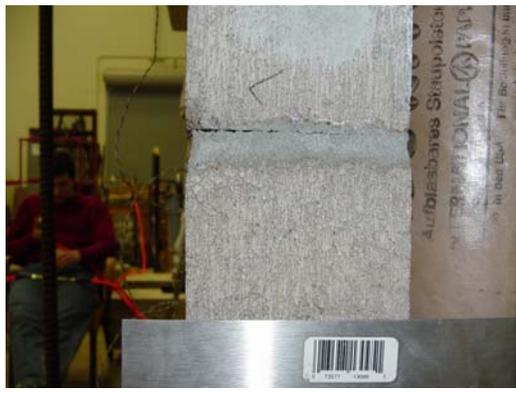
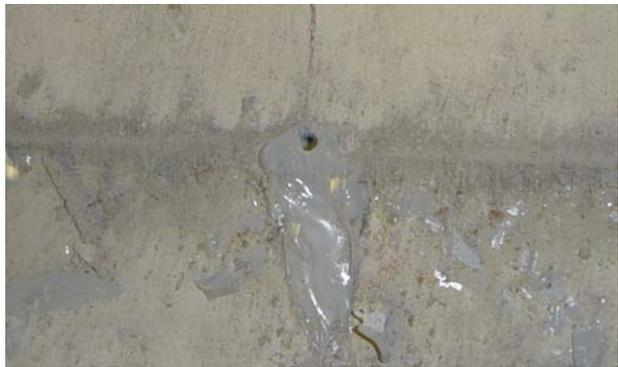
(a) Cracking

(b) Arching Action

(e) Pullout

Figure 5.8. Wall #9 Failure

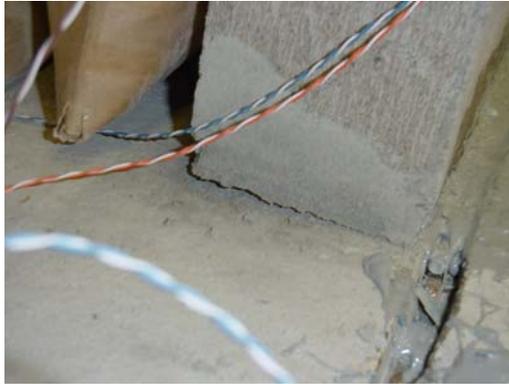
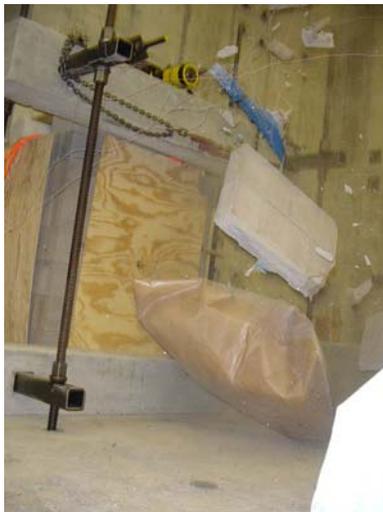
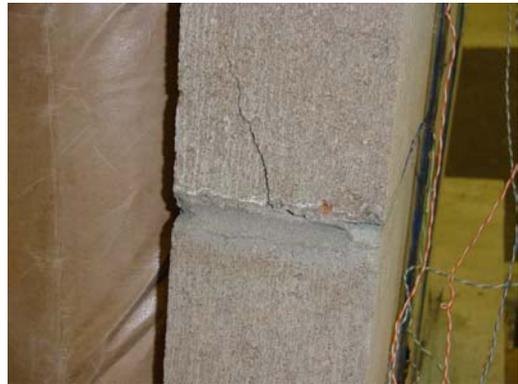
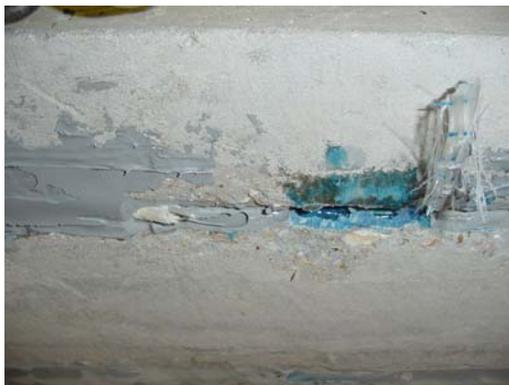
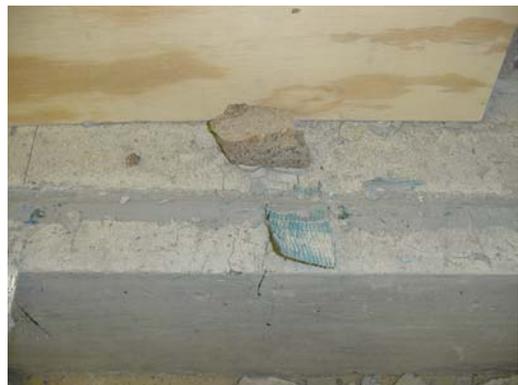
(a) Arching Action

(c) Failure

(d) Crack on Side of Block

(e) Pullout

(f) Sheared Connection

Figure 5.9. Wall #10 Failure

5.9e), but a portion of the rod remained in the beam. The FRP was sheared at the bottom boundary (Figure 5.9f).

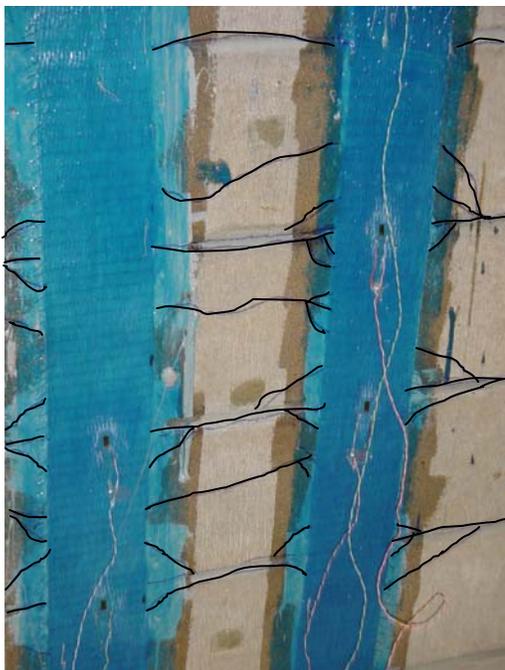
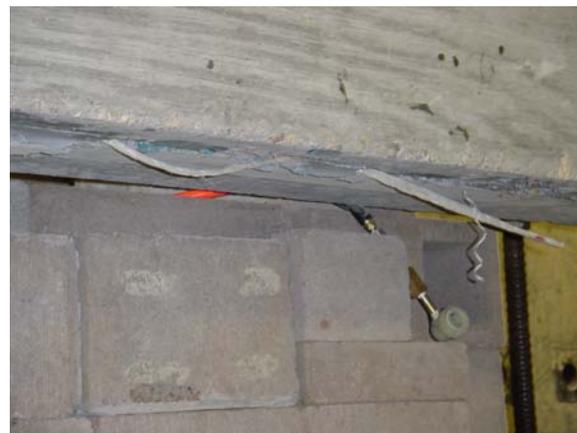
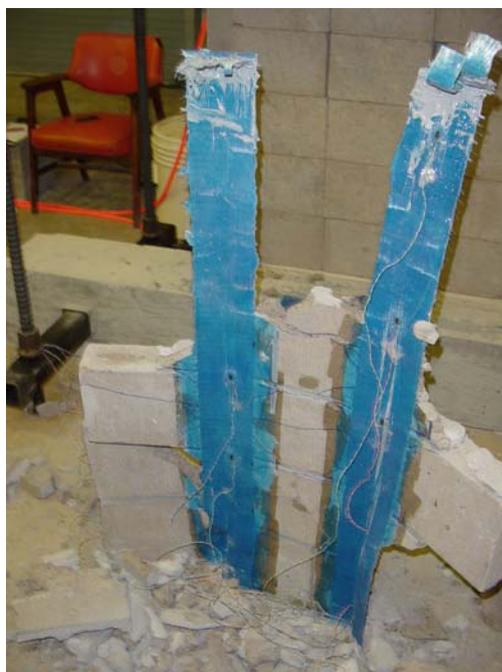
(a) Cracking

(b) Pullout

(c) Wall Held Together

Figure 5.10. Wall #11 Failure

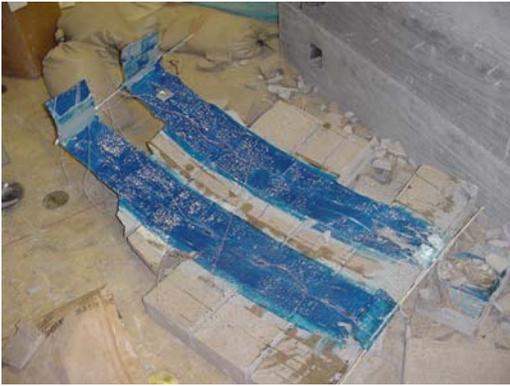
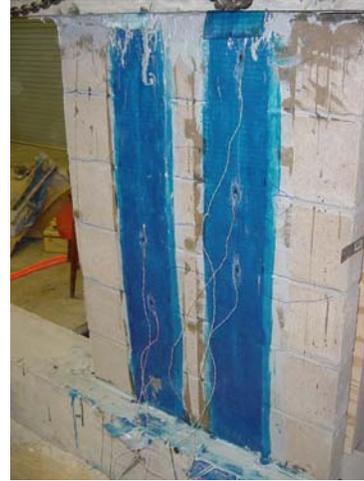
(a) Pullout

(b) Cracking

Figure 5.11. Wall #12 Failure

5.1.12. Wall #12. Wall #12 had the highest reinforcement ratio of all of the walls tested in Phase I. This wall was reinforced with 6.5 in (165.1 mm) wide sheets anchored to the boundaries. At 2.6 psi (17.9 kPa), cracks formed at midspan and above the fourth course. This was followed by additional cracking at 4.6 and 4.8 psi (31.7 and 33.1 kPa) above the fifth and second course respectively. Initial failure was the pullout of the FRP sheets from the bottom beam followed by pullout from the top (Figure 5.11a). This failure occurred at 15.2 psi (104.8 kPa) and a deflection of 1.9 in (48.3 mm). Arching and propagation cracks and cracks through the blocks were present (Figure 5.11b). The laminates held the system intact after failure (Figure 5.11a).

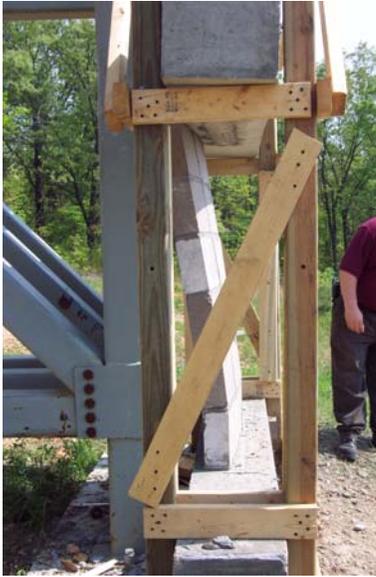
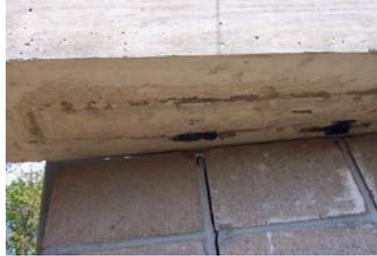
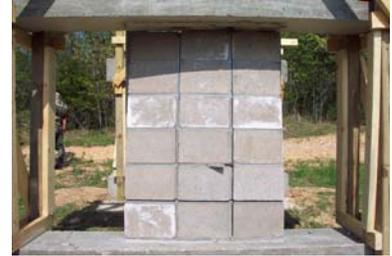
(a) Side View

(b) Sliding Failure at Boundary Element

(c) Front View

Figure 5.12. Wall #1 Failure

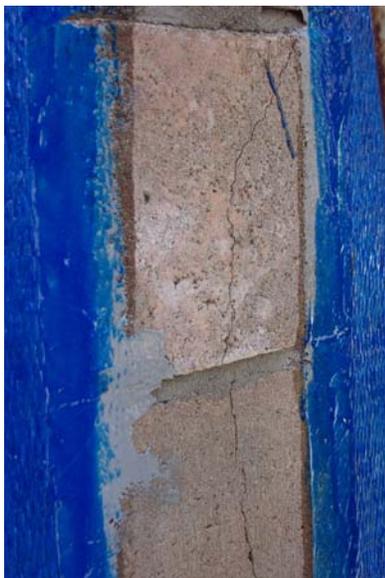
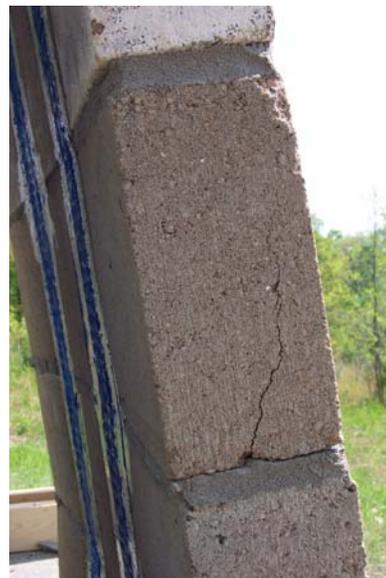
(a) Cracking Through Blocks

(b) Crack on Side of Block

Figure 5.13. Cracking

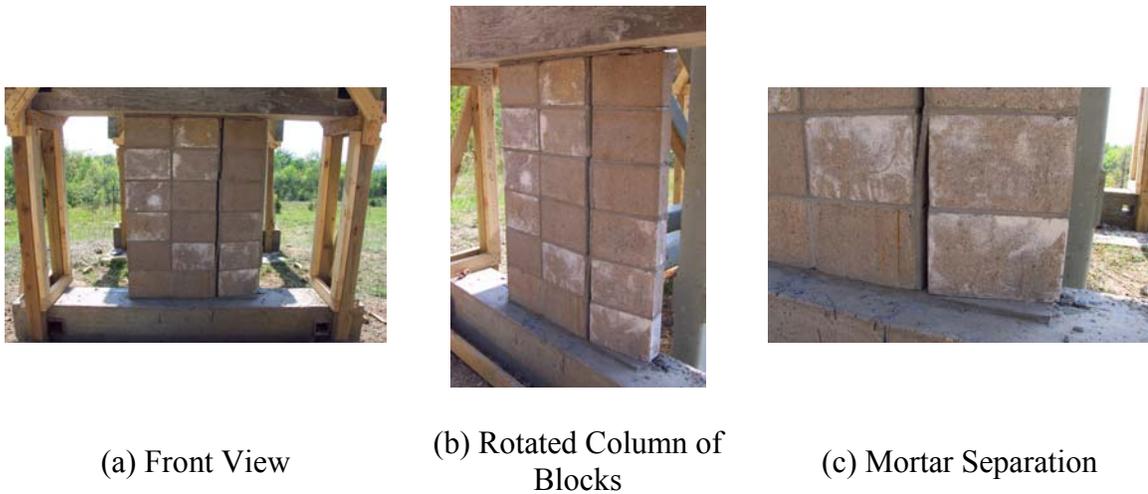
event induced heavy damage on the wall as seen in Figure 5.14. The column of blocks on the end began to rotate about the head joint where the FRP was bonding this column to the center column. Failure occurred after the 5 lb (2.3 kg) charge was set off as illustrated in Figure 5.15. Further rotation occurred with the loss of one of the blocks from the wall. The anchorage details remained intact. Propagating cracks near the midspan mortar joint indicate that the wall system was approaching the onset of delamination.

Figure 5.14. Damaged Wall

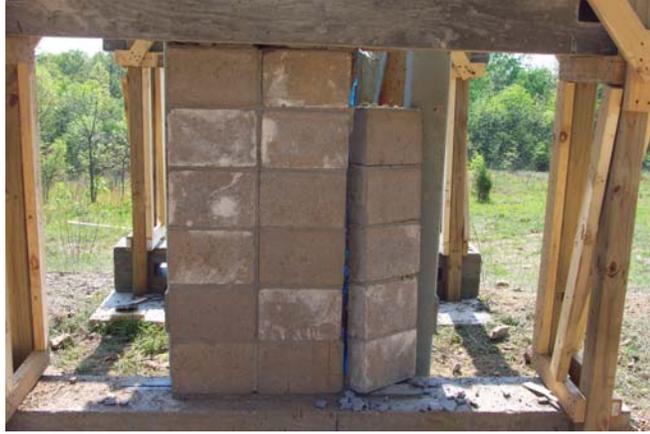
Figure 5.15. Wall #2 Failure

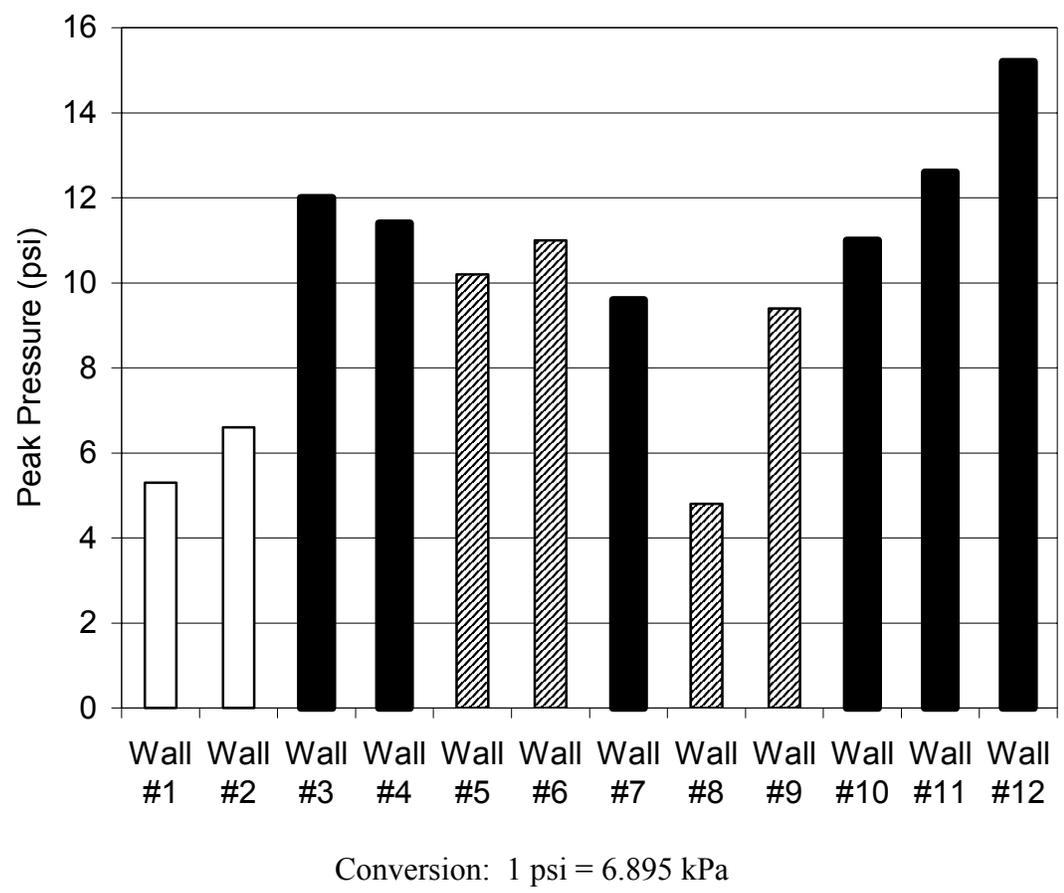
elements. This can be seen by comparing the results of Walls #7 and #8 to Walls #3 through #6 (Figure 5.16). Walls #3 through #6 investigate the condition in which the reinforcement is anchored to the boundary members. In Walls #7 and #8, the same reinforcement is used without the anchorage. For the case of the GFRP sheets, the unanchored condition provides a capacity between the unreinforced case and the anchored case. Some benefit can be obtained just by applying the sheets to the walls. When anchorage of the sheets is provided, this research suggests additional capacity is gained. This is not true in the case of the NSM rods. When the NSM rods are installed without anchoring them to the boundary, they behave in much the same way as an unreinforced wall. When anchorage is provided, continuity is developed and additional capacity is obtained.

Figure 5.16. Peak Out-of-Plane Pressure Results for Phase I Test Walls at Failure

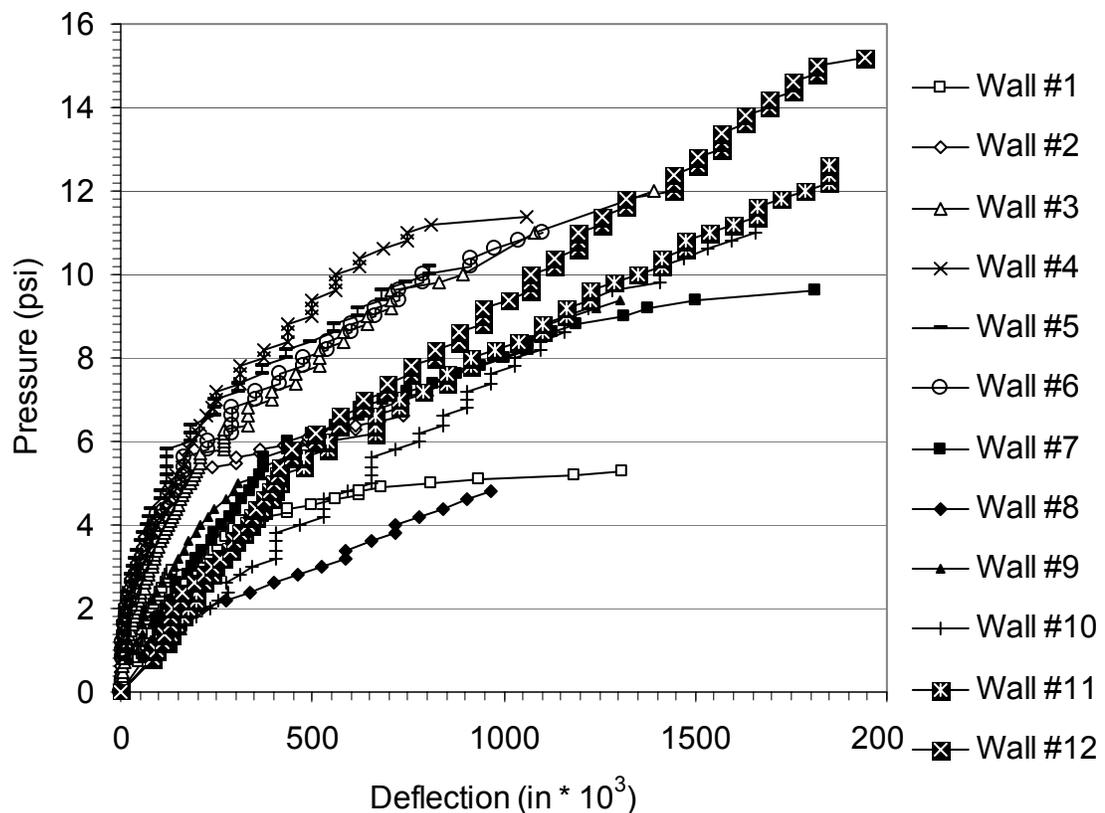
Figure 5.17. Pressure versus Displacement for Phase I Walls

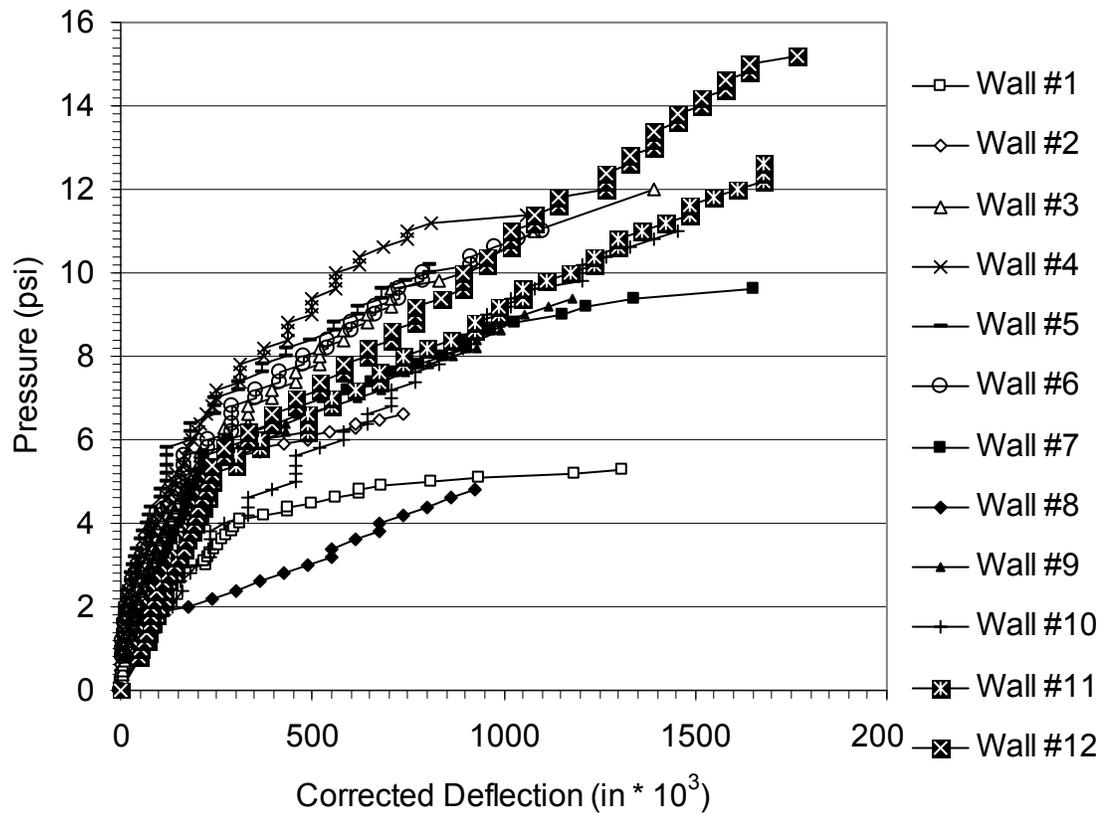
Using the plot of pressure versus corrected deflection illustrated in Figure 5.18, the strain energy of each wall can be calculated by estimating the area under this load versus deformation curve. For this research, Wall #1 was used as a control or benchmark on which to base a strain energy ratio. The normalized strain energy as shown in Figure 5.19 is the ratio of the strain energy of a given wall to that of the control wall, Wall #1. From this figure, it is clear that the laminates provide the system with the ability to absorb more energy prior to failure. This was observed visually during the out-of-plane tests well. The walls strengthened with NSM rods failed in a brittle manner. When the laminates were used, more of the wall was held together, and you could usually tell when

Figure 5.18. Pressure versus Corrected Displacement

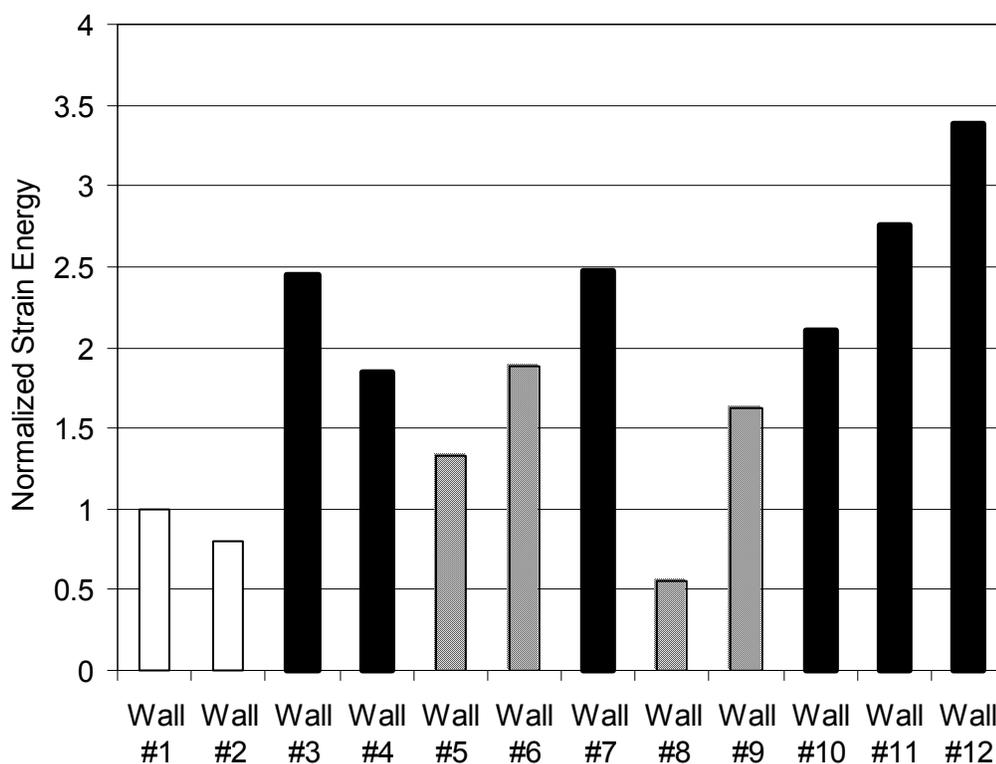
Figure 5.19. Normalized Strain Energy Ratio

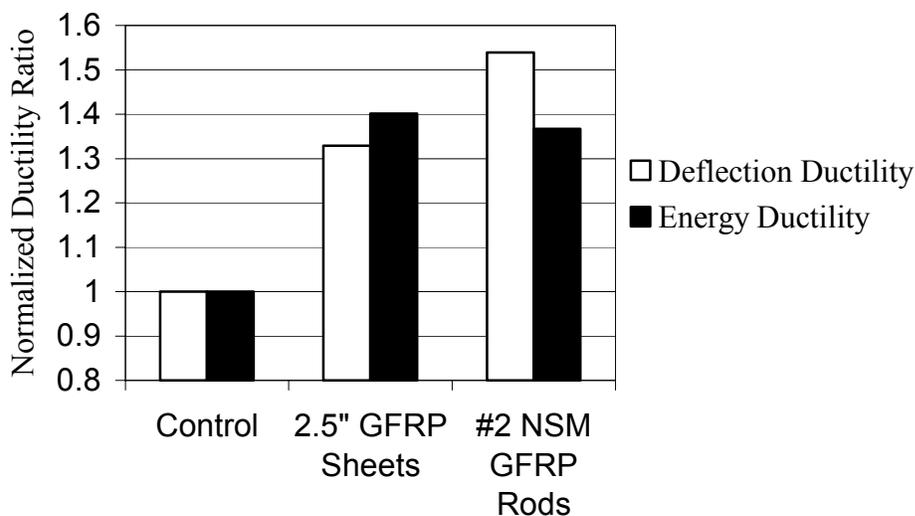
Figure 5.20. Strengthening Scheme Effects on Normalized Ductility Ratio

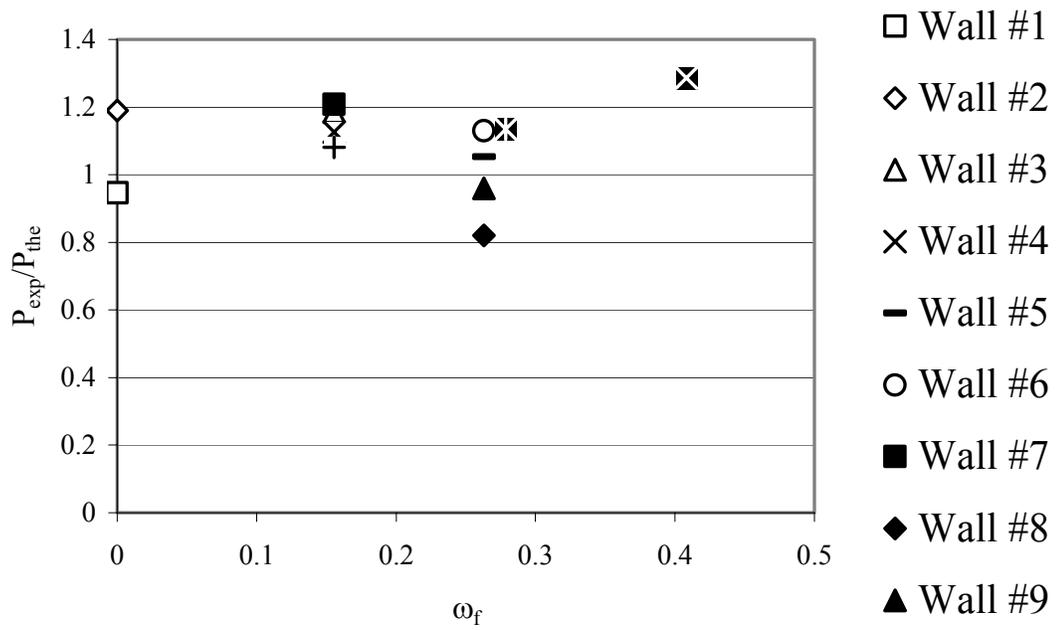
Figure 5.22. Pressure Ratio versus Reinforcement Index

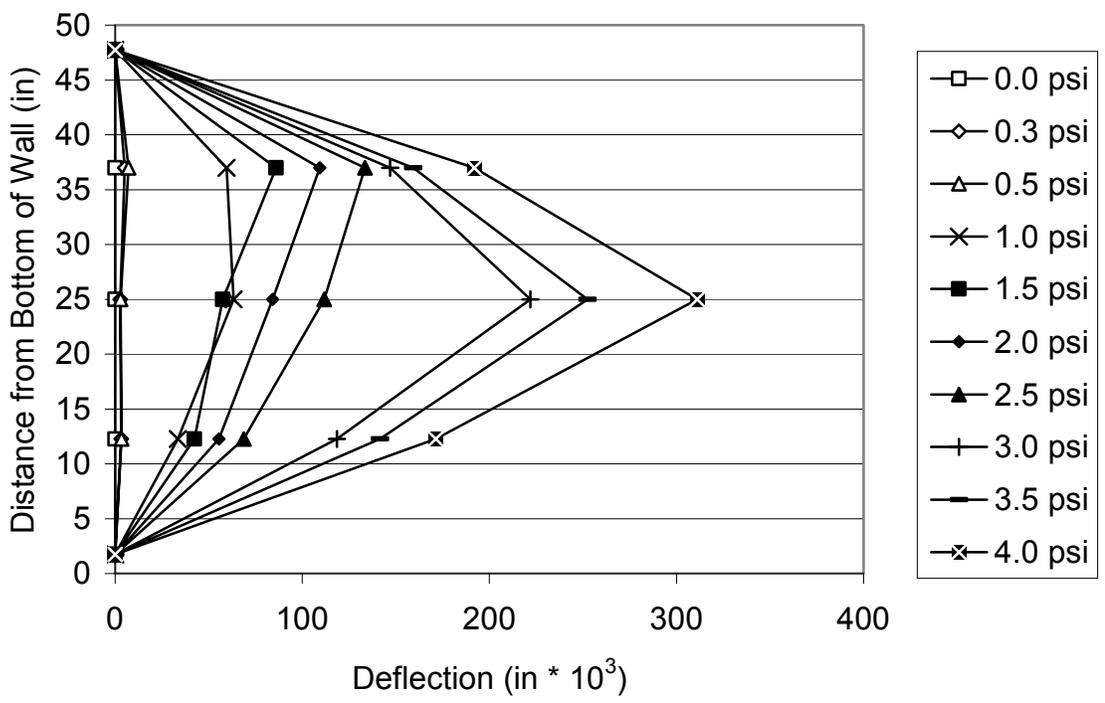
Appendix A.1 contains plots of deflection readings at various pressures versus the height of the wall. These plots have been normalized to take into account the slight rotation of the top boundary member that occurred during testing. The deflection plots show the deflected profile of the walls up to the point where the dial gages were removed for safety reasons. It is evident from these plots that arching action is present in the experiment.

Figure A.1.1. Wall #1 Deflected Shape

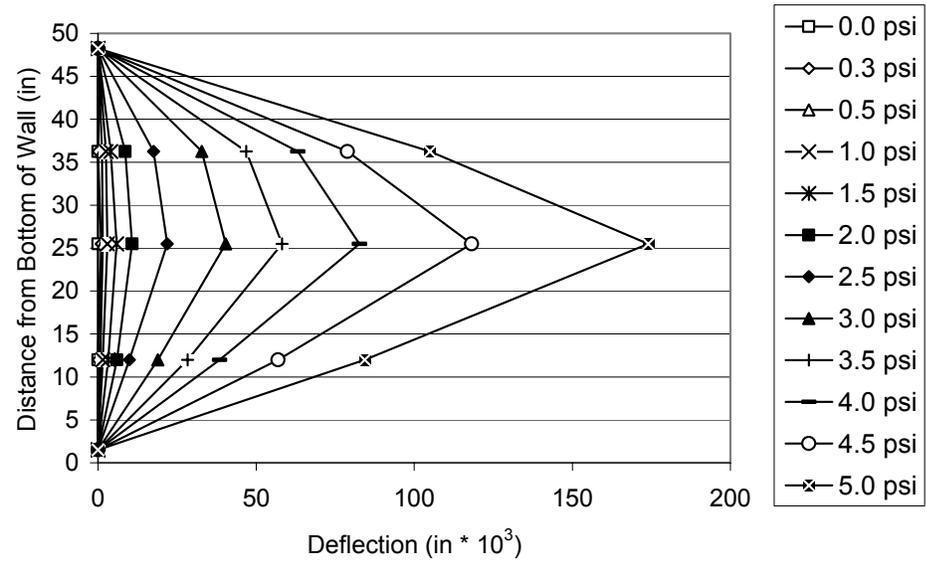
Figure A.1.2. Wall #2 Deflected Shape

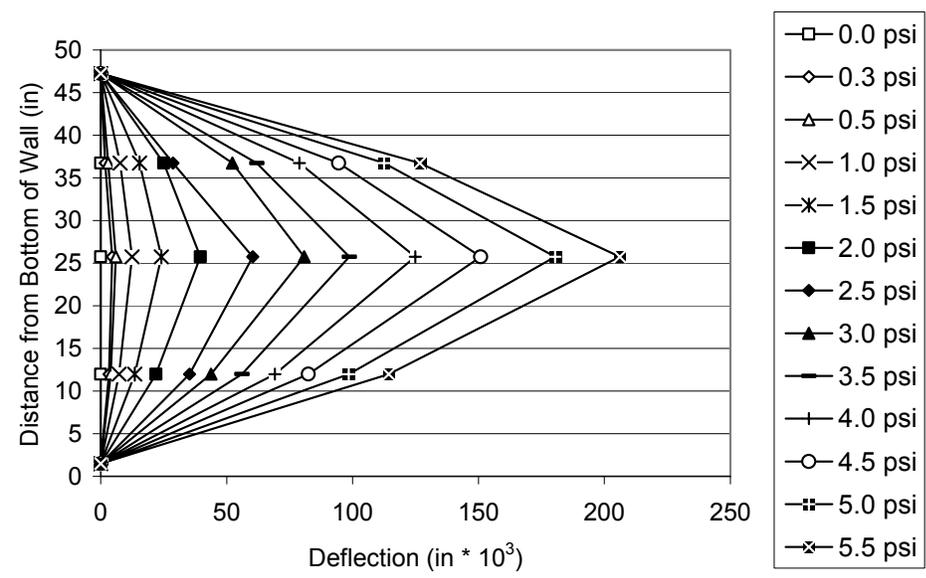
Figure A.1.3. Wall #3 Deflected Shape

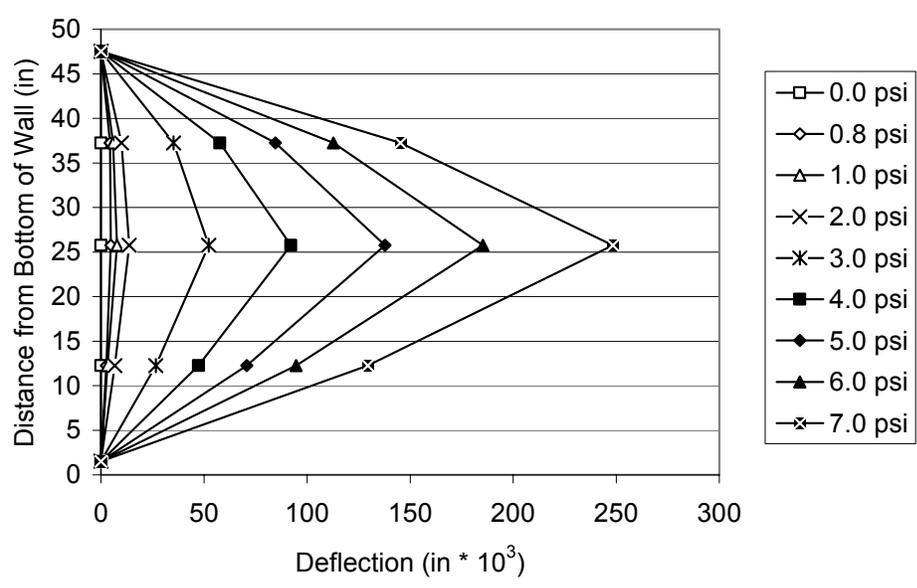
Figure A.1.4. Wall #4 Deflected Shape

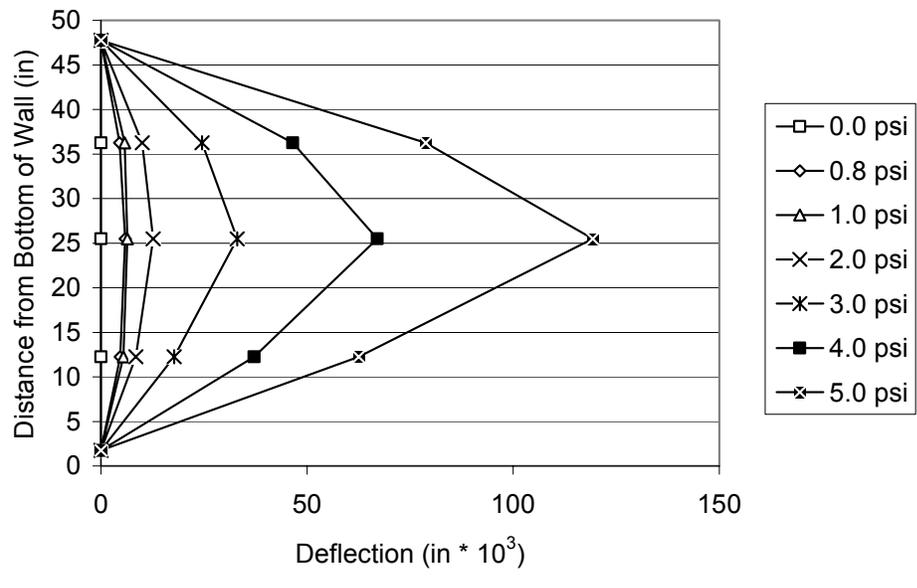
Figure A.1.5. Wall #5 Deflected Shape

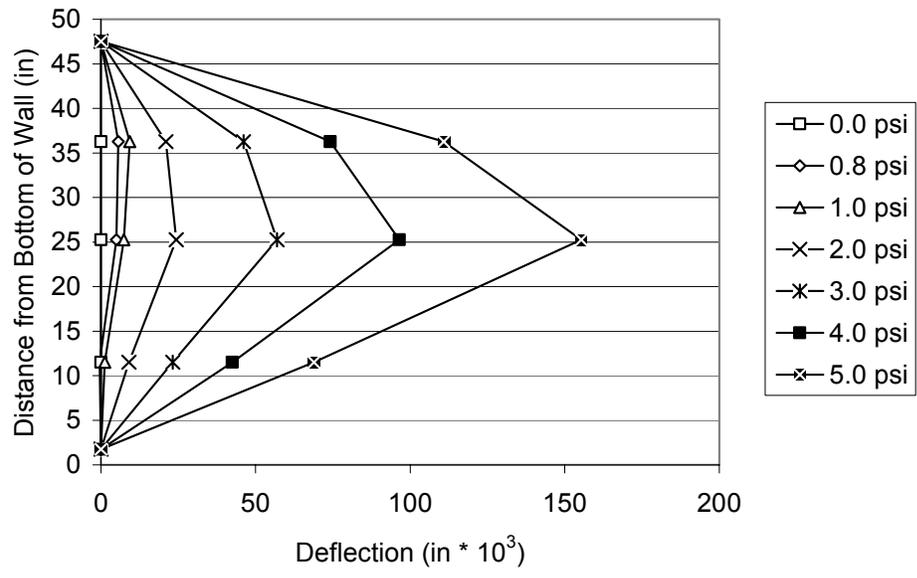
Figure A.1.6. Wall #6 Deflected Shape

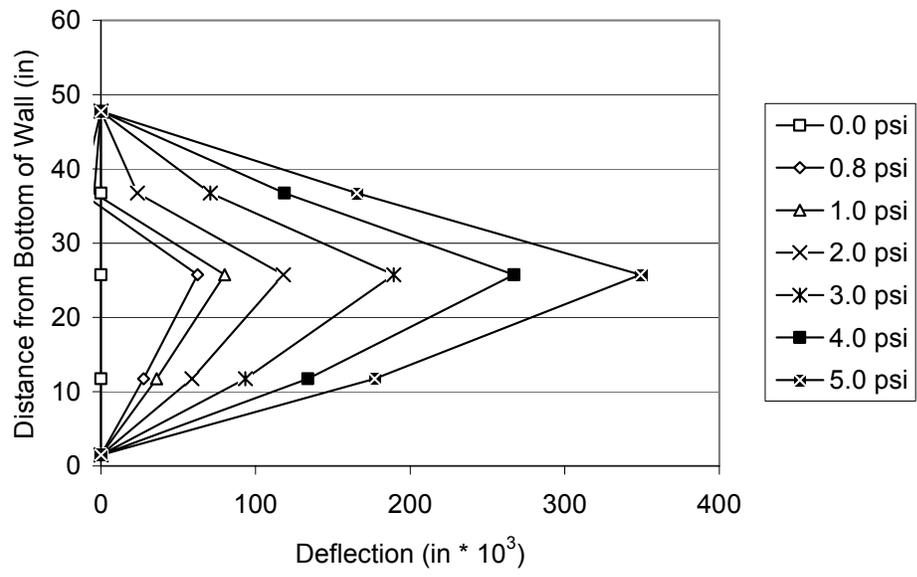
Figure A.1.7. Wall #7 Deflected Shape

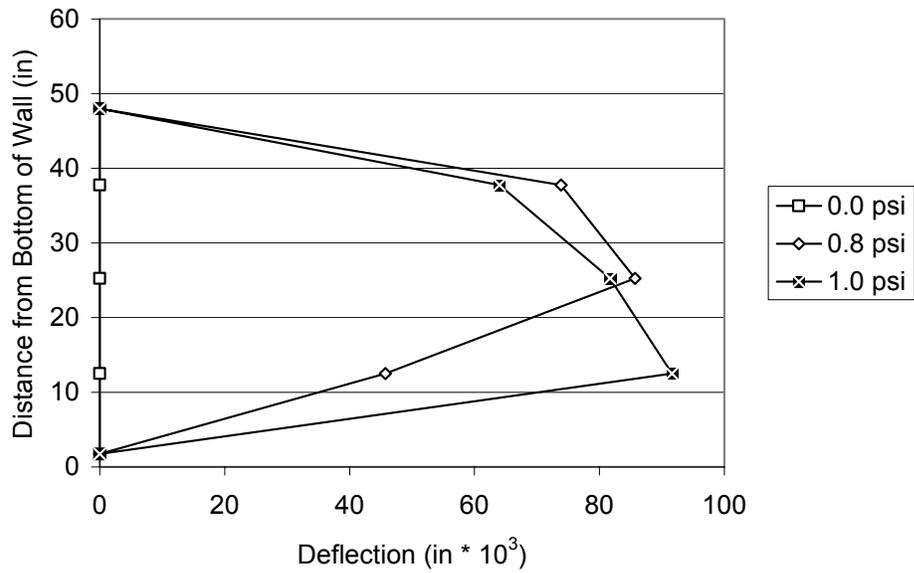
Figure A.1.8. Wall #8 Deflected Shape
