OUT-OF-PLANE STATIC AND BLAST RESISTANCE OF UNREINFORCED MASONRY WALL CONNECTIONS STRENGTHENED WITH FIBER REINFORCED POLYMERS

University of Missouri-Rolla

03-46

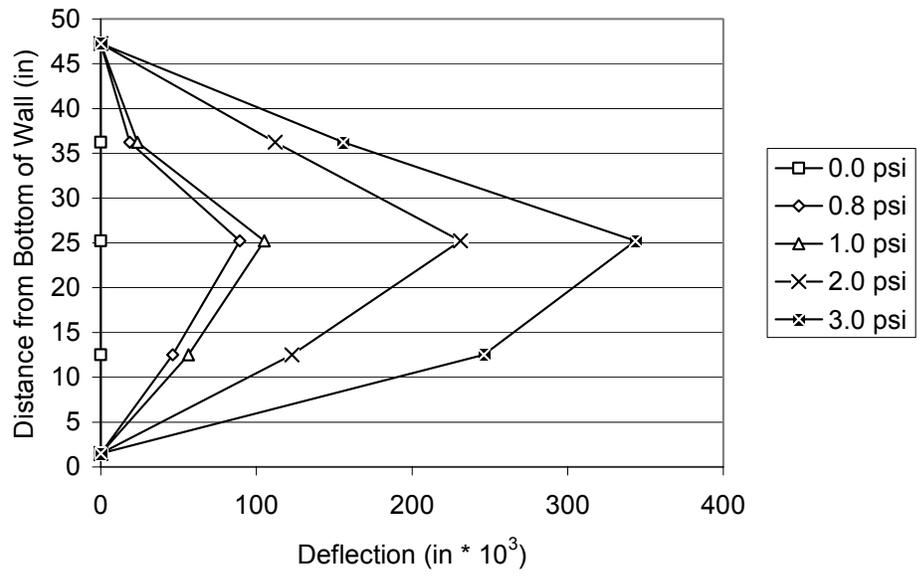
Figure A.1.10. Wall #10 Deflected Shape

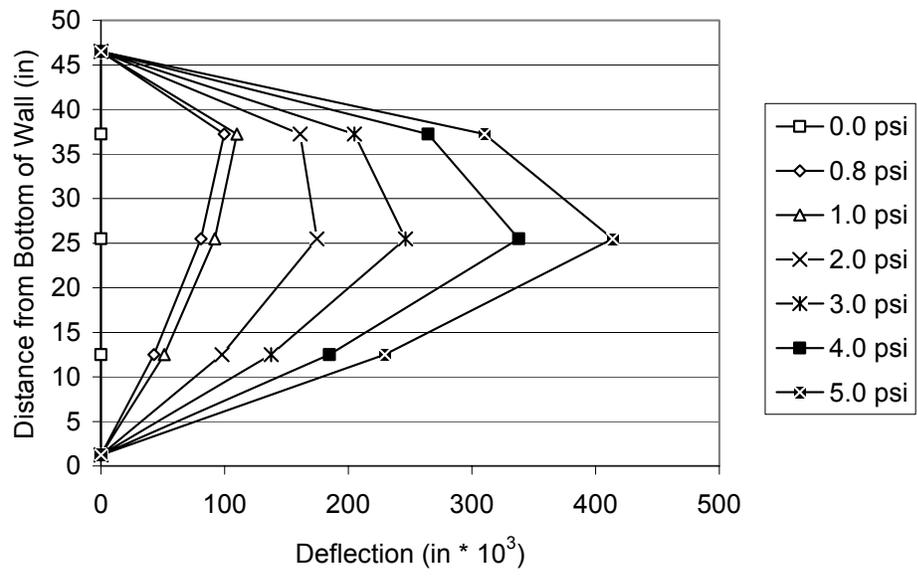
Figure A.1.11. Wall #11 Deflected Shape

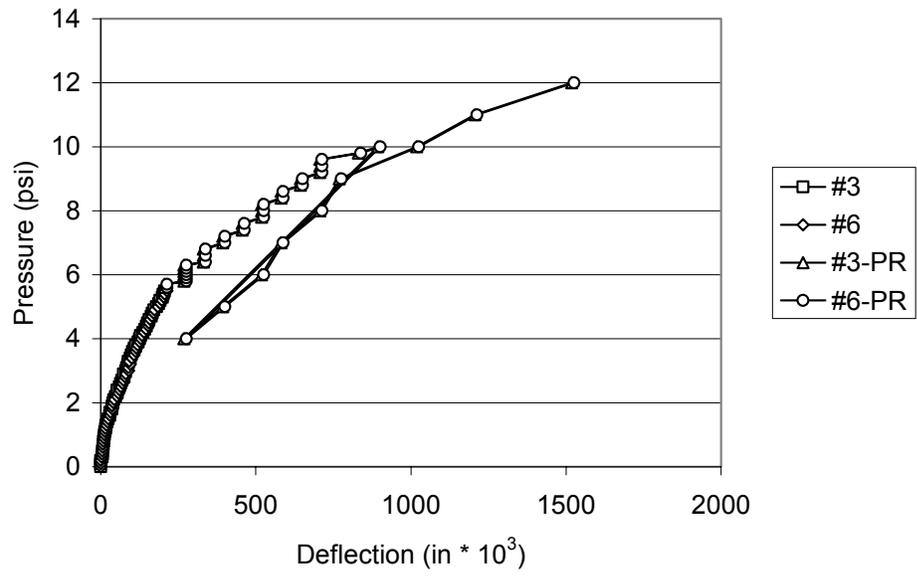
Figure A.2.3. Wall #3 Pressure vs. Midspan Deflection

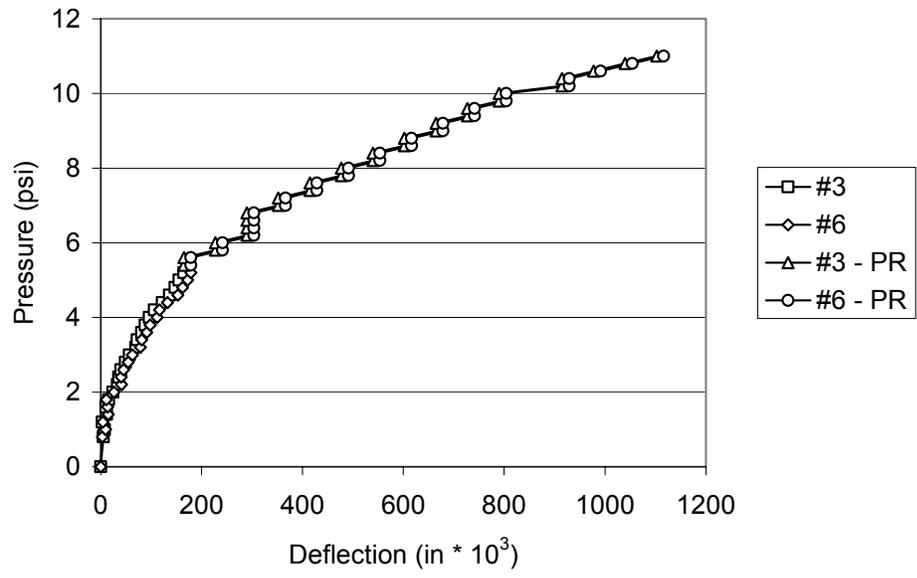
Figure A.2.6. Wall #6 Pressure vs. Midspan Deflection

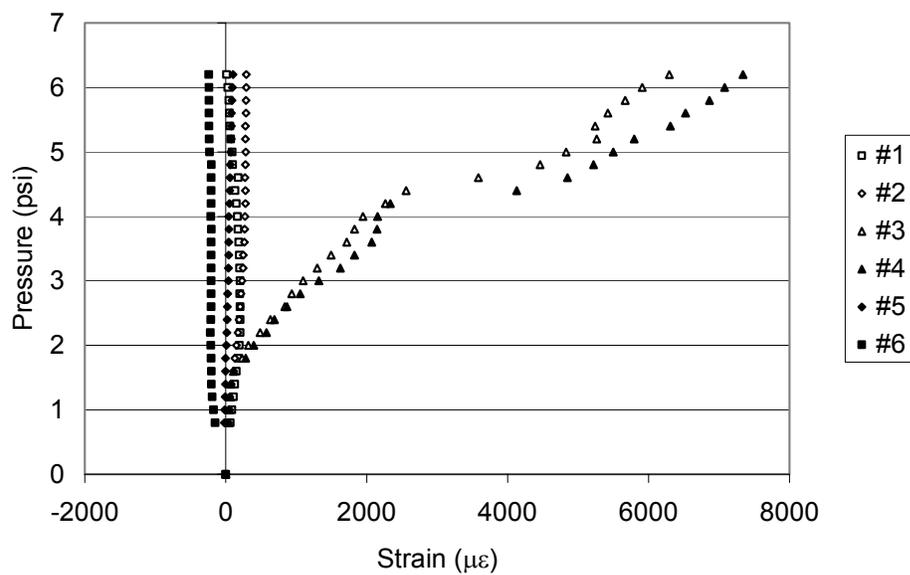
Figure A.3.4. Wall #6 Pressure vs. Strain
