PASSIVE AND ACTIVE NEAR-SURFACE MOUNTED FRP RODS FOR FLEXURAL STRENGTHENING OF RC BEAMS

Abstract

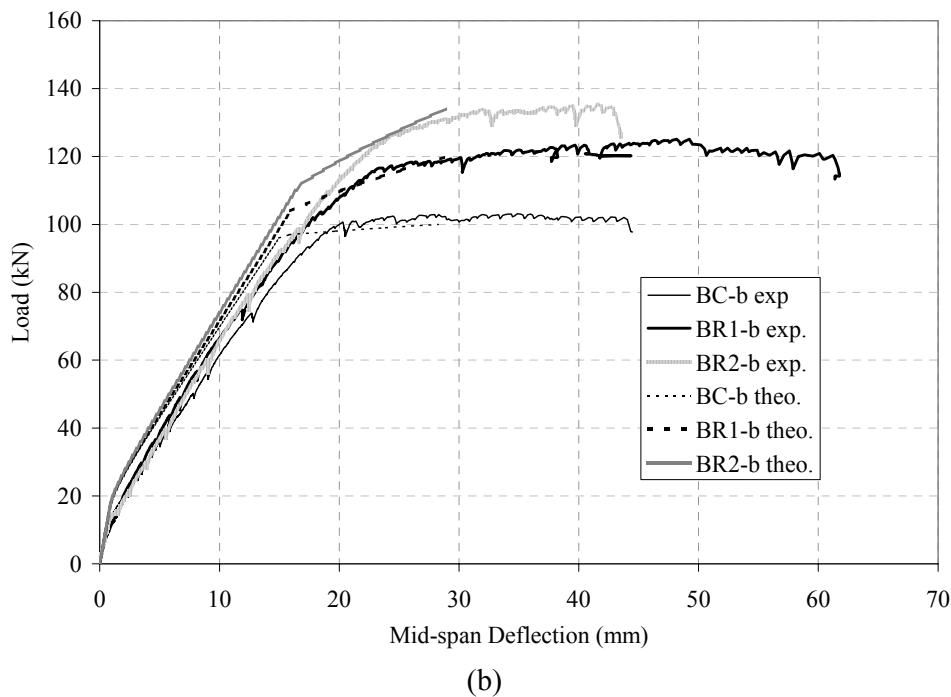
Figure 3. Experimental and Theoretical Load vs. Mid-span Deflection Curves of the Tested Beams: a-series (a) and b-series (b).

close agreement with the prediction of the analytical model. The experimental and theoretical load-deflection curves are reported in Figure 3, showing good correlation up to the ultimate load.

Also reported in the same figures are the load-deflection curves of the strengthened beams. The global behavior was common to all beams. As a result of the external strengthening, a moderate increase in stiffness was achieved in the region between cracking of the concrete and yielding of the steel longitudinal reinforcement. Also, the yielding load, corresponding to the change in slope of the curve, increased appreciably. After yielding, the control beams had a flat load-deflection behavior,

whereas in the strengthened beams yielding of the steel rebars led to a reduction in slope, but the FRP rod allowed the beam to take additional load. Theoretical and experimental curves generally correlate well up to yielding. In the post-yielding phase, the stiffness of the experimental load-deflection curve was usually lower than predicted, due to slippage of both steel and NSM reinforcement. Prediction of the ultimate load was very accurate when failure was by concrete crushing after yielding of the steel reinforcement; less accurate (with errors varying from 13% to 17%) when failure occurred by debonding mechanisms, not accounted for in the model.

As visible from the load-deflection curves in Figure 3, strengthening with NSM FRP rods does not appreciably increase the stiffness of RC beams, but only their strength. In order for a stiffness increase to be achieved, the strengthening system must be active rather than passive, i.e., the NSM rods need to be prestressed or post-tensioned. In a real strengthening situation, there is no

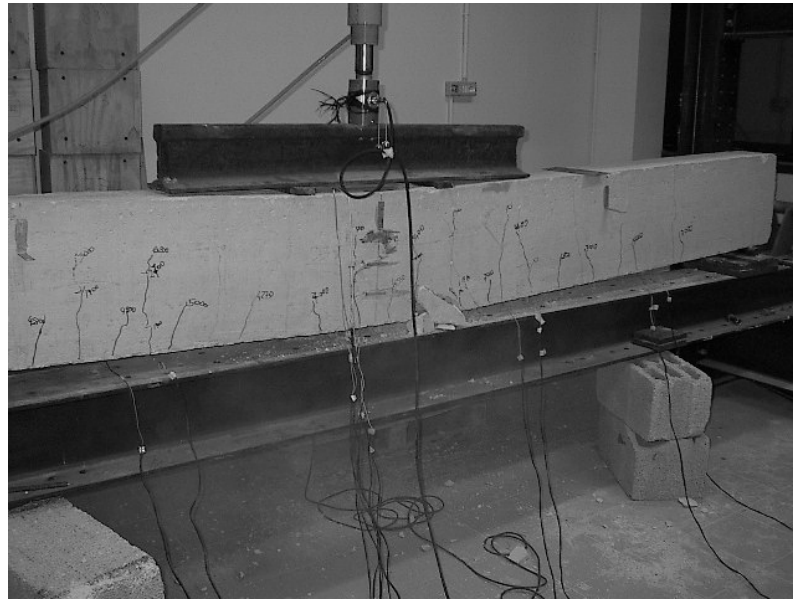
Figure 4. Failure of Beam BR1-a

Failure of Beam BR1-a, strengthened with one NSM CFRP rod, occurred under an applied load of 84.7 kN, corresponding to a 39.8% increase in capacity with respect to the control beam BC-a. The failure mode was debonding of the NSM rod. A typical crackling noise during the test revealed the progressive internal micro-cracking of the epoxy paste, especially in the post-yield phase when the increase in load was almost entirely taken by the NSM rod and its tensile stress increased considerably. Inclined and longitudinal cracks formed in the concrete surrounding the epoxy-filled groove. Such “bond” cracks were mainly located near each flexural crack and at the ends of the beam, that is, at the locations where bond stresses are maximum due to the transfer of stresses between the concrete and the NSM reinforcement. Finally, part of the concrete cover of the internal steel reinforcement was split off in a catastrophic fashion starting from the maximum moment region (Figure 4-a) and the epoxy prisms detached from the concrete with a thin layer of concrete remaining attached to their surface (Figure 4-b). After failure, the load dropped to a value close to the capacity of the control beam and deflection kept on increasing, until the test was stopped. This part of the load-deflection curve has not been reported. Due to “premature” bond failure, the experimental ultimate load was about 13% lower than the theoretical one.

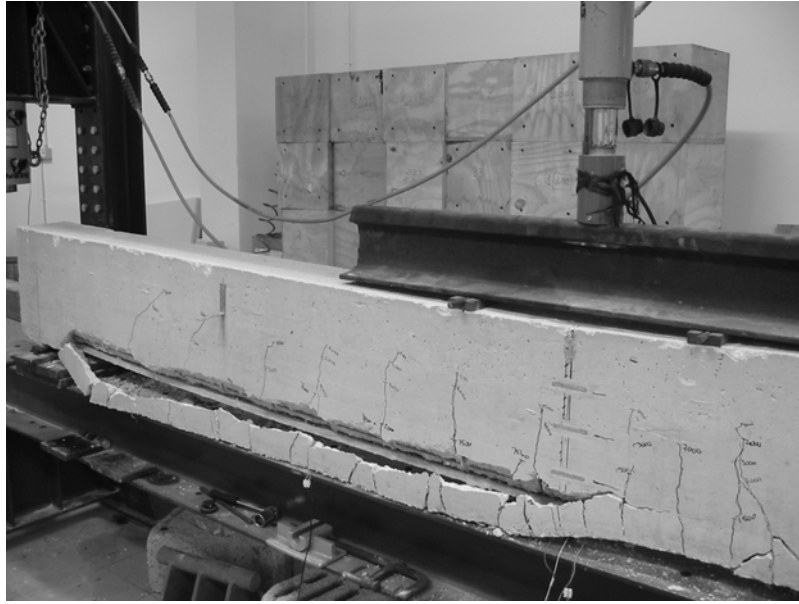
Figure 5. Failure of Beam BR2-a

Failure of Beam BR2-a occurred under an applied load of 97.3 kN, corresponding to a 60.6% increase in capacity with respect to the control beam BC-a and to a 14.9% increase over BR1-a. The higher FRP reinforcement ratio should have made debonding less critical for this beam than for BR1-b. However, the presence of two NSM bars side by side at relatively close distance between each other and with the edges (30-mm clear distance between the grooves, equal to about 1.8 times the groove size; 69-mm clear distance from the edge, equal to about 4.3 times the groove size) generated higher stresses in the concrete surrounding the grooves, similarly to what happens in lap splices of steel reinforcement in concrete. The failure mode was debonding of the NSM rods by spalling of the concrete cover of the longitudinal reinforcement along the edges of the beam (Figure 5). This suggests that, when using more than one NSM bar for strengthening, the distance between two adjacent grooves and the distance of each groove from the edges of the beam should not be less than a minimum value to be established upon appropriate testing.

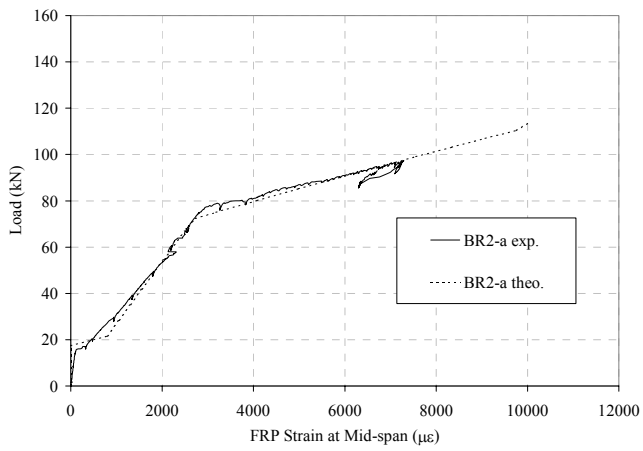
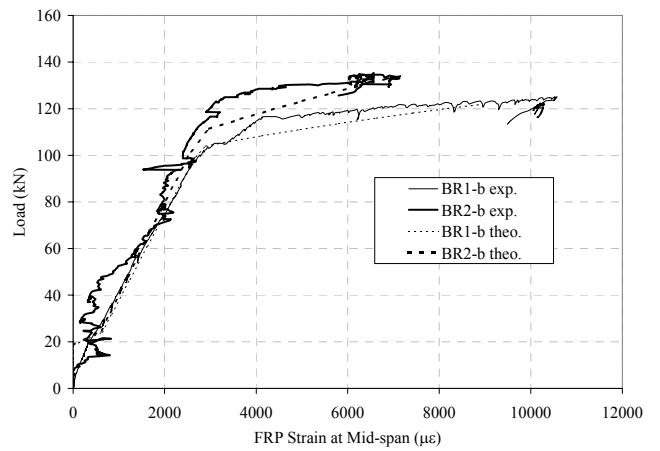
Figure 6. Experimental and Theoretical Curves of Load vs. FRP Strain at Mid-span: a-series (a) and b-series (b).

Figures 6 and 7 show the theoretical and experimental load vs. FRP and top concrete strain at mid-span. After steel yielding, the strain in the FRP increased at a much faster rate as indicated by the reduced slope of the curve. This is due to the fact that, after the rebars yielded, the FRP alone resisted further increments of the tensile component of the internal moment couple. There is good agreement between experimental and theoretical results up to the experimental ultimate load.

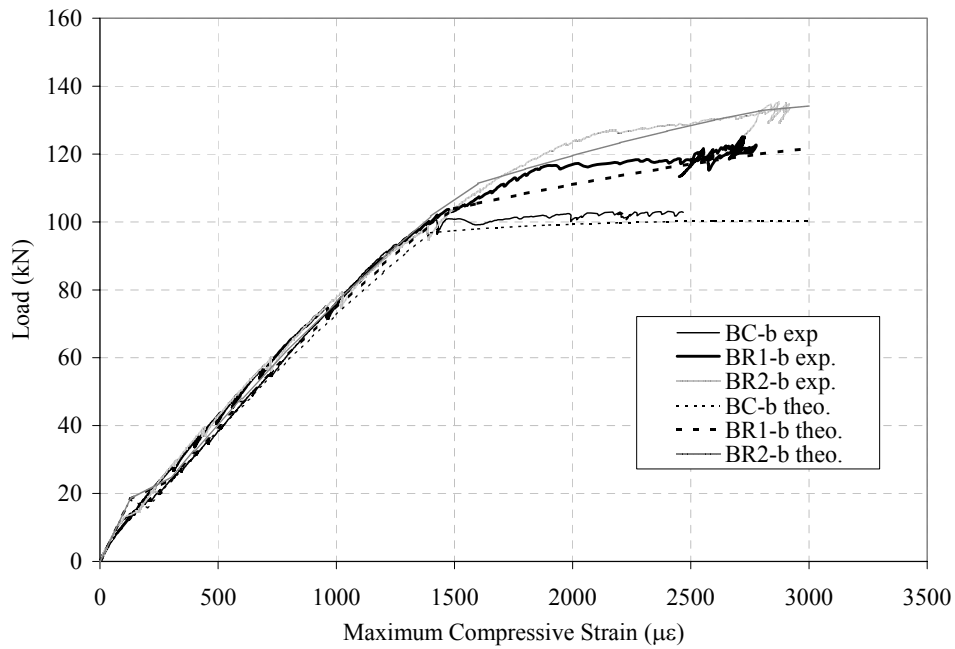
Figure 7. Experimental and Theoretical Curves of Load vs. Top Concrete Strain at Mid-span: a-series (a) and b-series (b).
