Post-Repair Performance of Corroded Bond Critical RC Beams Repaired with CFRP

by B.C. Craig and K.A. Soudki

Synopsis: Presented in this paper is an investigation on the ability of externally applied fiber reinforced polymer (FRP) laminates to maintain bond of steel reinforcement in concrete members subjected to corrosion. Specimens were transversely confined with CFRP laminates in the bond zone after being subjected to various degrees of corrosion ranging from 2 to 10% theoretical mass loss. Some specimens were further corroded after repair to assess the effects of further structural deterioration. Control beams were subjected to minor amounts of corrosion and tested to failure without repair. Test results showed that CFRP wrapping was able to confine the corrosion cracking resulting in an overall flexural failure for all repaired specimens unlike the brittle bond splitting failures of the control specimens. CFRP confinement proved less effective at higher levels of pre-repair corrosion. Initial amounts of post-repair corrosion enhanced the performance of the CFRP repair by increasing the confining pressure; however the concrete rapidly deteriorated as the corrosion increased. In

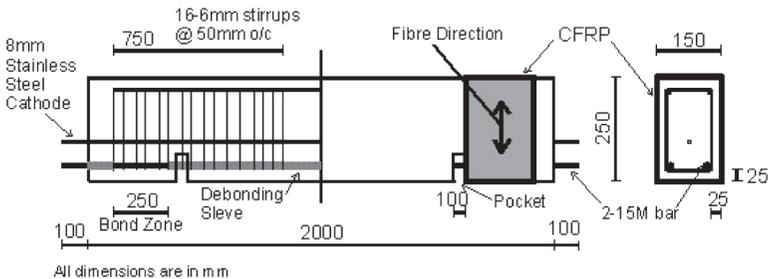
Figure 1 – Test Specimen Reinforcement and CFRP Layout

The beam specimen measured 150 mm wide, 250 mm high and 2000 mm long as illustrated in Figure 1. Beams were reinforced to provide a ductile failure in the event that an adequate bond length was provided. Reinforcement consisted of two No. 15M, Grade 400, deformed bars to achieve a reinforcement ratio (ρ_s) of 0.012. The tension reinforcement was placed such that 25 mm of clear cover was maintained to the side and bottom of the bar ($c/d_b = 1.56$). The length of the reinforcing bar was selected such that a minimum of 100 mm was exposed on either end of the beam to allow for instrumentation. Shear zones were reinforced with 6 mm diameter stainless steel stirrups at 100 mm spacing to ensure adequate shear resistance. The 28-day concrete compressive strength was 42 MPa and the yield strength of the tension reinforcement was 440 MPa.

Reinforcing bars were debonded from the concrete outside of the bond zone using low-density polyethylene tube. Pockets were formed in the concrete tension zone near the midspan of the beam, outside of the bond zone, to allow for easy instrumentation of the tensile reinforcement during testing.

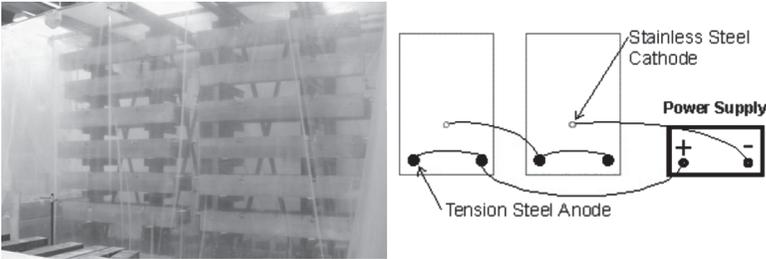
Figure 2 – Corrosion Tent and Electrical Setup

Specimens were deteriorated using accelerated corrosion by means of an impressed current. The corrosion setup is shown in Figure 2. To facilitate the corrosion process, an 8 mm diameter hollow stainless steel tube was cast within the beam to act as an internal cathode. Furthermore, the concrete in the bottom third of the beam was contaminated with NaCl in order to produce a concrete mixture with 2.3% chlorides by mass of cement.

Specimens were connected in series by wires through the stainless steel bar and the tensile reinforcement to a power source. A constant current was applied such that the stainless steel bar acted as the cathode, and the tensile reinforcement as the anode in the corrosion reaction. The polyethylene debonding sleeves acted as insulator around the tension reinforcement ensuring that all corrosion occurred in the bond zones. Current

Theoretical mass loss was calculated using Faradays Law, which specifies the amount of mass loss expected at a specific current density over a specific time frame (Jones, 1996). Specimens were corroded at room temperature in a humidity tent where they were subjected to cycles of 2.5 days at 100% relative humidity and 1 day dry for the duration of the corrosion period (Figure 2).

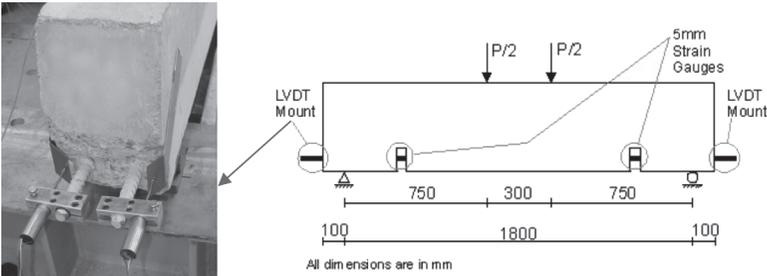
Figure 3 – Test Setup and Instrumentation

Specimens were tested to failure in four-point bending using the configuration shown in Figure 3. The specimens were simply supported over a span of 1800 mm, with a constant moment region measuring 300 mm.

Overall beam performance was monitored using a load cell and a displacement transducer (LVDT) located at the midspan of the beam. Slip displacement of the tensile steel was measured using LVDT's mounted to the free ends of the reinforcing bar. The LVDT's determined the free end slip by measuring relative displacement between the reinforcing steel and concrete surface as the bar was pulled through the concrete. The tensile steel stress was measured using 5 mm strain gauges attached to the bars within the pre-cast pockets at four locations.

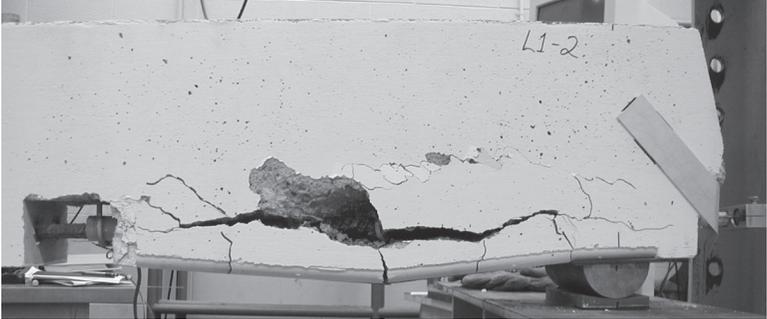
Figure 4 – Bond Splitting Failure Crack Pattern, Series L1

For all bond lengths, the control specimen failed by bond splitting action. For Series L1 and L2, this deviated from the designed mode of failure. The two percent theoretical mass loss provided enough loss of confinement to cause both specimens to fail abruptly. Series L1, with the longer bond length, was still able to achieve yielding of the reinforcing bar prior to loss of load carrying capabilities. Visually, the effect of the bond splitting is shown in Figure 4 where longitudinal cracks were developed along the length of the bar through the bond zone. These cracks were partially developed from existing corrosion cracks. Lack of confinement around the reinforcing bar is evident as the concrete is cracked and displaced in the bond region. At the time of failure, a sudden loss in load carrying capability for all three members can be seen in the form of an instantaneous drop on the load deflection curve (Figure 5). None of the members were able to achieve their full flexural capacity. Similar behavior may be observed for all beams with respect to their bond slip behavior (Figure 6). It is evident that the series with the longer bond length was able to develop bond stresses closer to the ultimate capacity. The following sections discuss the behaviour of the different test series.

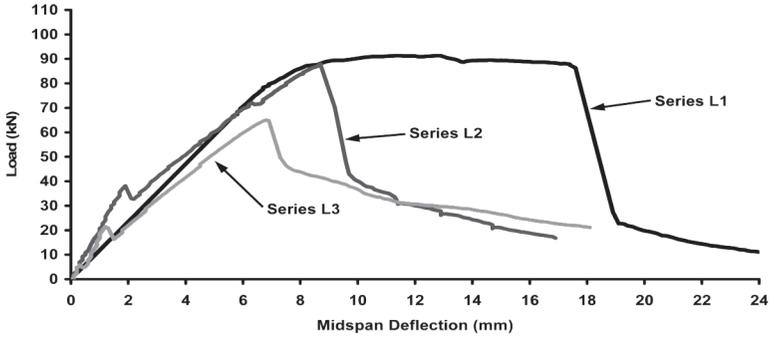
Figure 5 – Load-Deflection Curve for Unconfined Members

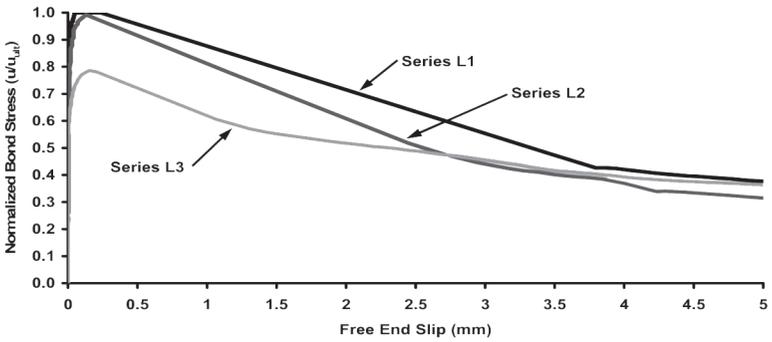
Figure 6 – Bond Stress vs. Free End Slip for Unconfined Members

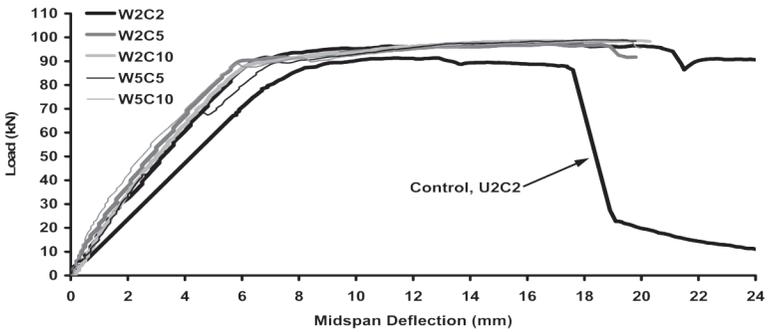
Figure 7 – Load-Deflection Behavior, Series L1

It is apparent from the load-deflection plots in Figure 7 that the post-repair beams were able to outperform the control beam. The repaired beams were able to achieve a ductile flexural failure. Analysis of the slip data indicated that unlike the control specimen, there was zero or negligible free end slip in the reinforcement for all repaired specimens. This indicates that none of the specimens provided any evidence of potential premature failure due to bond degradation. Therefore, for this series, the wrapping improved the performance of the corrosion damaged beams up to of 10% theoretical mass loss.

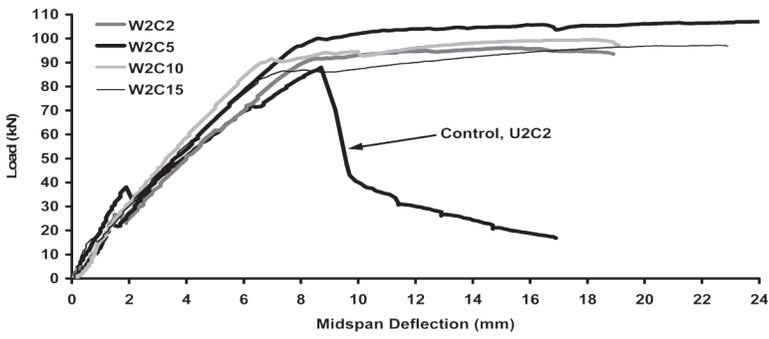
Figure 8a – Load-Deflection Behavior, Series L2

Beams that were repaired at 2% theoretical mass loss were able to achieve a ductile flexural failure (Figure 8a). No additional deterioration was observed as the post-repair corrosion increased. Slip gauges indicate that little to no slip was measured up to failure of the specimen. At 10% mass loss, a slip of 0.04 mm was measured at the free end of only one bar indicating a potential weakening of the concrete around one of the tension bars. Slip initiation occurred around 3.66 MPa bond stress, which is 73% of the maximum predicted bond capacity. The slip was localized to one area of the tensile reinforcement and did not continue to propagate. The measurement is small and could be linked to experimental error. However, the possibility remains that under sustained load, the slip could continue eventually leading to failure. The high level of corrosion may have increased the confinement pressure beyond the compression strength of the concrete causing local crushing around the ribs leading to weakening of the bond strength. In general, the results indicate that beams in the L2 series confined at 2% mass loss were able to re-establish a ductile flexural failure with minimal indication of bond degradation. This result exhibits a significant improvement over the control specimen, which failed by bond splitting.

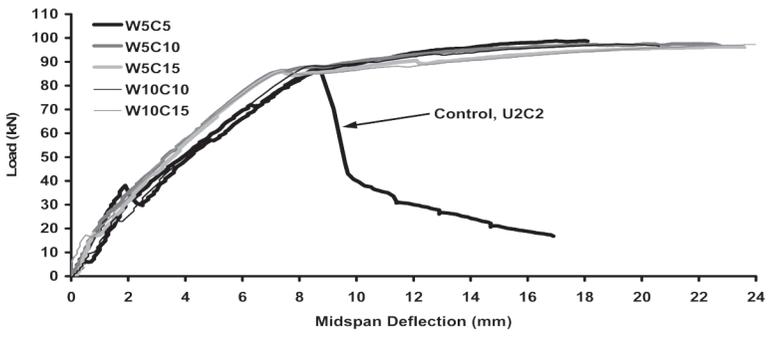
Figure 8b – Load-Deflection Behavior, Series L2

In terms of overall behavior, beams repaired at 5% mass loss show a similar trend to those repaired at 2% mass loss. Figure 8b shows that the load-deflection plots are relatively consistent with only slight differences most likely due to variations in material properties. However, when examining the local free end slip behaviour of the reinforcing bar, there is evidence that slip occurred in specimen W5C15, which was subjected to the highest level of post-repair corrosion. Specimen W5C10, corroded to 10% mass loss, behaved similarly to specimen W5C5 at 5% mass loss with little to no slip in the reinforcing bar at the time of failure. The additional post-repair corrosion damage induced in specimen W5C15 developed enough pressure to further deteriorate the concrete surrounding the reinforcement, thus weakening the mechanical interlock component of the bond. A free end slip of 0.07 mm was recorded at the time of failure. Slip initiation occurred at a bond stress of 3.60 MPa, which demonstrates a 28% reduction in bond stress at slip initiation relative to the theoretical maximum bond stress. This reduced level of bond stress at slip initiation is an indication of deterioration in the concrete, which could lead to a premature bond failure under sustained load conditions.

Specimens W10C10 and W10C15 exhibited load-deflection and load-slip behavior similar to the other flexural failures (Figure 8b). No significant degradation in bond strength was observed since no slip was recorded at the free ends of the tension steel. This indicates that specimen W10C10 out performed the other repaired beams corroded to 15 % mass loss (W2C15 and W5C15) due possibly to the initial bond enhancement created by small increases in the degree of corrosion. The concrete around the reinforcing bar was significantly cracked prior to repair, indicating that even though corrosion around the bar had occurred, some of the mechanical interlock could still be maintained. The small amount of corrosion after CFRP repair (2.2% experimental mass loss) has the potential of increasing the confining pressure in the bond zone since the

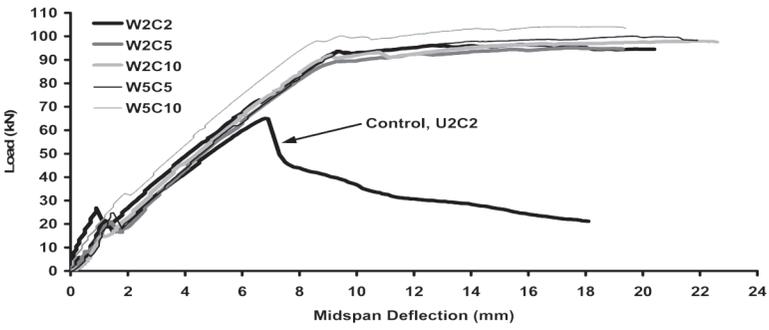
Figure 9 – Load-Deflection Behavior, Series L3

Based on the load-deflection plot in Figure 9, the failure mode for all corroded and repaired specimens had a ductile flexural failure, whereas the control specimen was subjected to a brittle bond splitting failure. The overall load-deflection behavior of specimens W2C5, W2C10 and W5C10 was similar to the beams that were not subjected to any further corrosion after repair (W2C2 and W5C5). This shows that even after additional corrosion, the overall performance of the CFRP repaired specimens was superior to the control specimen, U2C2, which failed by bond splitting.

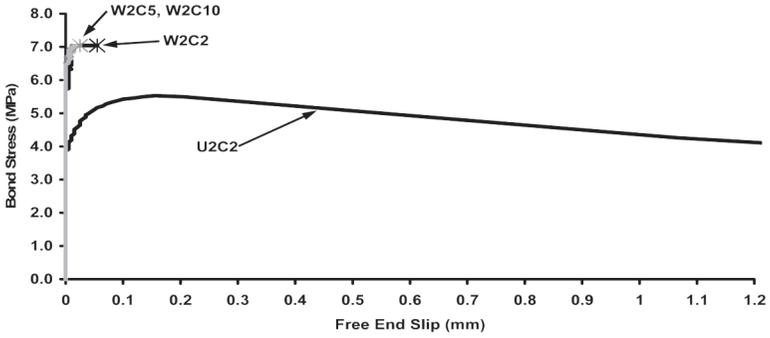
Figure 10 – Bond Slip Behavior, Series L3, Repaired at 2% Mass Loss

Examining the bond-slip curves, several observations can be made. The beams that were repaired at 2% mass loss had small amounts of free end slip at failure (Figure 10). The slip values of the steel reinforcing bar at failure were 0.06, 0.02, and 0.03 mm for specimens W2C2, W2C5 and W2C10, respectively. CFRP confinement to the concrete at the low corrosion levels preserved the integrity in the bond zone. Further corrosion after repair even up to high degrees of mass loss, up to 10%, did not damage the steel ribs and the surrounding concrete to a condition that would result in a bond failure. The internal pressure developed from the CFRP confinement allowed the reinforcing steel to continue to interact with the concrete. In turn, the added pressure reduced the overall slip by increasing the stiffness in the bond zone. Some degradation was observed at 10% mass loss with a 2% reduction in the slip initiation bond stress over the other two specimens. However, this change is very small and could be a result of other factors including experimental error.

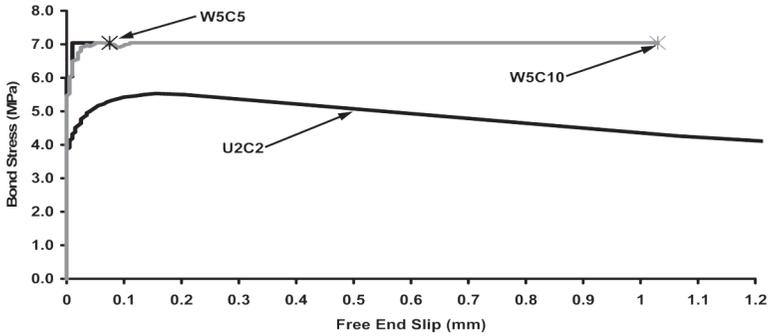
Figure 11 – Bond Slip Behavior, Series L3, Repaired at 5% Mass Loss

Different results were observed for the beams repaired at 5% mass loss. When tested directly after wrapping, W5C5 exhibited a free end slip of 0.08 mm at failure. When the corrosion was continued after repair up to a mass loss of 10%, the slip value for specimen W5C10 significantly increased to 1.03 mm (Figure 11). The free-end slip at yield was 0.07 mm whereas specimen W5C5 had slip initiation after yielding of reinforcement bar. The bond stress at slip initiation for W5C10 was 7% lower than the ultimate bond stress, exhibiting noticeable degradation compared to other repaired specimens. The large increase in slip at ultimate denotes that a bond pullout failure was in progress. The residual bond force caused by friction due to confinement was sufficient to lead to a flexural failure under static load conditions. However, under sustained load or fatigue testing, a premature bond pullout failure would be expected.
